DESCRIPTION

Aperia has released a new torque specification and Grade 8 hex bolt to enhance reliability.

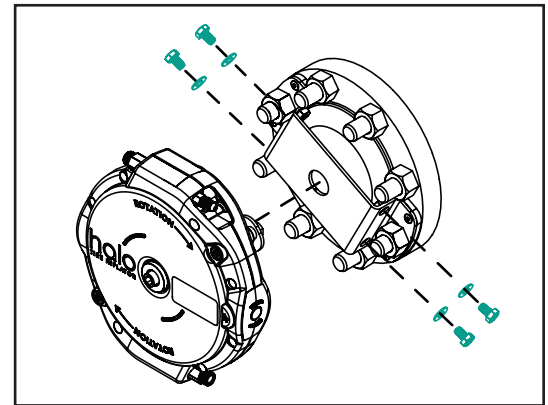
The Grade 8 hex bolts replaces the existing Grade 5 hex bolt during the installation of the Halo device (see Figure 1). All existing, and new bolts should now be torqued to the 20 +/- 2 ft-lb specification, as opposed to the previously communicated 15 +/- 2 ft-lb setting.

Figure 1. Updated bolts in teal

If the corrective actions are not completed at each vehicle's next preventative maintenance the Halo may be at risk of detaching from the vehicle during operation.

- The Grade 5 hex bolts should be torqued to 20 +/- 2 ft-lb during the next preventative maintenance.
- The Grade 8 hex bolts with nylon patch should be torqued to 20 +/- 2 ft-lb during the next preventative maintenance.
- All future Halo shipments will include Halo User Manual (IN-100UM_R03), which includes the updated torque specification.
- Bolts should be checked during recommended maintenance, as outlined in the Halo User Manual (IN-100UM_R03).
