## From ALETES, SM#240 1999 with Jabsco manual pump: Head backflow and Holding Tanks

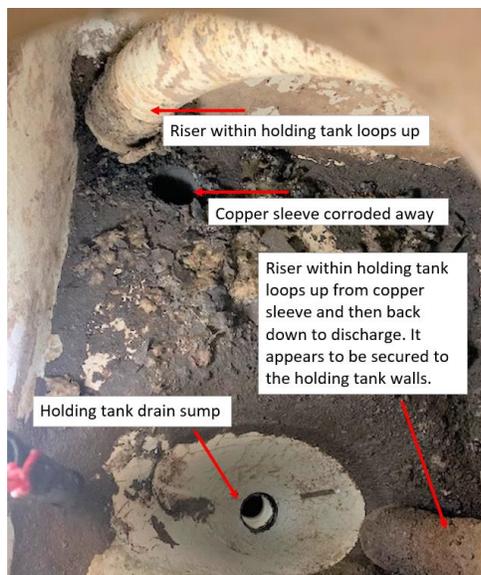
*1 copper sleeve*

So as one can see, the copper sleeve also corroded within the tank and ultimately the riser extension within the tank separated from it. Wastes were being pumped into the BOTTOM of the tank, and any disconnection of the riser hose in the inboard side would drain any remaining contents within the tank above the drain sump. One curiosity is why the riser within the tank would loop up and then back down so that the discharge point is low in the tank. We couldn't see but presume there is no vacuum breaker at the top of the loop, so as soon as the contents level would be above the discharge end of the loop, the riser would not drain itself, and in fact become a siphon for backflow. Anyway, since it seemed attached to the tank wall and/or top and we could not get into the tank to disconnect, we could not remove it and it was abandoned in place. NOTE TO OTHERS who have experienced the corrosion of the copper sleeve below the tank - this failure within the tank may be in your future as well.

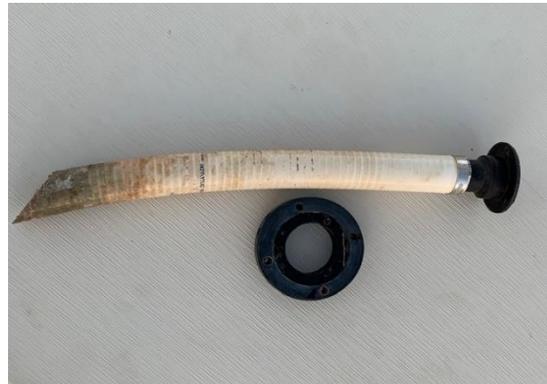
*2 Pump out riser*

After curing we filled the tank with clean water to test for leaks. There seemed to be none. However, overnight there was evidence of a slight leak. We suspect there was insufficient gap between the tube and the fiberglass for the somewhat viscous resin to fully flow and fill. Otherwise, this solution seems good. So now the plan is to remove the tube, ream out the fiberglass a bit more to achieve, say, a 2mm gap between them and once again fill with resin.
