General Summary

Affordable Inspections, Inc.

Karen Brown

15 Keasler Rd

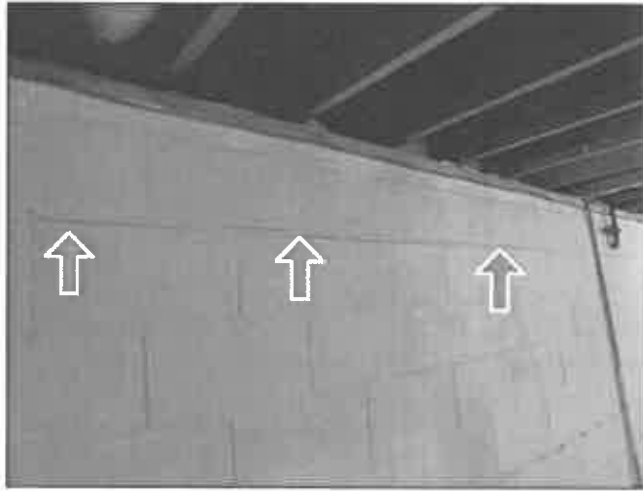
1.0 Item 1(Picture)

Horizontal cracking of the mortar joints was noted along the front foundation wall. No visible deflection was noted. This is usually a result of pressure against the foundation walls and can lead to eventual structural failure. The extend of the condition observed was not extreme and we would recommend further evaluation by a licensed professional engineer or to monitor the cracks and deflection over time for any change in appearance and take further action if they progress.

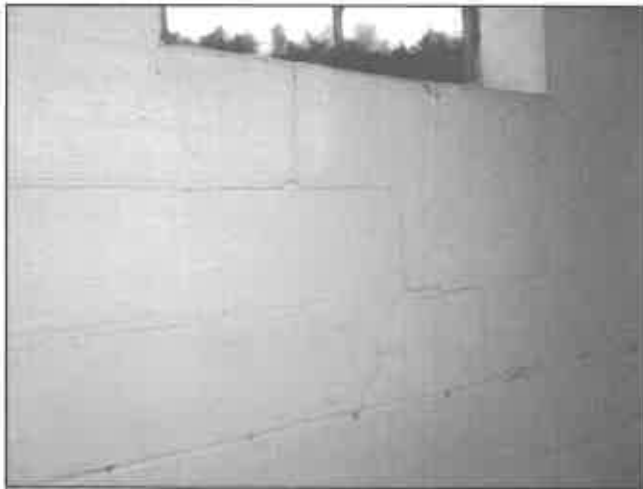
1.0 Item 3(Picture)

(2) Stair step cracking was also noted at the front foundation wall. As these cracks do not exceed 1/8" in width and no displacement of the block face is visible, they are not considered to be indicative of structural failure. These types of cracks are found on most homes in this area with block foundation walls due to our high clay content soil. We would however recommend that you seal or keep these cracks sealed to prevent moisture penetration and monitor over time for any change in appearance. If change is noted, Recommend consulting a licensed general contractor for further evaluation.

Stair step cracking of the mortar joints is visible . No structural failure or displacement of block was observed. We would recommend further evaluation and repair by a licensed general contractor if needed.

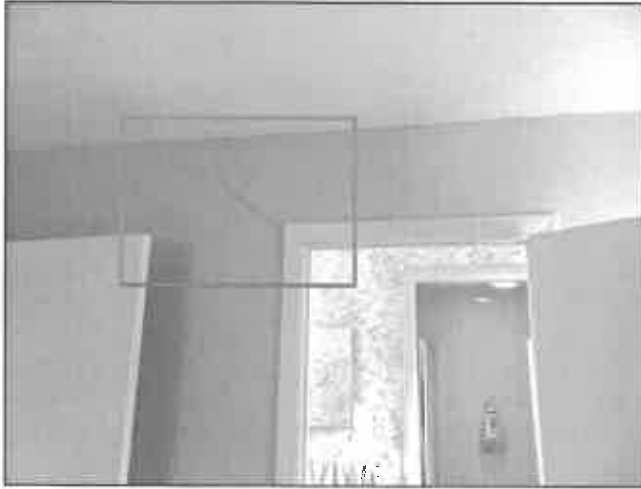
1.1 Item 1(Picture)

(1) In the master bedroom at the bathroom door, there is significant cracking at the corner of the door frame. I believe this is associated with the deterioration of the floor structure under the bathrooms as commented below in section 1.3. Recommend further investigation by licensed general contractor and repair as/if necessary.

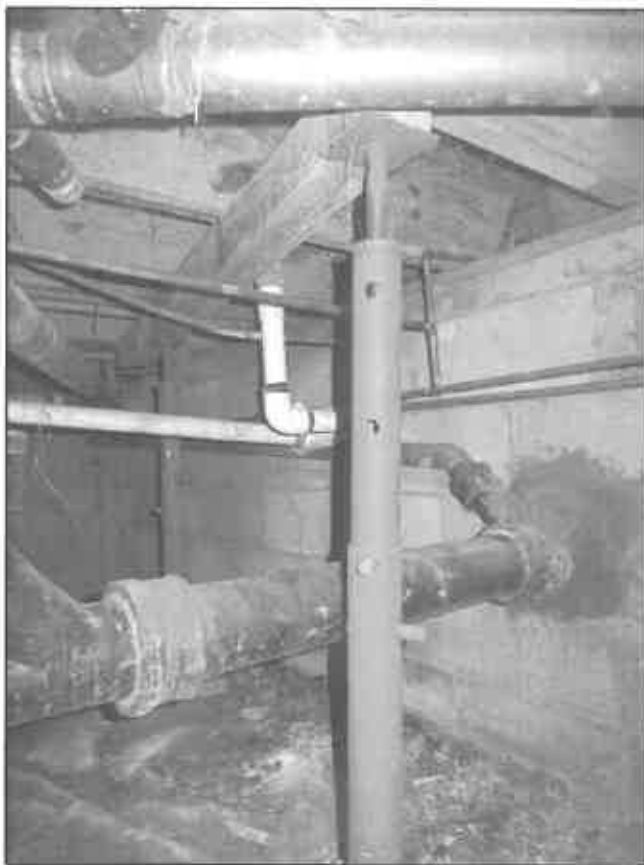
1.2 Item 1(Picture)

FYI: This house has slide style adjustable screw jacks in use supporting the floor structure. These are the type that use bolts to secure different sections of the posts. These types of adjustable style steel screw jacks are not designed or rated to be used as permanent supports for floor structures, although they are commonly used as such. Recommend further evaluation and replacement by a capable person or a qualified contractor.

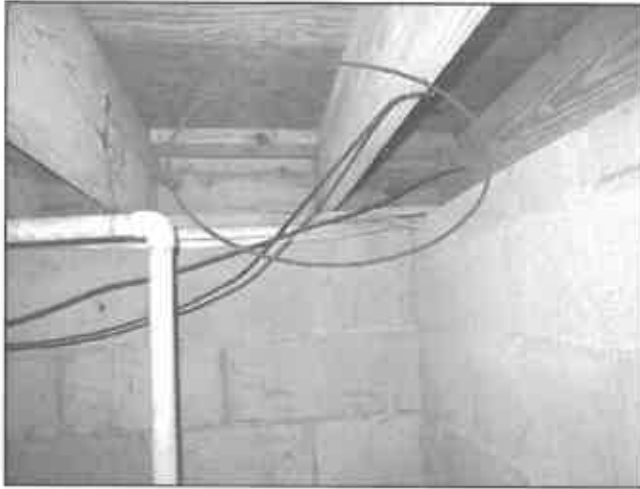
1.3 Item 1(Picture)

(1) The floor joists and other framing members in several locations (on the right side of the house

from the front door over in the crawlspace) have been attacked by wood destroying insects. They weaken the wood, eventually causing it to deteriorate completely. There was evidence of prior treatment of the house. I did not see any active wood destroying insects during the time of the inspection. This damage was also noted in the interior with weak spots in the floor and evidence of prior activity on the wall paper near the front door area as well as on the floor in the first bedroom. We would recommend further inspection and repair by licensed general contractor of any compromised wood members.

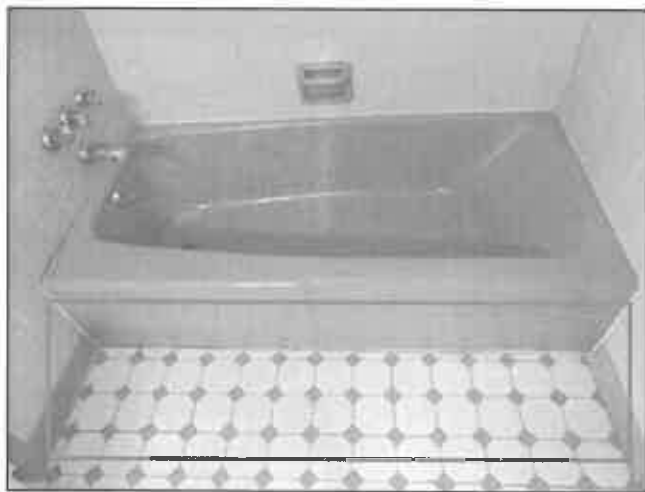
1.3 Item 15(Picture)

(2) The floor under the master shower area was heavily deteriorated and there was movement of the floor structure in front of the hall tub when stepped on. The deterioration and movement has lead to cracking of the hall bathroom floor with loose tiles in areas along with settling of the tub and cracking and displacement of the master shower floor. I believe there is continued leaking of the master bathroom shower as there are significant gaps/cracks in the grout between the tile walls and tile floor with no evidence of repairs in this area. There is evidence of prior repairs under the tub area, however the continued movement of the floor indicates that the repair is not sufficient. Recommend further evaluation and repair as needed by a licensed general contractor.

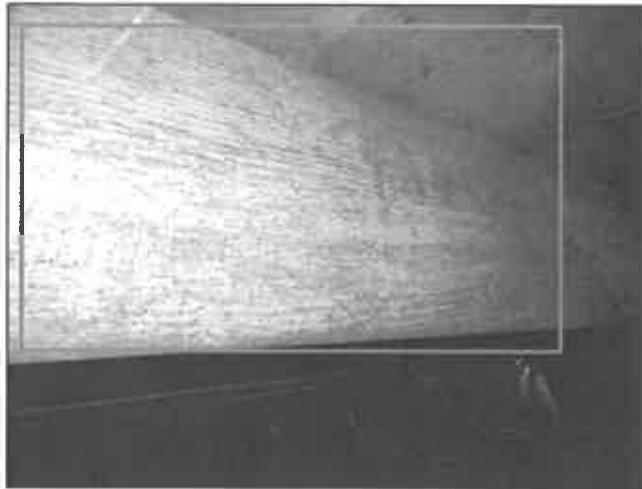
1.3 Item 24(Picture)

(3) There is surface growth on many of the floor joists in the crawlspace. No damage to the wood joists was visible from this growth, but the surface growth is indicative of a damp atmosphere which can be fertile ground for more destructive organisms. Recommend further investigation by crawlspace contractor specializing in moisture control.

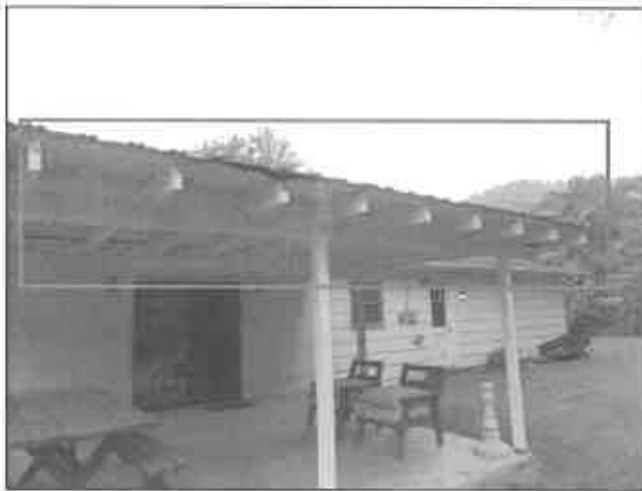
1.5 Item 1(Picture)

(1) The rafter tails of the rear porch structure are deteriorated. It appears that there used to be a fascia board that went across this area that presumably rotted away. Recommend further evaluation and repair/replace as needed by a capable person or a qualified contractor.

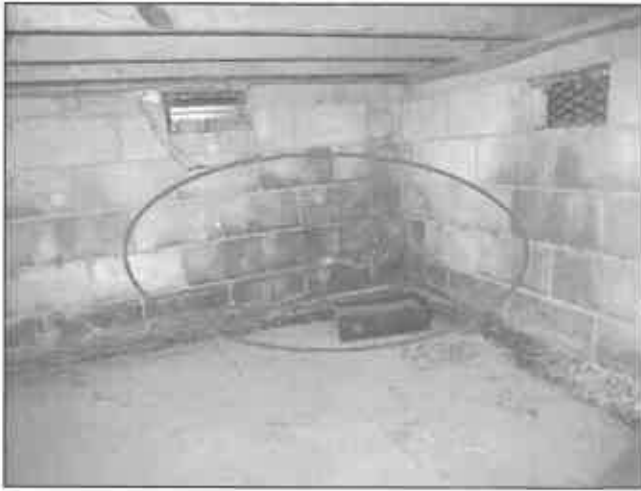
1.6 Item 1(Picture)

(1) There is visible evidence of moisture penetration at the right front foundation wall and electronic moisture meter readings were elevated. No evidence of standing water was noted . Moisture on the inside of the block is usually indicative of failure of the waterproofing system on the exterior face of the block. This is also where a gutter down spout was noted to be draining (commented on below in roofing). Consequences of this condition vary widely and we would recommend taking steps to keep roof water away from the foundation to prevent future moisture penetration in this area.

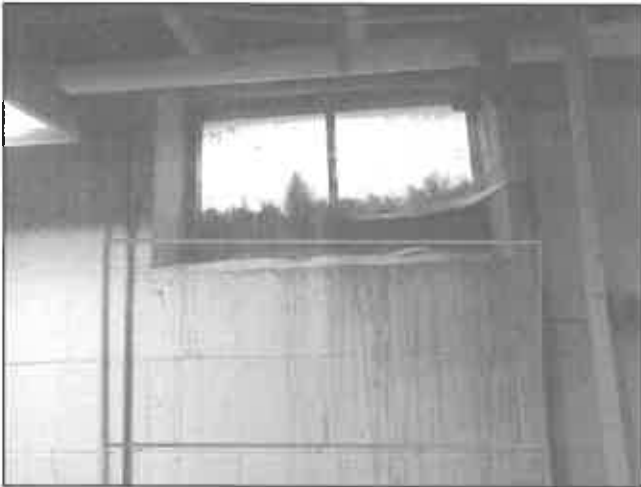
1.6 Item 2(Picture)

(2) Evidence shows that water entered the rear basement windows during the storm. At the exterior, it was noted that the yard slopes towards these windows and the window wells are full of debris (commented on below). Recommend addressing the grading and cleaning of the window wells to prevent this from occurring again during the next 100 yr storm.

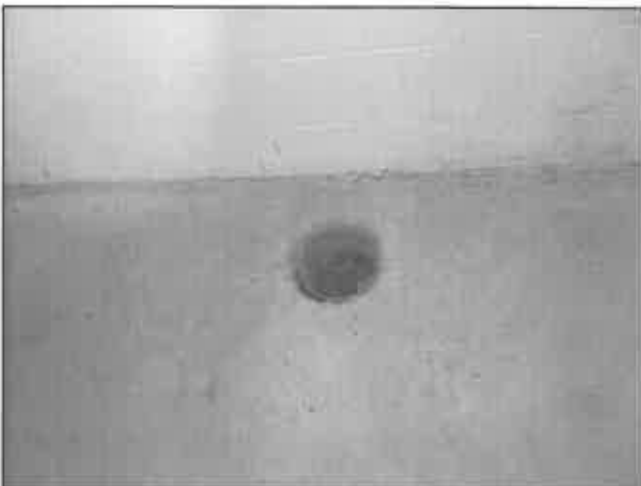
1.6 Item 4(Picture)

(3) FYI: In the basement, there is a basin for an older sump pump. This is no longer in use. Recommend sealing to prevent moisture entering the basement area.

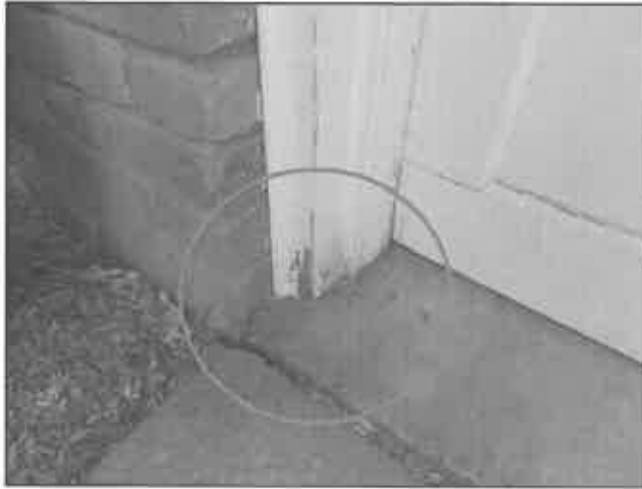
2.0 Item 1(Picture)

The bottoms of the jamb and trim of the garage door are deteriorating. Damaged exterior components can allow for infiltration of moisture and further damage to framing or other interior materials. Recommend repair or replacement by a capable person or a qualified contractor.

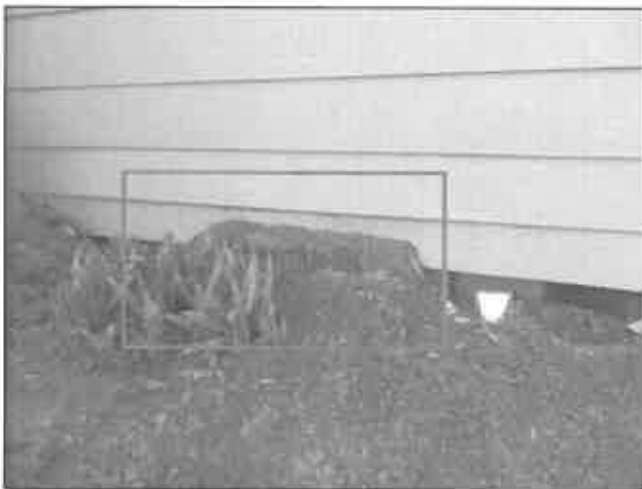
2.1 Item 1(Picture)

(1) The siding is deteriorated at the back of the house under the kitchen window area. Be advised that we are unable to see behind the siding to determine if any damage has occurred to concealed building components. Recommend further evaluation and repair as needed by a capable person or a qualified contractor.

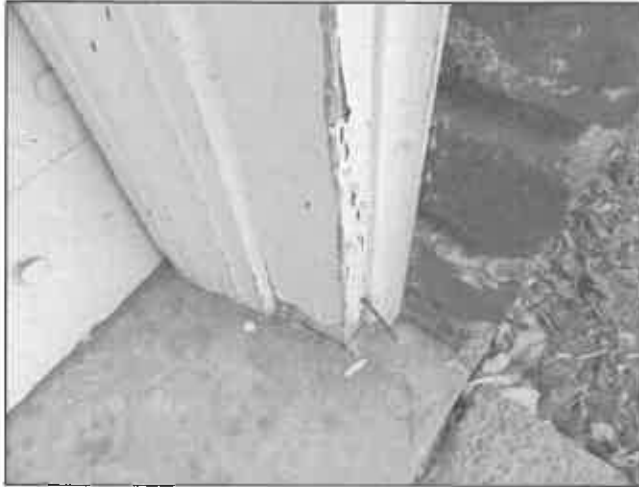
2.1 Item 3(Picture)

(2) As a general note: The exterior wood and wood trim is in need of general maintenance and painting. If the wood is not properly maintained it will eventually deteriorate, allowing moisture to infiltrate and damage interior building components. Recommend repair by a capable person or a licensed general contractor.

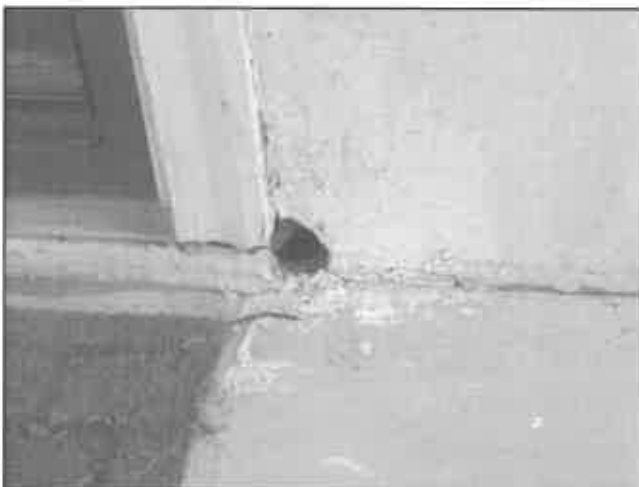
2.1 Item 6(Picture)

(3) At the back porch, there is a critter hole in the siding near the sliding glass door. This can allow entry of critters and moisture. Recommend further evaluation and repair as needed by a capable person or a qualified contractor.

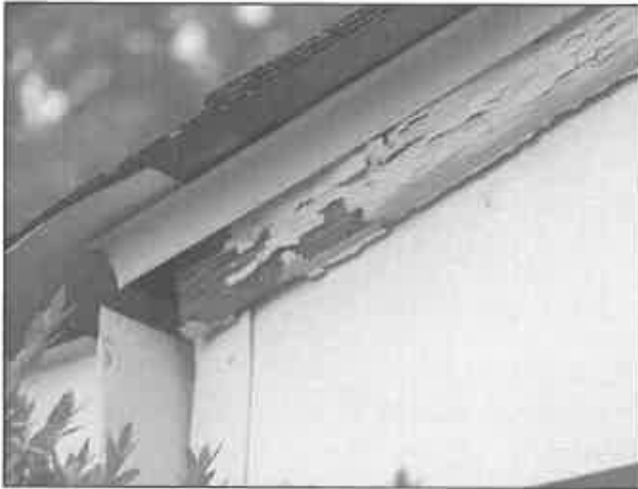
2.2 Item 1(Picture)

As a general note, the wooden soffits and fascia are in need of general maintenance and painting. Recommend further evaluation and repair by a capable person or a qualified contractor.

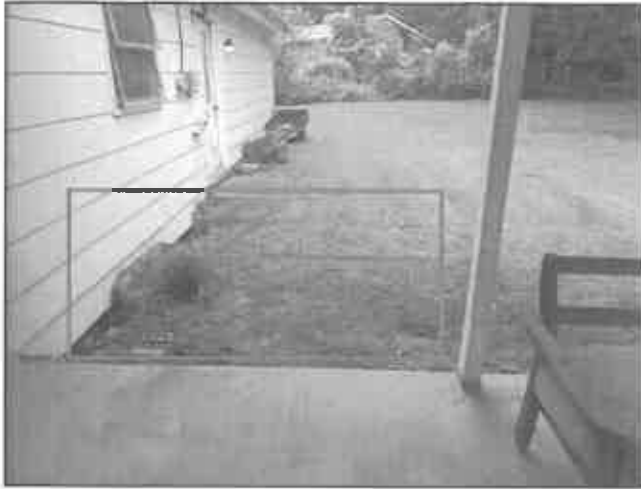
2.5 Item 1(Picture)

(1) Exterior grade should slope away from the foundation to prevent water infiltration. The grade slopes towards the foundation near the back porch area towards the window wells. Recommend to monitor during heavy rains, and correct drainage to shed away from house if water is flowing towards or standing near the foundation.

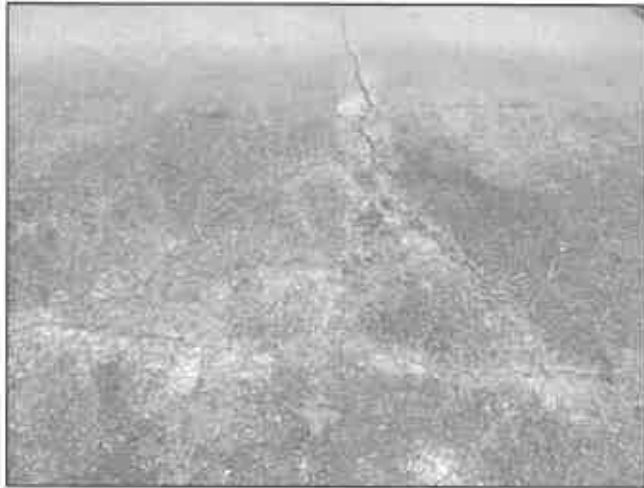
2.5 Item 2(Picture)

(2) The concrete driveway is cracked with some shifting/displacement noted: Recommend further evaluation and repair/replace/seal as needed by qualified contractor.

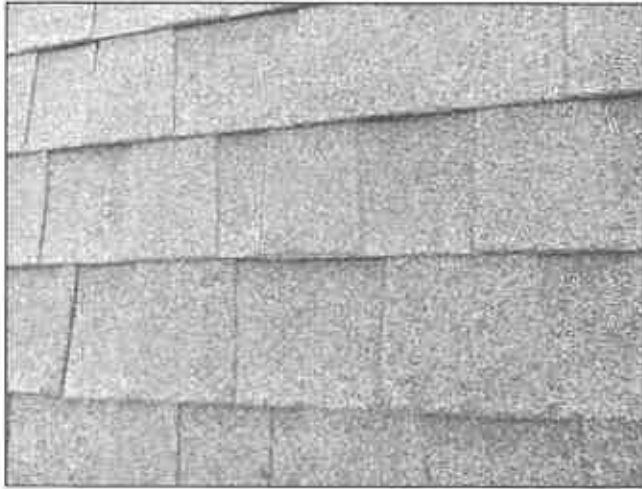
3.0 Item 1(Picture)

Overall the roof appeared to be in fair shape. I would estimate it to be in its second half of its life span. There was some edge deterioration noted in areas and some granule loss consistent with age. Recommend further evaluation by a qualified roofing contractor to estimate the remaining life span left in the roof coverings.

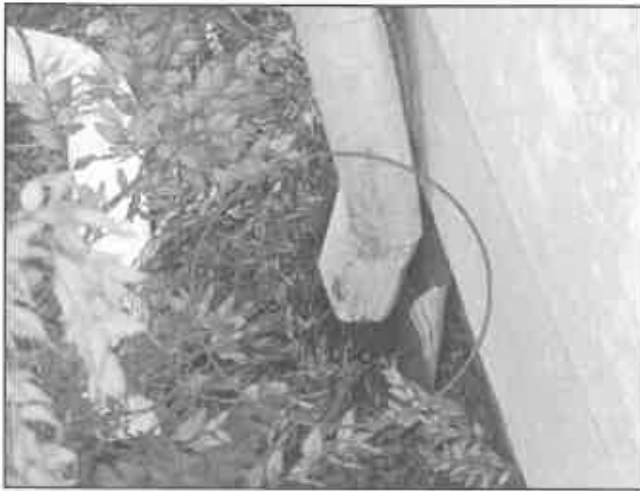
3.3 Item 1(Picture)

At the front corners of the house - Gutter downspouts should drain into ground drain lines that divert rain water away from the foundation. Otherwise, the large amount of water shed by a roof can greatly contribute to water in contact with the foundation and lead to moisture issues in the crawl space or basement. There is moisture penetrating into the crawlspace at the right front corner. Recommend

installing drain line extensions as needed.

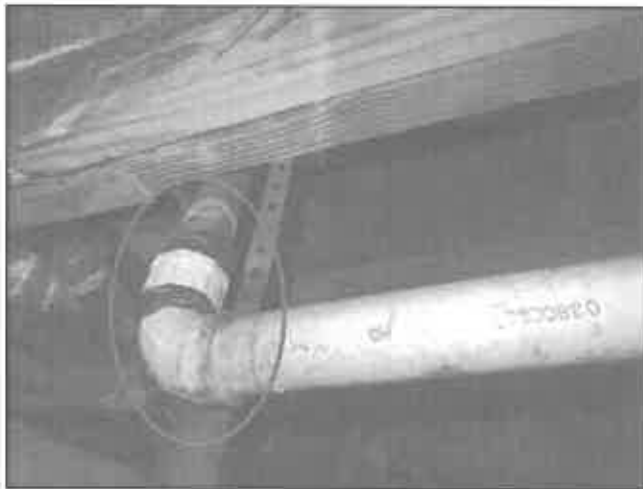
4.0 Item 1(Picture)

(1) There is leaking of the waste pipe under the hall tub at a questionable repair. This can lead to added moisture levels in the crawlspace and associated moisture issues. Recommend repair as needed by a capable person or a licensed plumbing contractor.

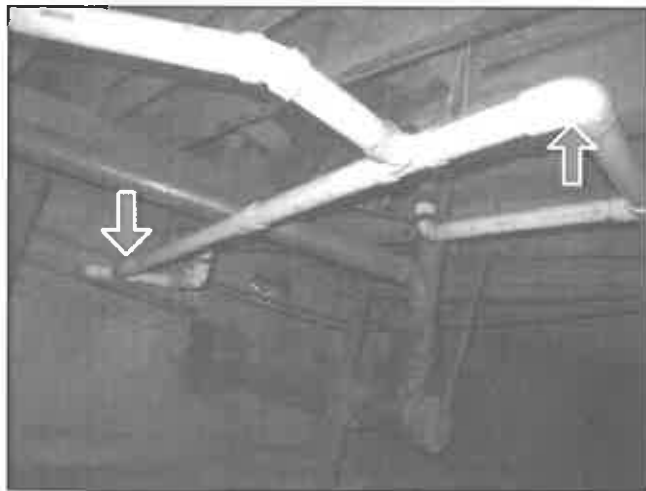
4.0 Item 3(Picture)

(2) The waste pipe leading from the master bathroom shower is back pitched. The height that the water needs to flow "uphill" is over 5". It was also noted that there is not a proper trap under the master shower. If this waste line was not back pitched, there would probably be sewer gasses emitting from the shower drain. Recommend repair as needed buy a licensed plumbing contractor.

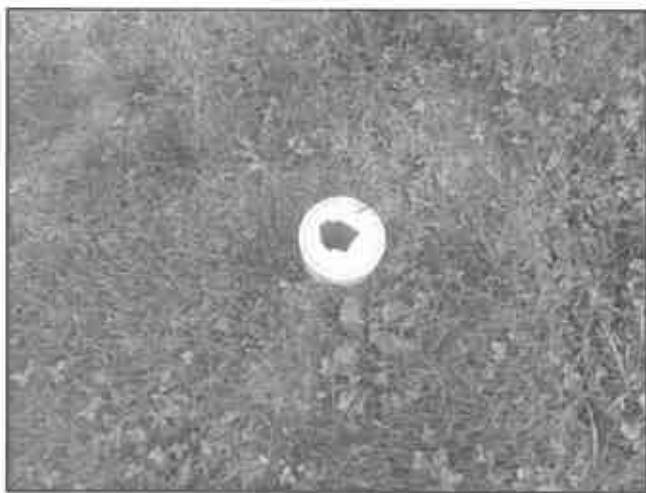
4.0 Item 5(Picture)

(3) The clean out cap for the waste line at the rear of the house is damaged. This can allow sewer gasses to escape. Recommend replacement as needed.

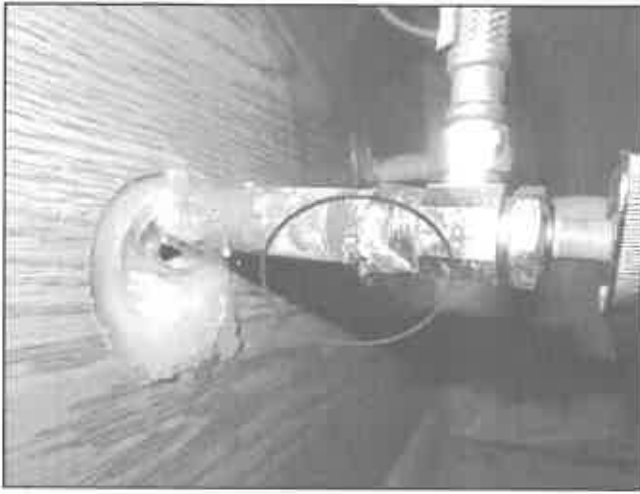
4.1 Item 1(Picture)

(1) The hot side water supply pipe under the kitchen sink leaks. Recommend repair by a capable person or a licensed plumber.

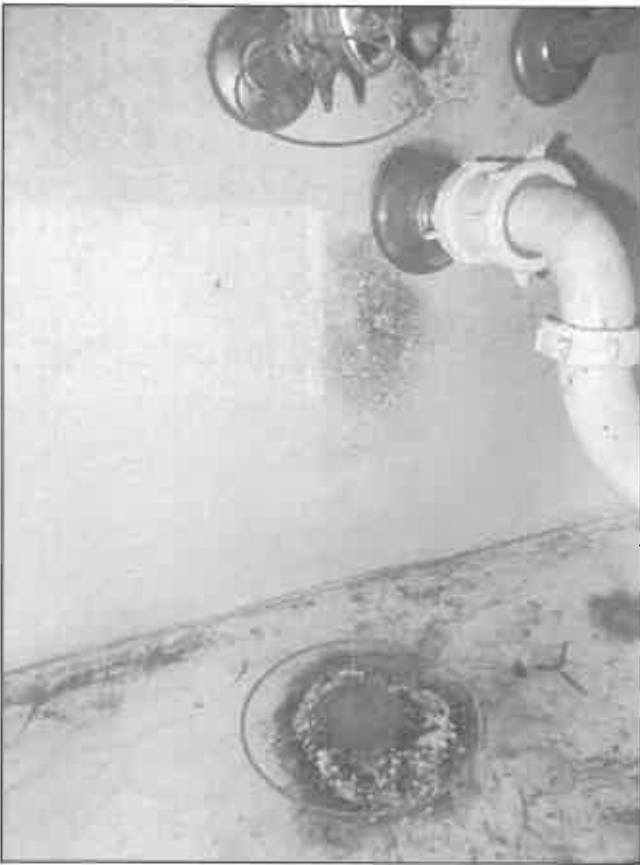
4.1 Item 3(Picture)

(2) There was evidence of prior leaking under the master bathroom sink. While this did not leak during the inspection, it did not appear that a repair has been made. Recommend further evaluation and repair/replace as needed by a capable person or a licensed plumber.

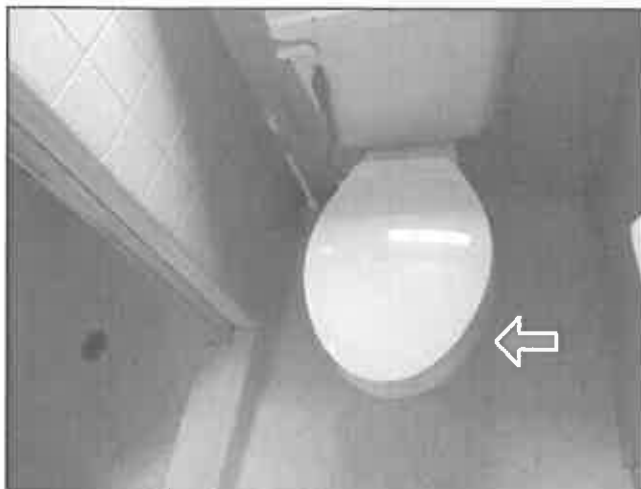
4.1 Item 5(Picture)

(3) While not exactly "loose", there was considerable rocking of both the toilets. Mobility at this point can weaken the wax seal and cause leaking and associated problems. We would recommend you have the anchoring bolts tightened. If bolts do not tighten or if after tightening, the toilet is still loose, that you check for deteriorated sub floor at this location. Recommend further evaluation by a capable person or a licensed plumbing contractor and repair as needed.

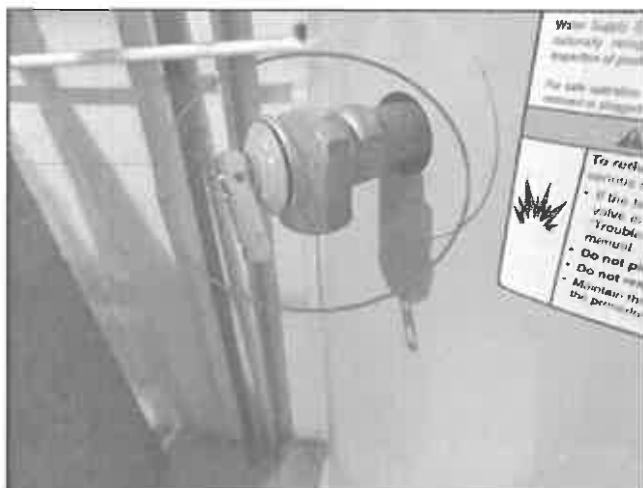
4.2 Item 1(Picture)

The TPRV (Temperature and Pressure Relief Valve) on the water heater needs a 3/4" pipe rated for hot water to extend to within 6 inches of floor for safety. The TPR extension is meant to reduce the chance of scalding water splashing on a person near the water heater, should the TPR valve activate. Recommend repair by a capable person or licensed plumber.

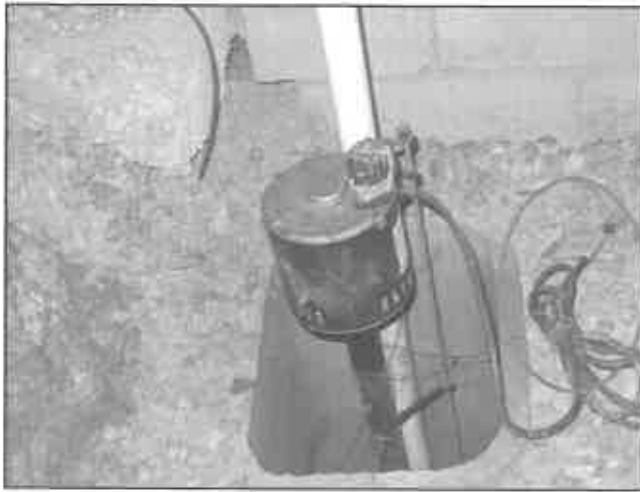
4.5 Item 1(Picture)

(1) The sump pump in the crawlspace was not plugged in nor did it have an electrical connection. I also was not able locate an exit for the discharge line at the front of the house. It would appear that the discharge is below ground. This is not the ideal configuration as it could prevent water from being pumped out. Recommend further evaluation and repair as needed.

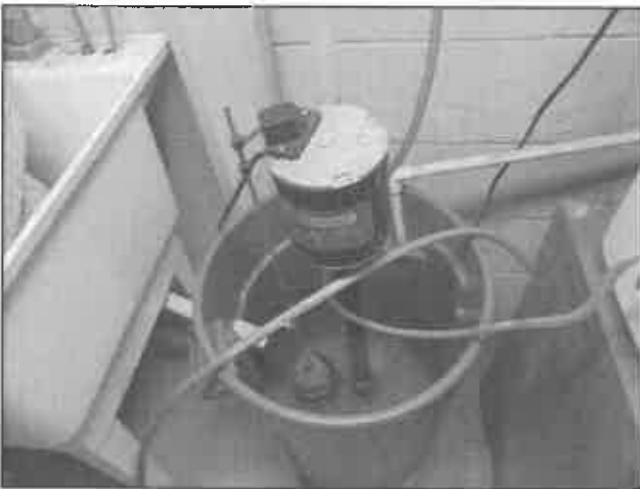
4.5 Item 4(Picture)

(2) The sump pump in the basement needs a lid/cover to prevent evaporation. The current configuration allows for evaporation of the water sitting in the sump which is then re-condensed and drained right back into the sump by the dehumidifier sitting right next to it, limiting the effectiveness of the dehumidifier.

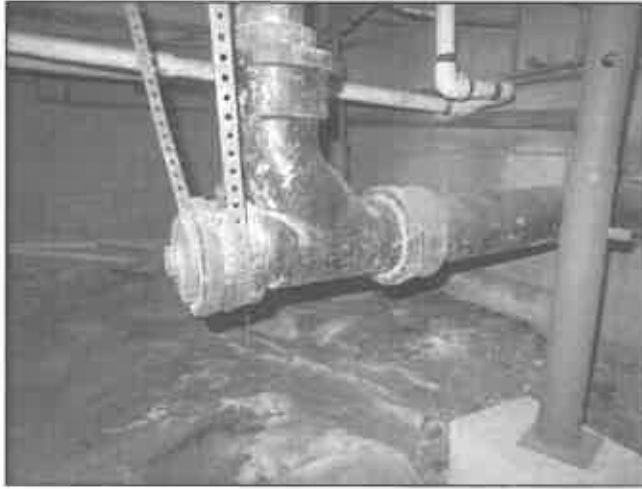
4.10 Item 1(Picture)

(2) This house has cast iron waste pipe in parts of the drain/waste system. Cast iron typically fails by rusting from the inside out. Within the scope of a home inspection of readily visible components, a full evaluation of the cast iron waste pipe is not possible. The typical life span of cast iron piping is anywhere between 60-100 years depending on its location and immediate environment. We would recommend that you have the cast iron lines sewer scoped by a licensed plumbing contractor to determine the inside condition of the cast iron pipes and get an idea of the remaining life left in them.

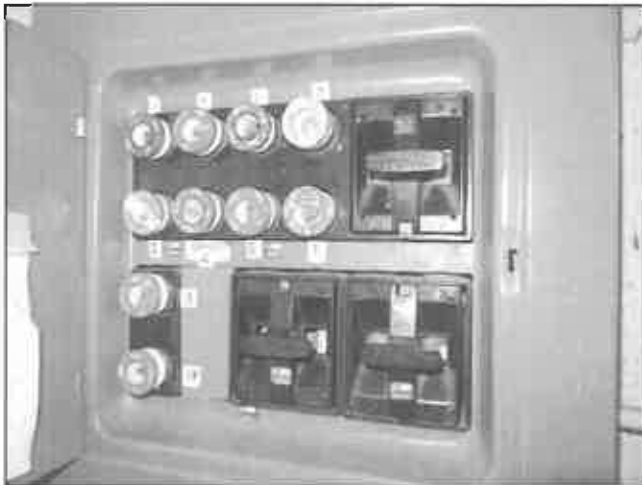
5.1 Item 1(Picture)

LIMITED INSPECTION - The main electrical panel is an older style fuse panel. Beyond an external visual inspection, we do not remove any of these components for further evaluation. This style of panel is considered outdated and is typically not able to handle the electrical demands of modern homes. This panel appeared to be a 60 amp service. Standard electrical services are now 200 amps to meet the demands of modern electrical equipment. Recommend further evaluation and consider replacement/upgrading by a licensed electrical contractor.

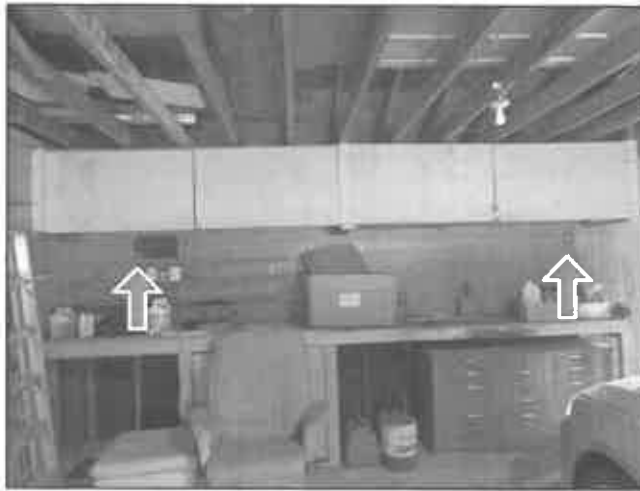
5.3 Item 1(Picture)

(1) In the garage at the upper outlets on either side of the work bench - The outlets measured as having open neutrals. This means that the outlets are using the ground wire to return the current to the electrical panel. This is considered a shock hazard. Recommend repair as needed by a licensed electrician.

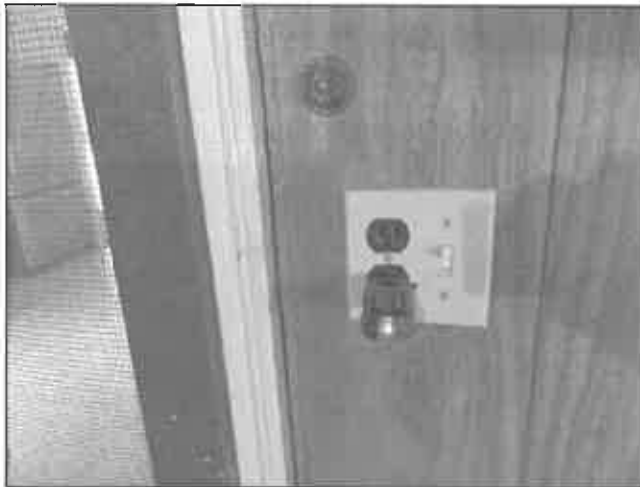
5.3 Item 3(Picture)

(2) The three prong receptacle at the garage door is ungrounded. Seeing a three prong outlet will suggest to the end user that the outlet is grounded, and potential damage can be done to electrical equipment (computers, tv's, etc.) and appliances, as well as being a personal shock hazard, if the outlets are not grounded. Recommend repair by a licensed electrician or label outlet as ungrounded.

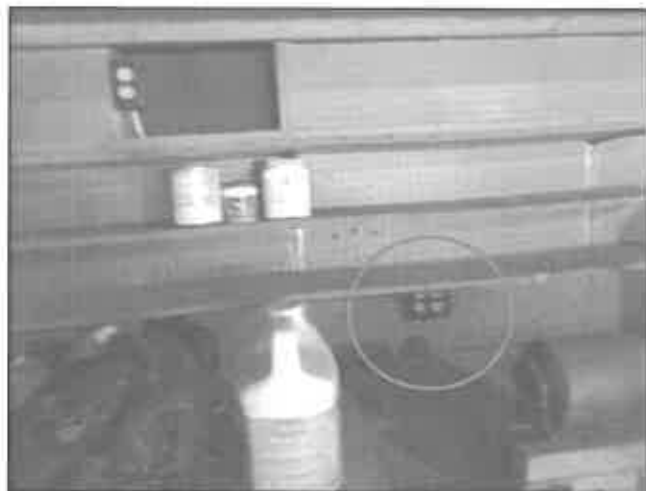
5.3 Item 4(Picture)

(3) An electrical receptacle is loose at the garage work bench. In use, a loose receptacle can cause the wires inside to loosen, arc and become a fire hazard. Recommend repair by a capable person or a licensed electrician.

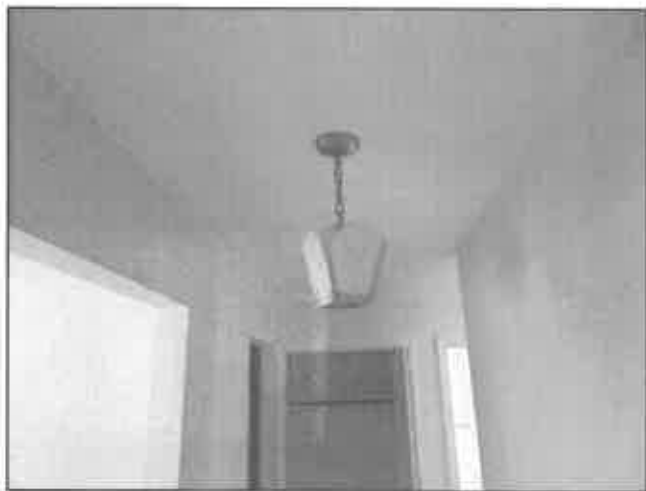
5.3 Item 5(Picture)

(4) The ceiling light at the front entry did not come on. Recommend changing the light bulb. That failing, consult with a licensed electrician.

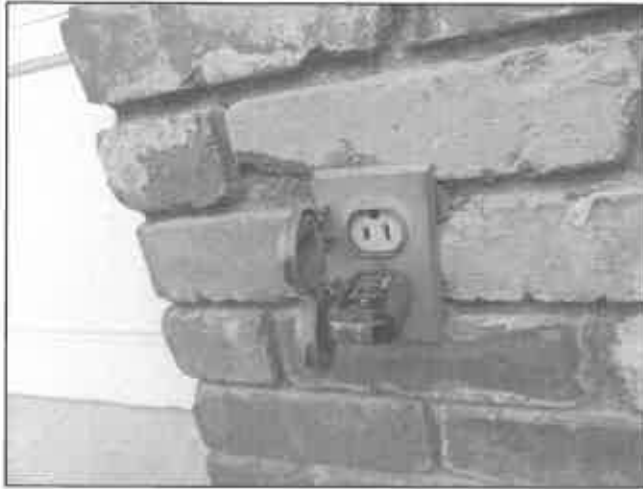
5.4 Item 1(Picture)

(1) FYI: Though it was not required for this outlet at the time of construction, no ground fault protection was noted at any of the interior outlets near water or the exterior outlets. These outlets did not trip when tested with a test device. We would recommend, as a safety upgrade, that gfcı receptacles be installed in all wet locations and anywhere within 6 feet of a water supply.

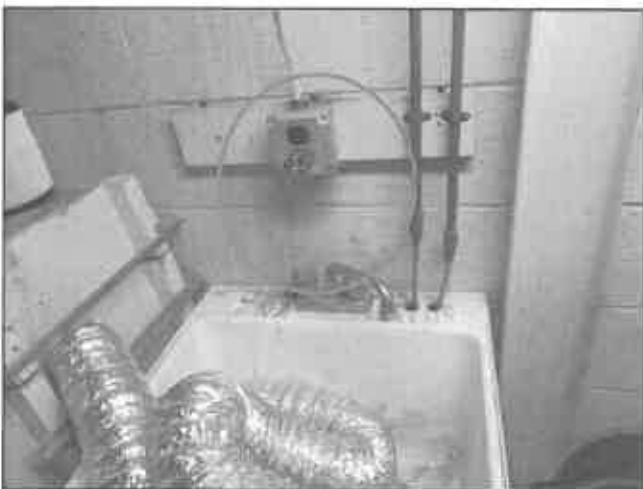
5.4 Item 5(Picture)

(2) An outlet in the basement utility sink has the hot/neutral reversed . This could result in shocking a user who would assume that the switched leg of a lamp, etc. is the hot one and expect an appliance to be turned off when it, in fact, is not. In addition, this outlet was not GFCI protected. Refer to licensed electrical contractor for further evaluation and repair as needed. Recommend considering upgrading to a GFCI protected plug for safety.

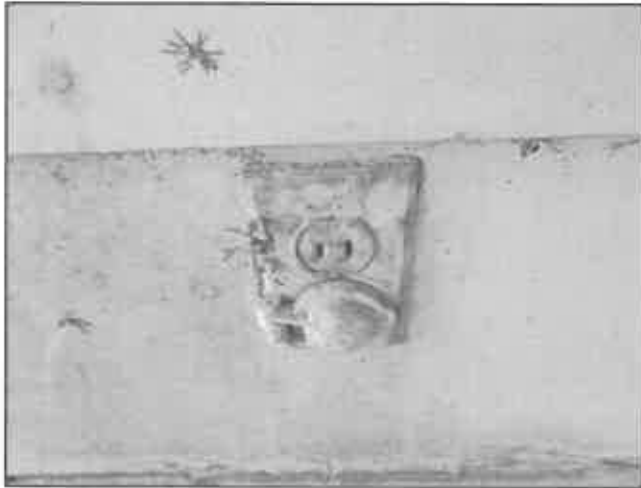
5.4 Item 6(Picture)

(3) The outlet at the rear porch needs a weatherproof cover for the receptacle. A wet or damp

receptacle is both a fire hazard and a shock hazard. This outlet was also ungrounded and without GFCI protection. Recommend further evaluation and repaired/replacement as needed by a capable person or a licensed electrical contractor.

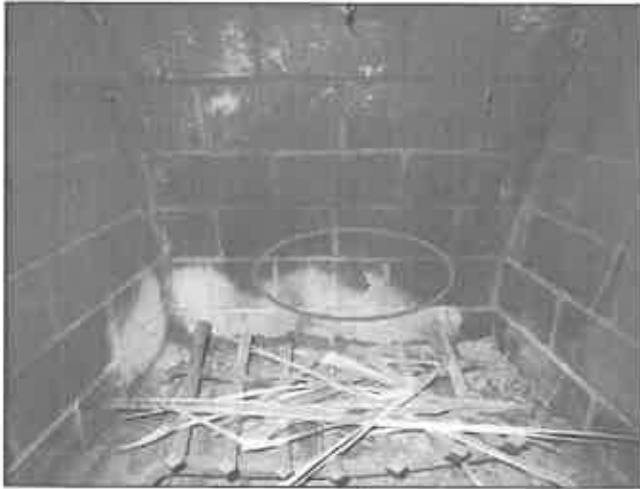
6.4 Item 1(Picture)

One of the bricks in the firebox of the fireplace is cracked and needs to be repaired. Damaged lining in the firebox can allow excessive heat to be transferred to combustible framing, etc. behind it and lead to a fire hazard.

Recommend further evaluation and repair by a qualified fireplace/chimney professional

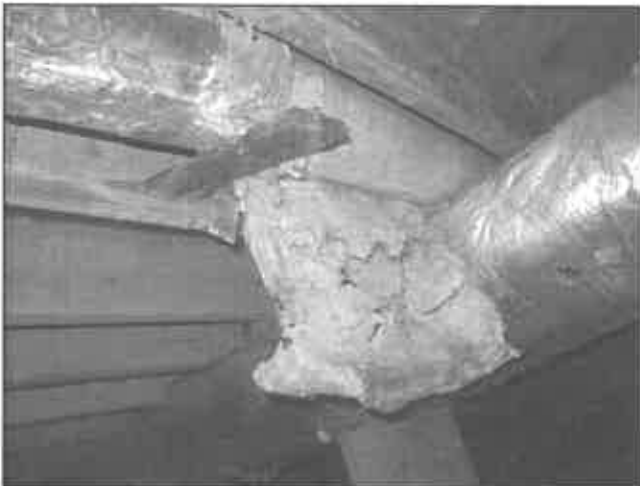
6.5 Item 1(Picture)

(1) Insulation around the duct work in the crawlspace area is falling off in a couple of location. Recommend re-installation as needed for energy efficiency and to prevent the formation of condensation.

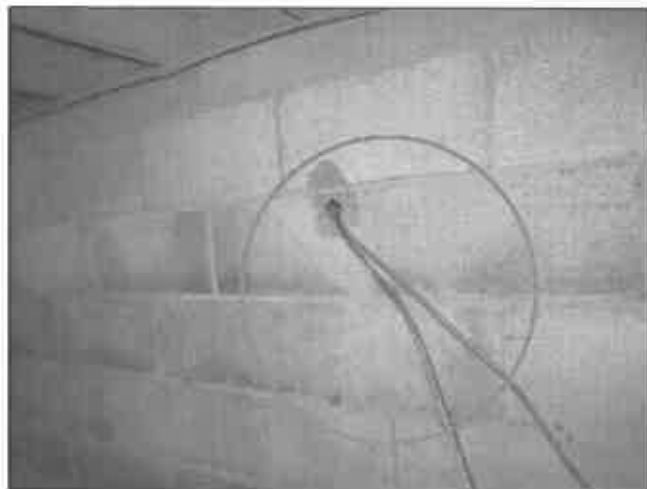
6.12 Item 1(Picture)

The abandoned fuel lines for a buried fuel oil tank are visible at the front foundation wall. Examination of a buried tank is beyond the scope of our inspection of visually accessible components. This tank (if still present) is not in active use. There is risk with having a buried fuel oil tank on the property, most common would be undetected leaking. Recommend further evaluation to determine if there is still a buried tank present and further evaluation by a soil engineer if it is determined that there is one present. A soil engineer can provide further information about the tank by taking and analysing soil samples from around the tank to determine if there has been any leaking and if any action is needed.

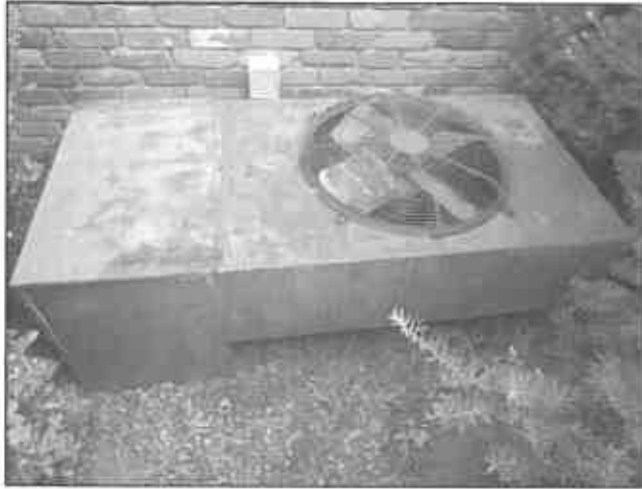
7.0 Item 1(Picture)

FYI: The A/C functioned well at the time of inspection; however, this system is old. I was not able to determine an exact manufacture date as the tag was painted over, but I would place this unit at mid to late 90's, putting this thing potentially at over 30 years old. HVAC equipment is value engineered for 12-15 yrs of service but they can often last much longer with proper maintenance and servicing. You may wish to have this unit further evaluated by a licensed HVAC contractor or budget for a possible need for replacement in the future.

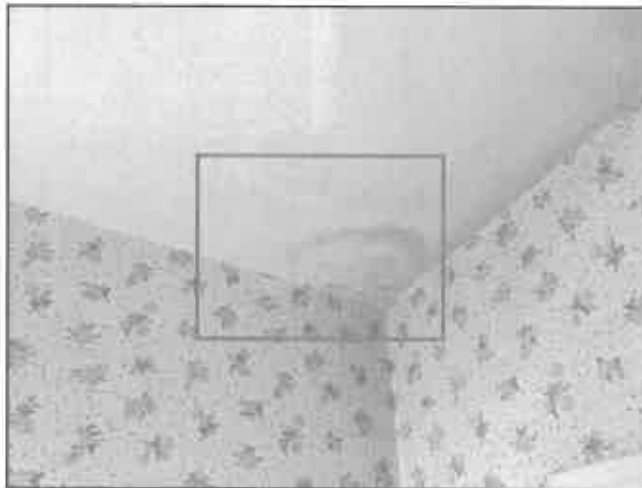
8.0 Item 1(Picture)

(1) There were two areas on the hall bathroom ceiling that appear to have come from moisture. Both of these areas measured dry at the time of the inspection despite it having rained at the start of the inspection. I suspect that this is from a prior roof issue that no longer seemed present. It was noted that the spot in the corner appeared to have some dark fungal growth present. I can not determine if there was other fungal growth behind this area. Recommend further evaluation and repair as/if needed by a qualified contractor.

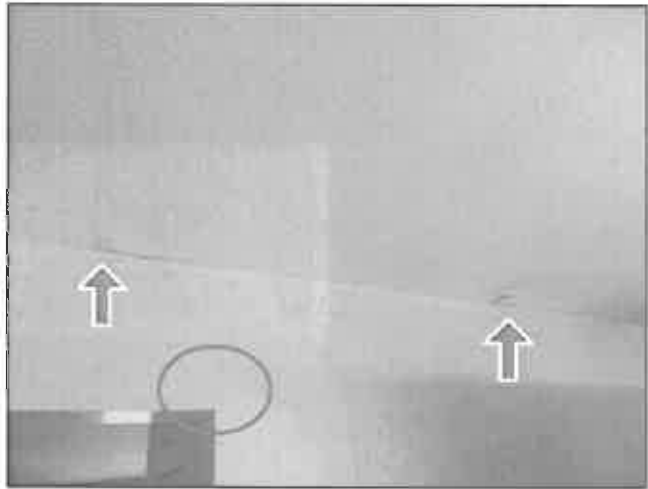
8.0 Item 4(Picture)

(2) In the dining room, there were two spots on the ceiling with damage. These appeared to be a bit more than just a nail pop. Below at the door frame was a crack. This indicates some potential movement at this area. This is on the opposite side of the house as the WDI damage noted above in the structural section. Recommend further evaluation and repair as/if needed by a capable person or a qualified contractor.

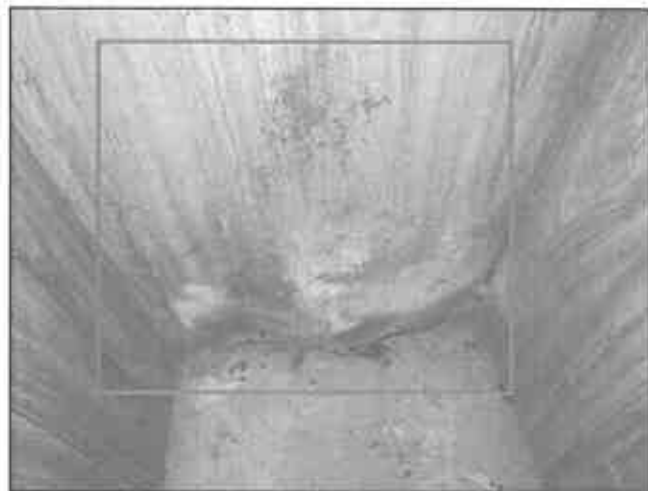
8.1 Item 1(Picture)

(1) In the right front corner of the garage, there was heavy fungal growth on the wood paneling. This area measured dry at the time of the inspection as well as the adjacent wall and there were not indications of leaking noted. This MAY have been from stored wet items in this area. There may be further fungal growth behind the paneling. Recommend further evaluation and repair/cleaning as needed.

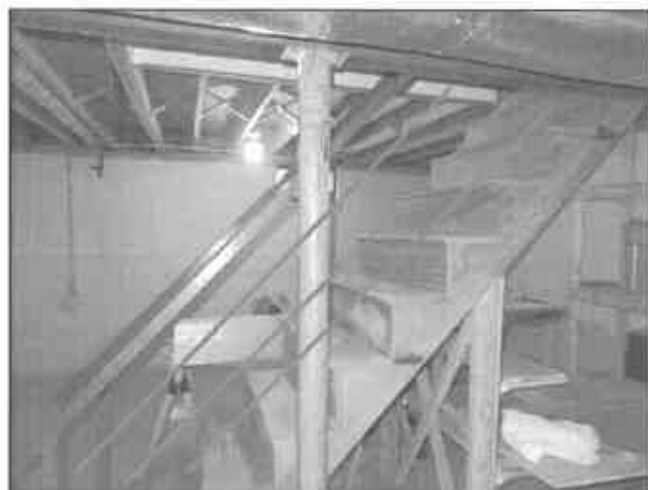
8.3 Item 1(Picture)

FYI: While common for this era of construction - There is no barrier at the open sides of the stairs to the basement. This is now considered a fall hazard (for people and pets). Recommend considering the installation of a barrier with pickets to help prevent falls.

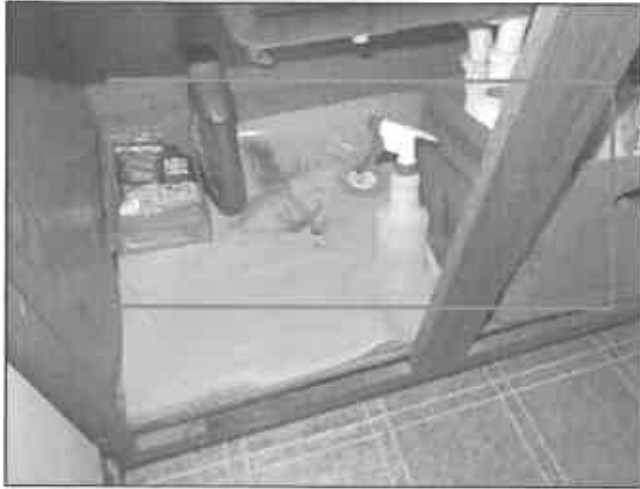
8.4 Item 1(Picture)

The floor of the cabinet below the kitchen sink has been damaged and will need to be replaced. Recommend further evaluation and repair or replacement by a capable person or a qualified contractor.

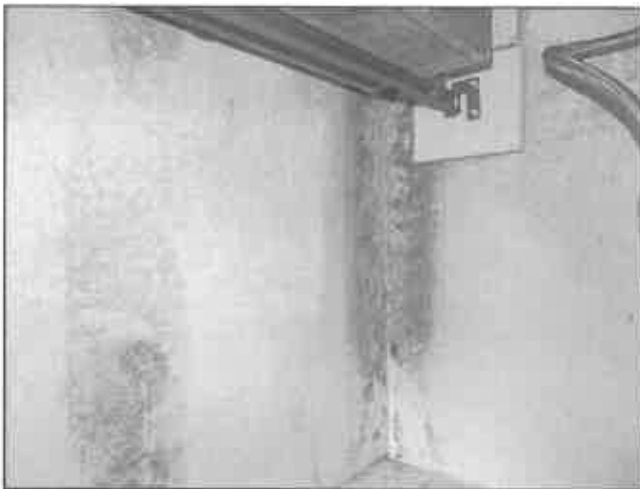
8.8 Item 1(Picture)

(1) Leaking under the master bathroom sink has lead to a considerable amount of fungal growth. Recommend further evaluation and clean/replace as needed. This area measured dry a the time of the inspection.

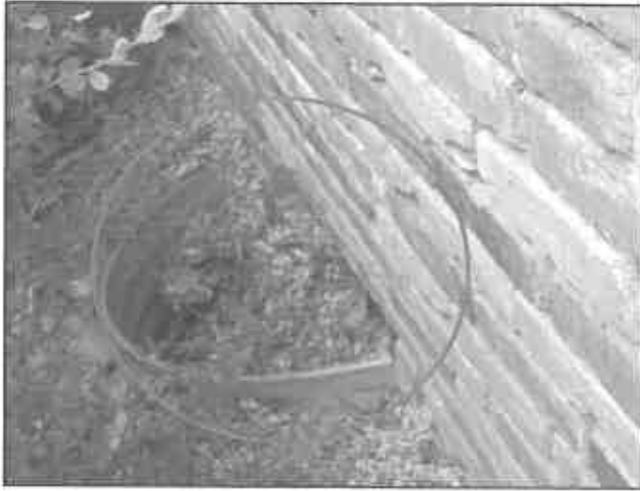
9.1 Item 1(Picture)

All of the foundation vent and window "wells" around the house are filled with debris above the level of the vents/windows. This can provide a direct path for water to enter the crawlspace/basement areas. The bottom of wells should be a minimum of 4" below the vent and preferably filled with gravel to aid in drainage. Recommend repair by a capable person.

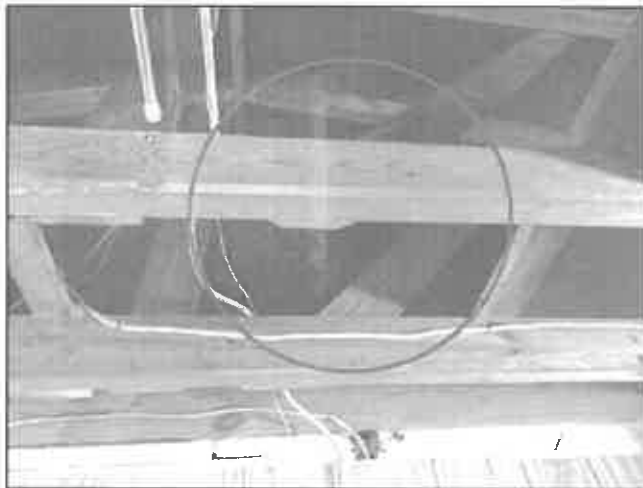
9.4 Item 1(Picture)

(1) FYI: Though it was allowed when this house was constructed. It was noted that there is a gable vent opening from the garage into the attic area above the living area. This is now considered a safety hazard as a fire in the garage could quickly spread into the house area. Recommend considering blocking off this vent and ventilating the attic in a different manner.
