## Operational Assessment of ANO-2 Steam Generator Tubing for the Remainder of Cycle 14

February 3, 2000

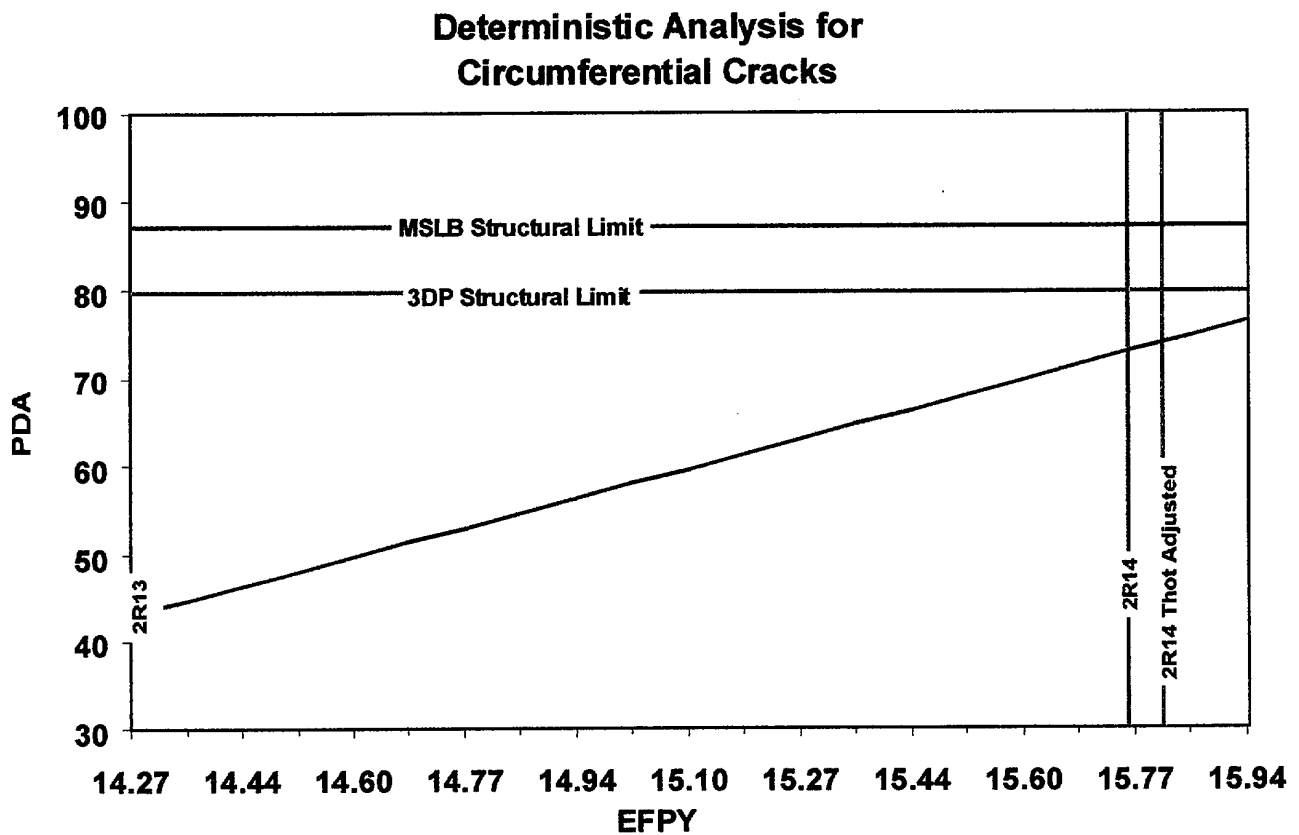
During 2P99, a limited inspection (503 tubes), was performed to mitigate potential leakage. The size and number of indications were well within the number projected in the previous operational assessment. No credit for this inspection was taken in the deterministic evaluation. Nine indications were identified and repaired. The beginning of cycle flaw size at a POD of 0.95 was used. This was equivalent to 43 percent degraded area (PDA)<sup>4</sup>. The growth rate used was the 0.95 value from the growth rate distribution based on a site specific sizing evaluation from 2R13. This value was equal to 20 PDA/EFY<sup>5</sup>. Based on these inputs, operation for the full cycle is justified with added margin. This analysis was offset 3.7%<sup>6</sup> for increasing T-hot and is depicted in Figure 4.1 below:

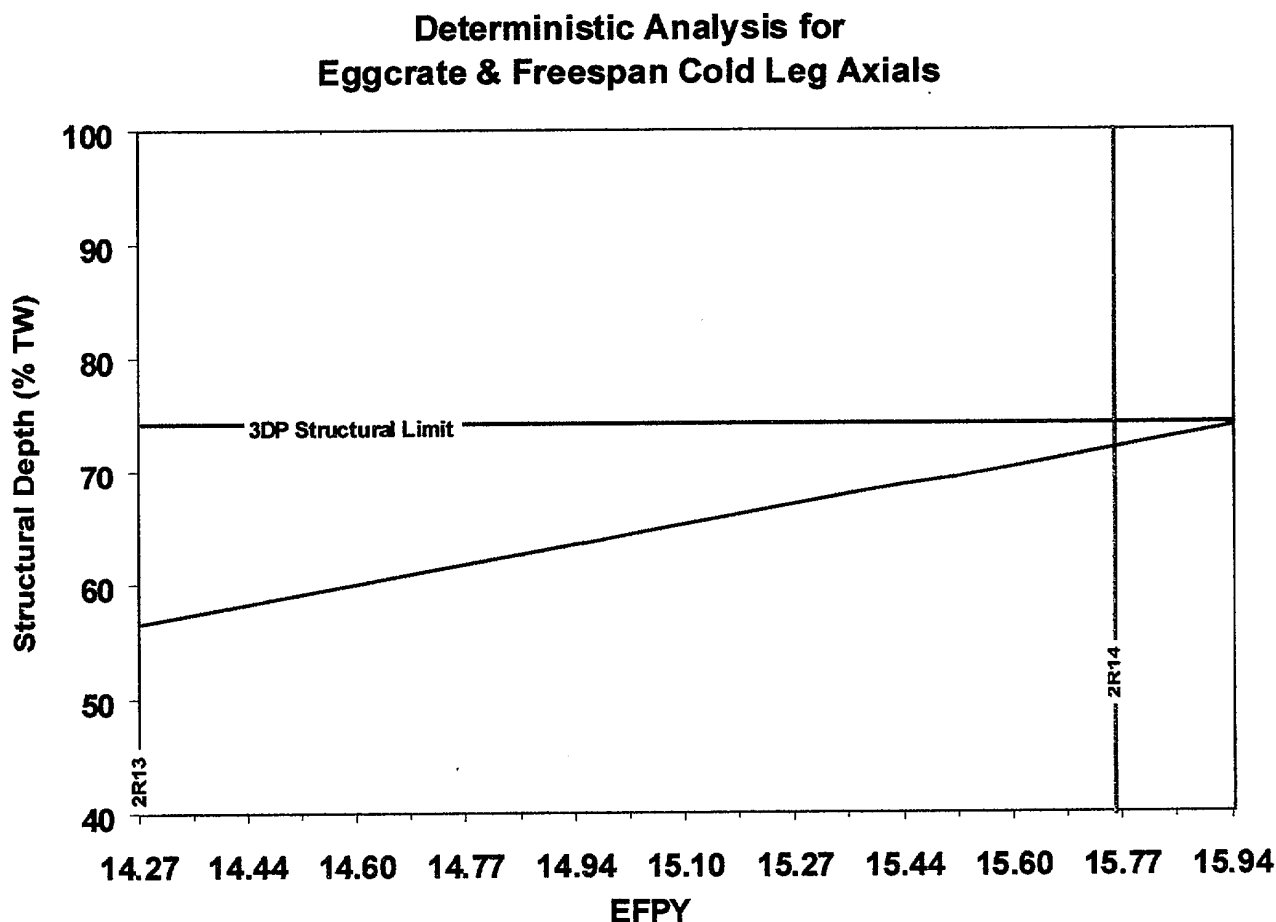
Figure 4.2

During 2P99, this area of the generator was not inspected. The operational assessment performed following 2R13 concluded operation for the full cycle was justified due to the limited number of indications and the size of the flaws, as well as the lower temperature this tubing experiences during full power operation. Based on these facts, it was not feasible to perform a growth rate study for this type of flaw. For the deterministic evaluation, the 0.95 growth rate of the hot leg eggcrates was used offset by a reduction in temperature of 15° F, which accounts for the location of the flaws high in the tube bundle. An approximate 50° F drop occurs across the bundle. The growth rate value is 10.35% per EFPY. The 0.95 POD value for this type of flaw is 56.6% structural depth with a length of 0.58 inch. These values result in a deterministic evaluation that meets the 3ΔP criterion at the next scheduled outage. This is depicted below in Figure 4.2.

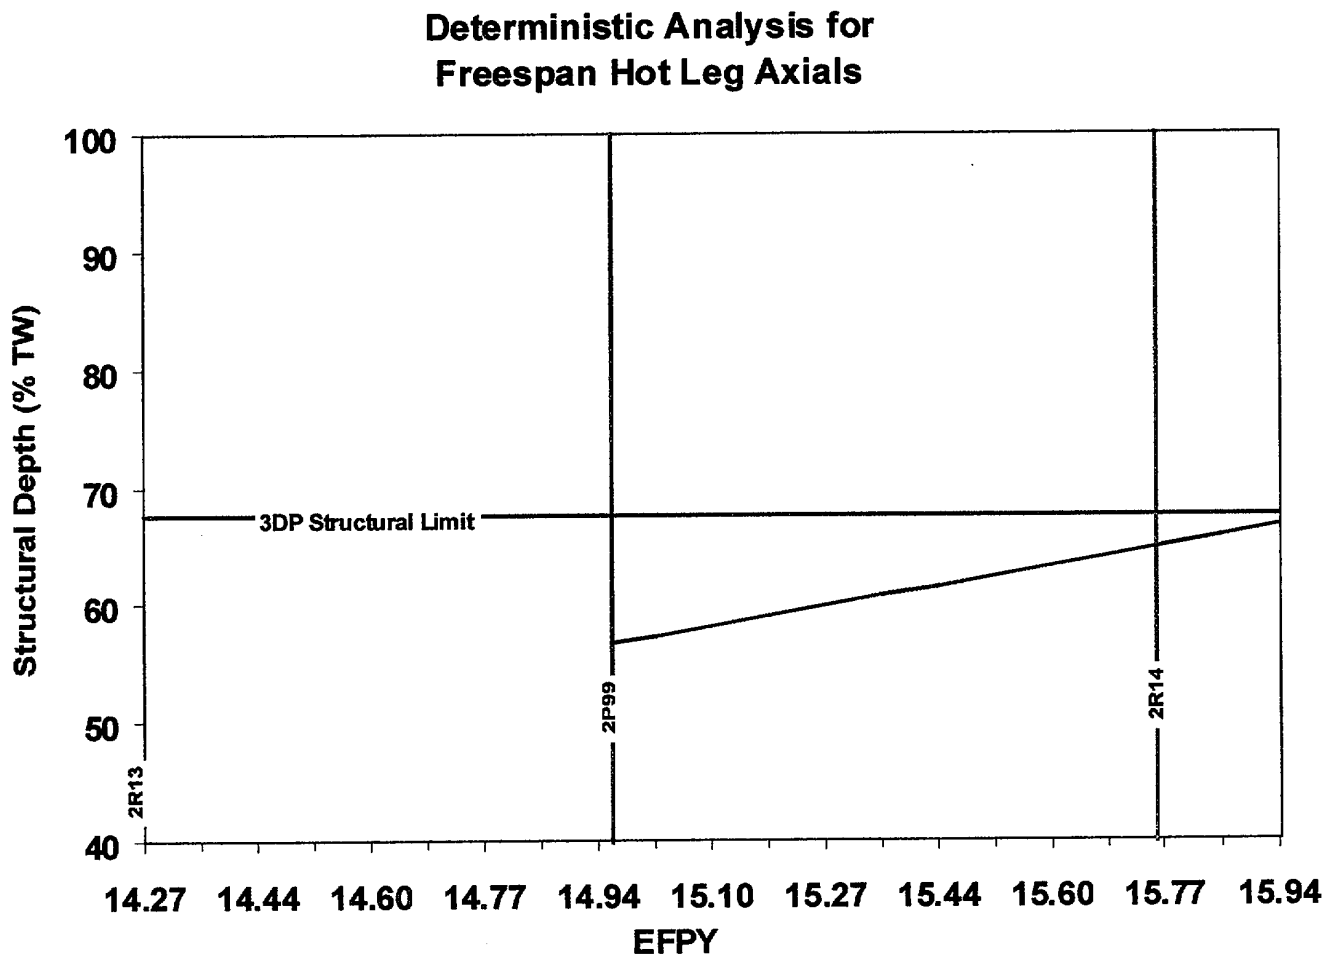
**Figure 4.3**

The hot leg free span area of the generator was included in the bobbin examination conducted during the 2P99 inspection. Five indications were identified and repaired. The sizes of the flaws were bound by the previous operational assessment. Once again, the 0.95 POD value was taken from the site specific performance demonstration (SSPD) performed following 2R13. This value was equal to 56.6% structural depth with a length of 1.48 inches. The 0.95 value on growth was offset by 15° F since the majority of the free span indications are found in the upper portion of the tube bundle. This value is equivalent to 10.35% per EFPY. This data is depicted in Figure 4.3 below:

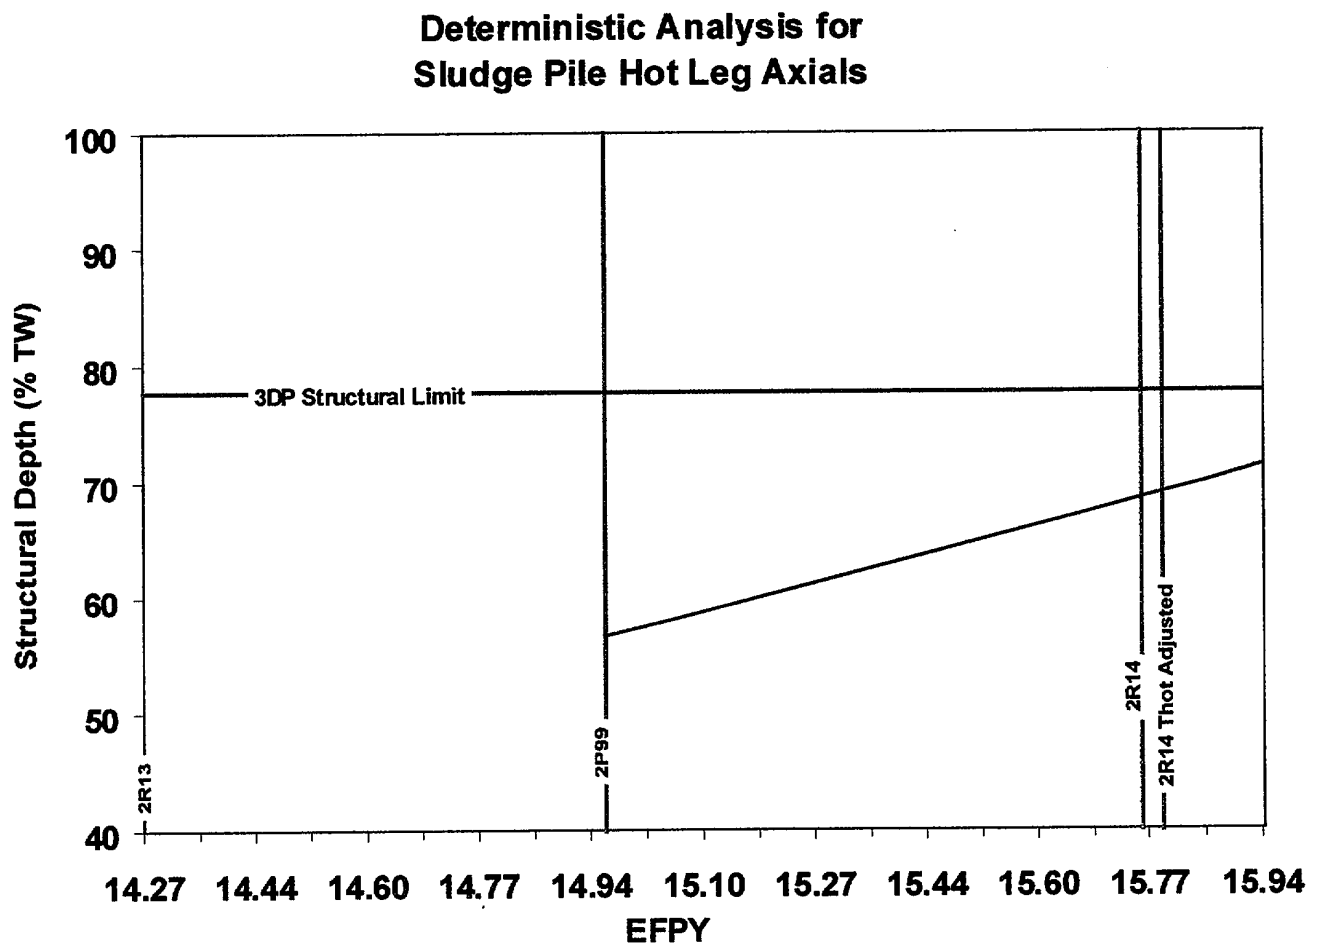
Figure 4.4

In previous outages, it was proven that consistent detection of axial cracking in the sludge pile was achieved with MRPC. Since the 2P99 inspection was performed in 100% of the tubes in the sludge pile area, credit was taken for the inspection. The 0.95 POD value for the sludge pile axials was a 56.6% structural depth with a 0.44 inch length. The 0.95 growth rate value was used due to the proximity of the flaws to the hot leg tube sheet. This growth rate was equivalent to 15.0% per EFPY. Additionally, a correction for increasing T-hot was used (3.7 %). This analysis is depicted below in Figure 4.4:

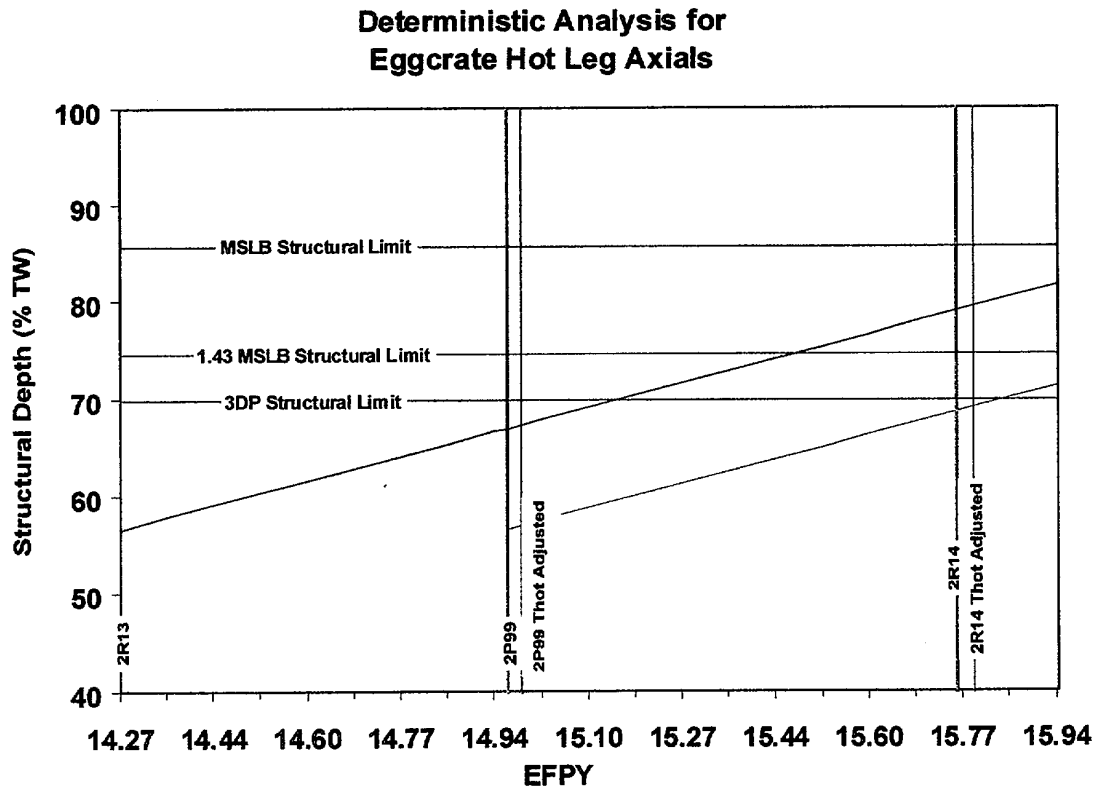
The initial deterministic evaluation for the eggcrate axial indications on the hot leg was performed during 2P99 to justify startup as part of the condition monitoring program. This initial evaluation justified approximately 7 months of operation and was submitted to the Staff December 21, 1999 (2CAN129911)<sup>1</sup>, based on using the peak in-situ pressure achieved on the worse case flaw identified (R72L72). After analysis to determine the maximum achieved pressure and completion of the growth rate study, this evaluation was repeated using the data in accordance with the EPRI Steam Generator Integrity Assessment Guidelines<sup>2</sup>. A 0.95 growth rate value of 15.0% per EFPY was used. The growth rate data was developed using information from the last three outages. To calculate the beginning of cycle flaw, the 0.95 value from the POD curve was used. The POD curve was developed from the SSPD performed following 2R13. The SSPD was previously described in the operational assessment submitted following 2R13 (2CAN069911). The 0.95 value for beginning of cycle structural depth was determined to be 56.6% with a length of 0.98 inch.

Based on the attached evaluation, tube R72L72 had a 278 psi of margin above the 3ΔP criterion. The inputs to the model were benchmarked against the previous outage (2R13) to evaluate if the values were appropriate. This data is depicted in Figure 4.5 below. The point at which 3ΔP would have been exceeded for the first half of the cycle was approximately 0.12 EFPY beyond 2P99. Using the same input values for the remainder of the cycle, the 3ΔP criterion would not be reached until after the designated EOC. This evaluation also accounts for the increase in operating temperature.

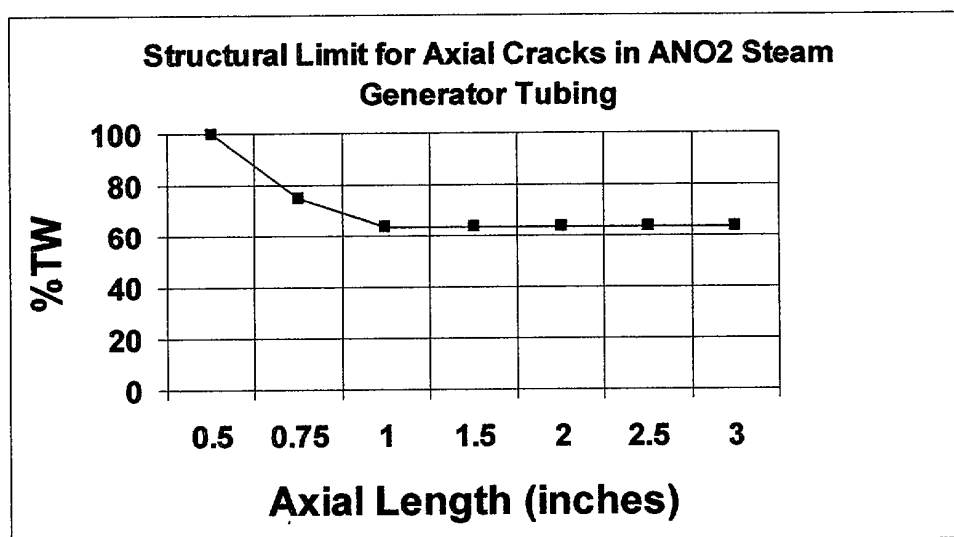
Figure 4.6

As shown in the figure, the structural limit in the range of lengths observed during 2R13 is 100% through-wall (TW). The largest of the two flaws (R50L114) was 0.33 inch in length and had a maximum depth of 75% TW. Since 2R13 was the first time that this mechanism was examined, it is possible that a flaw could have been left in service if it was at the detection level of the test. Using the plus point coil, the minimum detectable depth would be approximately 20% based on the EPRI qualification. To be conservative, a 40% TW value was used. Applying a maximum growth rate based

on the eggcrate axial data, 40% TW would be added for a total of 80% TW. Based on the length and calculated depth, the largest postulated flaw would pose no threat from a structural or leakage standpoint. Based on the above results, it is acceptable to operate full cycle due to potential axial cracks in a dented eggcrate.

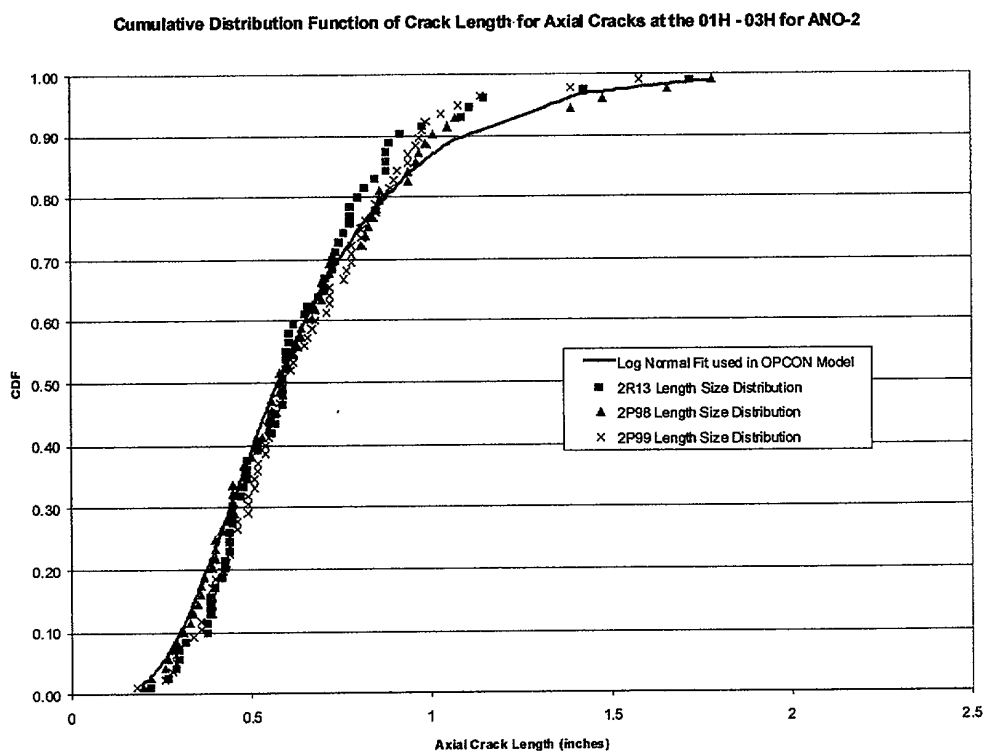
**Figure 5.4**

Figure 5.4 confirms that the distribution on crack lengths has not changed significantly in the last three outages.

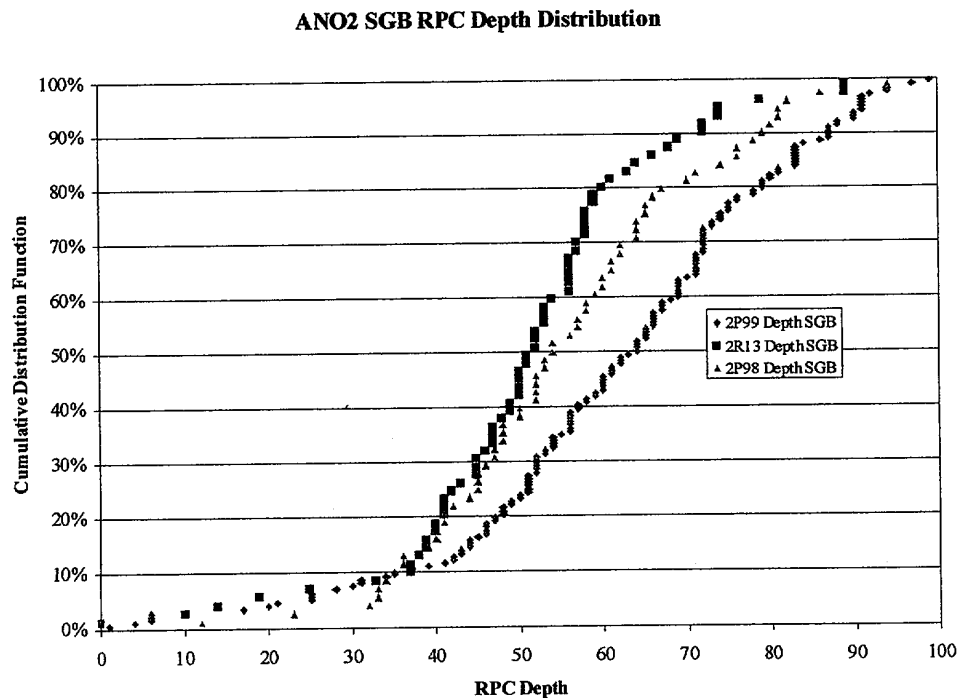
**Figure 5.5**

Figure 5.5 represents the distributions of maximum depths as measured by MRPC for the last three outages which was previously submitted in the condition monitoring report (2CAN129911)<sup>3</sup>. It is apparent in this figure that in the most recent outage (2P99), the depths were approximately 10-15% deeper than those sized in previous outages. Further investigation into the rationale for this result determined that several of the analysts were using channel 1 (300 KHz) instead of the mix channel P1 (300/100 KHz) to perform sizing of the flaws. This data was re-analyzed using the P1 mix. Both the 2P98 and 2R13 outages were performed using the P1 channel for sizing. This resulted in a reduction in depth consistent with the two previous outages. This is depicted in Figure 5.6:
