Declaration of Rachel J. Watters on Authentication of Publication

JRC/ICE2007-40096

Prevention of Derailments due to Concrete Tie Rail Seat Deterioration

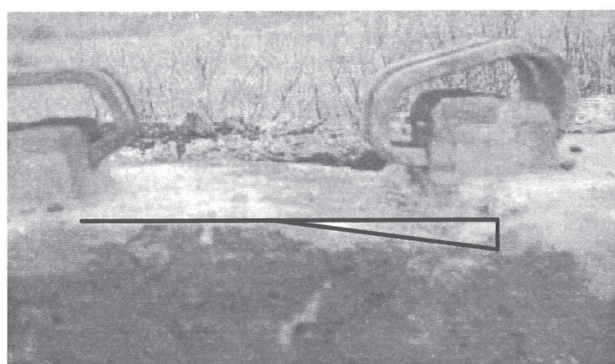
Photographs from concrete ties removed from the derailment site and other areas in the railway industry show a wear pattern that has a triangular shape with loss of material on the field side of the tie. This shape and the type of abrasion shown indicate that the tie was over loaded on the field side and only one-half of the available bearing area was taking up the applied loads. Figure 1 shows the triangular abrasion pattern with the black lines highlighting the abrasion shape. Figure 2, from an internal BNSF report, is the measured profile of an abraded concrete tie from a recent Amtrak derailment showing that the abrasion, still in a triangular pattern, within one inch from the gage side shoulder [6].

Figure 1. Triangular abrasion pattern in a concrete tie with black lines outlining a triangular pressure distribution assumed for this analysis.

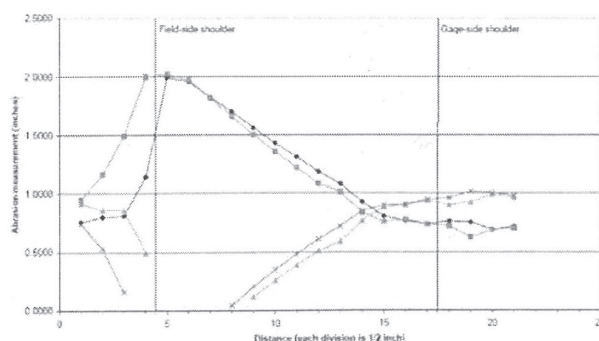
Figure 2. Concrete tie rail seat abrasion measurements.

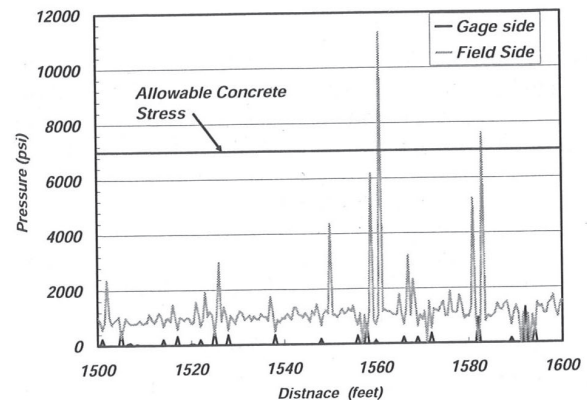
Figure 4 represents the pressure on the field and gage side around a recent Amtrak derailment. The derailment is around the 1560-foot marker. At this location, the concrete stress contact from the wheel rail load predictions exceeds the allowable concrete stress. Under these conditions, it would be expected that the concrete would begin to fail and produce a pattern as those seen at the site and depicted in figure 1. For

worm rail or deteriorated tie condition, these loadings combinations could be worse.

Figure 4. Field and gage side pressures around the derailment site.

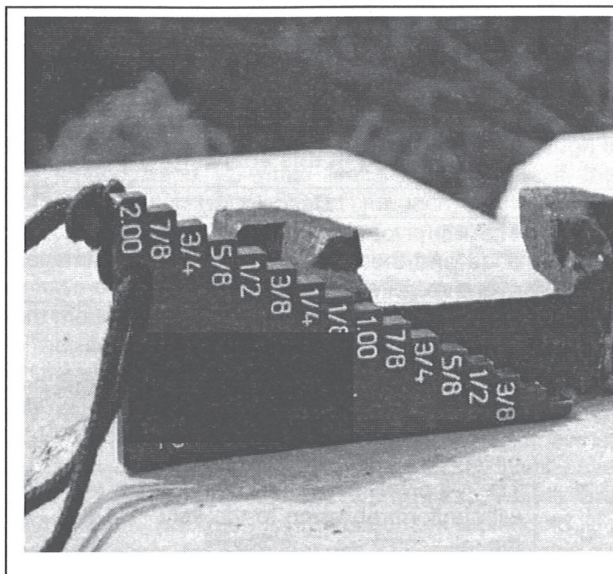
Figure 7, shows one rail seat abrasion measurement device currently available. Other similar devices or a rules/tape can be used to measure concrete tie abrasion. This gage fits between the abraded tie and the rail base to measure concrete tie abrasion. Other similar feeler gages or a ruler can be used in the absence of a specific measuring device.

Figure 7. A Typical rail abrasion measurement device
