# AN EVALUATION OF REMEDIATION TECHNIQUES FOR CONCRETE TIE RAIL SEAT ABRASION IN THE FAST ENVIRONMENT

By: Richard P. Reiff\*

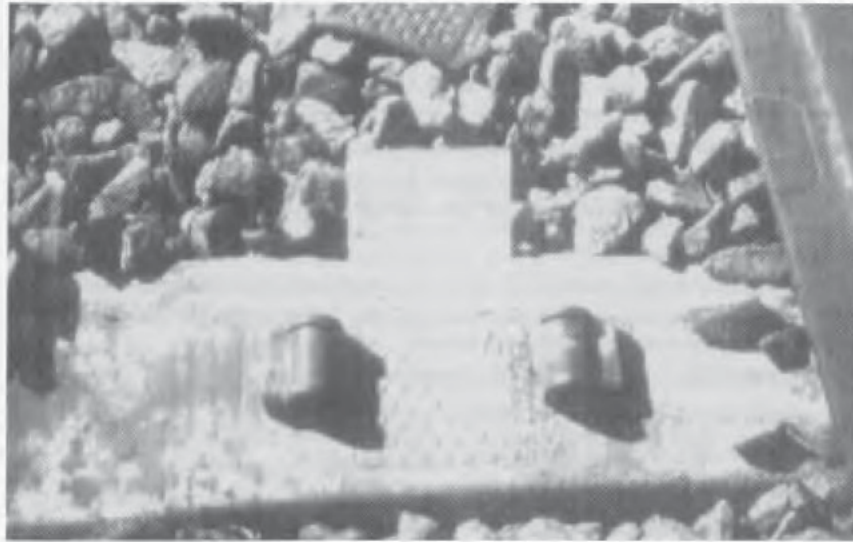
Figure 1.

Concrete tie abrasion results when tie material under the pad is lost to abrasion, hydraulic action and motion transmitted from the rail. The loss appears in the form of a localized breakdown of cement paste under the rail seat. (See Figure 1.) Abrasion is typically compared, in appearance, to tie plate cutting in wood ties. Wood, however, is subject to both fiber crushing and decay, which allows the tie plate to cut into the surface of the tie.
