Railroad Accident Brief

Accident No.: DCA-05-FR-010
Location: Home Valley, Washington
Date: April 3, 2005
Time: 9:35 a.m., Pacific daylight time¹
Railroad: BNSF Railway Company
Property Damage: \$854,000
Injuries: 30
Fatalities: None
Type of Accident: Amtrak passenger train derailment

NTSB/RAB-06/03

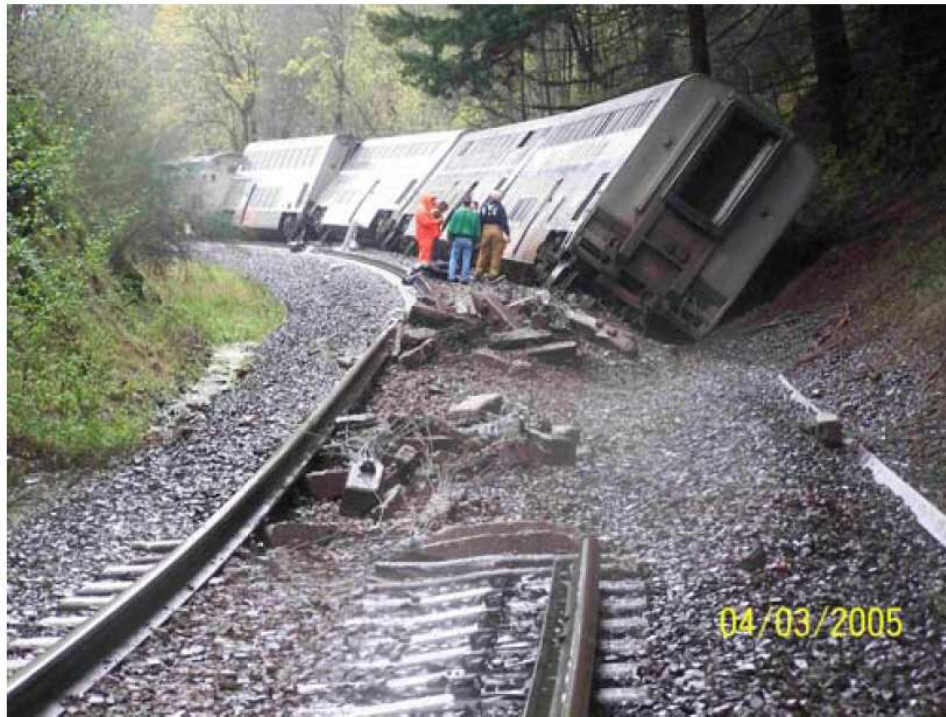
Figure 1. Derailment site.

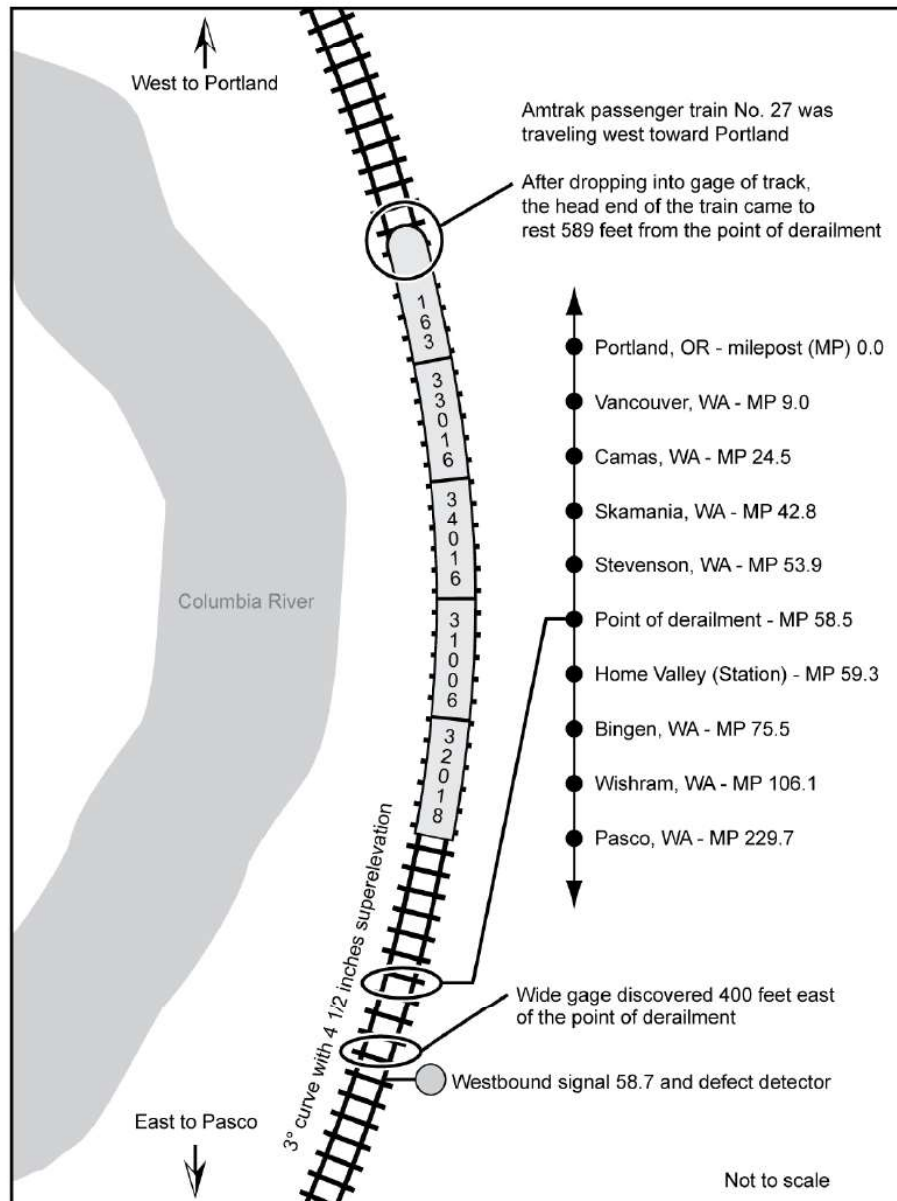
The Amtrak train traversed about 1 1/4 miles of straight (tangent) track before it entered a 3° left-hand curve and derailed. (See figure 2.) The engineer stated that he first became aware of the derailment when an emergency brake application occurred that he had not initiated. The conductors and passengers stated that they became aware of the derailment when they were thrown around and jostled in the coach cars, followed by clouds of dirt and debris entering the cars.

Figure 2. Sketch of accident site.

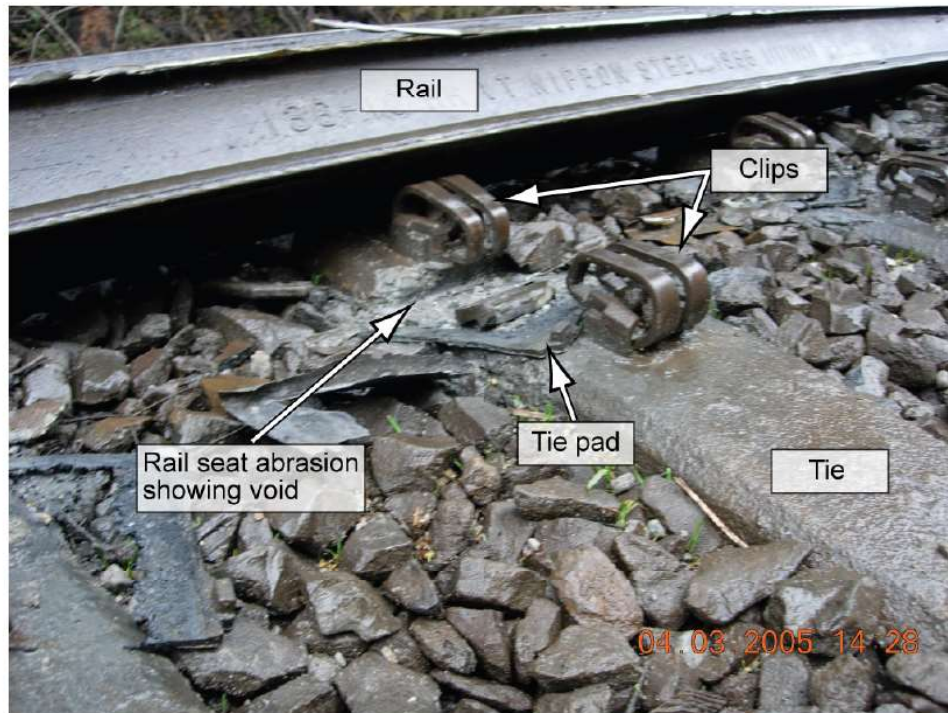
The investigation determined that the point of derailment was at MP 58.56 in curve No. 58B. Around that location, there were 19 consecutive concrete crossties that exhibited rail seat abrasion, which ranged in depth from 1/16 inch to 1 1/4 inches into the concrete surface on the field side²³ of the outside curve rail. The abrasions created voids between the bottom of the rail base and the top of the concrete crossties, which allowed the rail to deflect downward and rotate outward under load. (See figures 4 and 5 for two

views of the rail seat abrasion at the derailment site.) This rotation of the rail resulted in gage widening as trains passed over the area. Another sign of the gage widening under the load of the train was the streaking²⁴ in the center of the rail head of the inside curve rail. The locomotive unit of Amtrak passenger train No. 27 was the first vehicle to derail. It appeared that a wheel first derailed near the deepest abrasion.

Figure 4. Rail rollover and rail seat abrasion at derailment site.

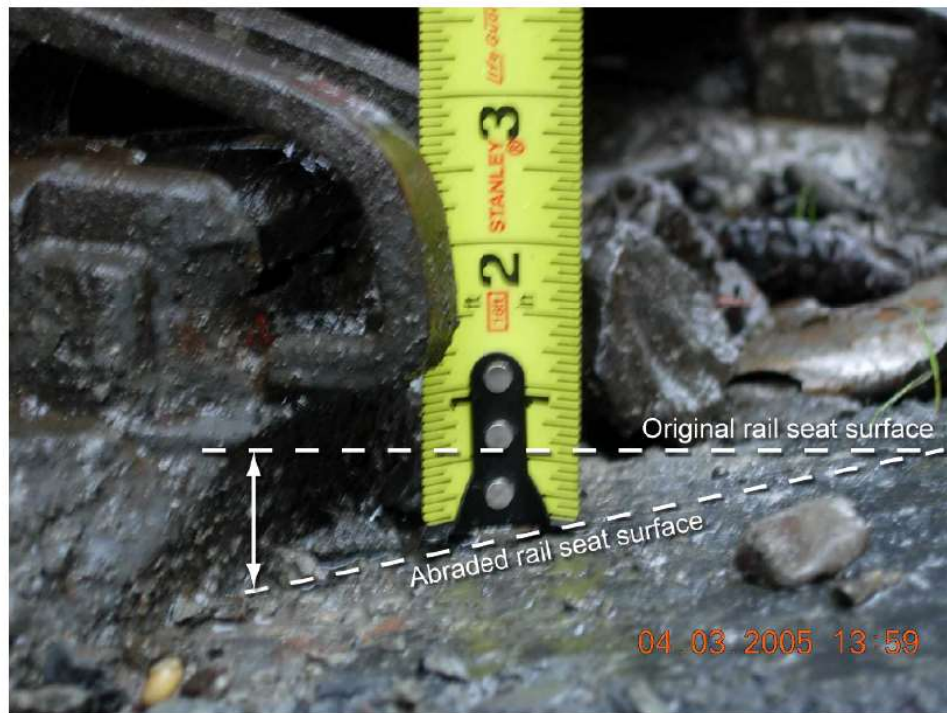
Figure 5. Concrete crosstie abrasion of about 1 inch at derailment site.
