Improvements to a chinese Arbour Press.

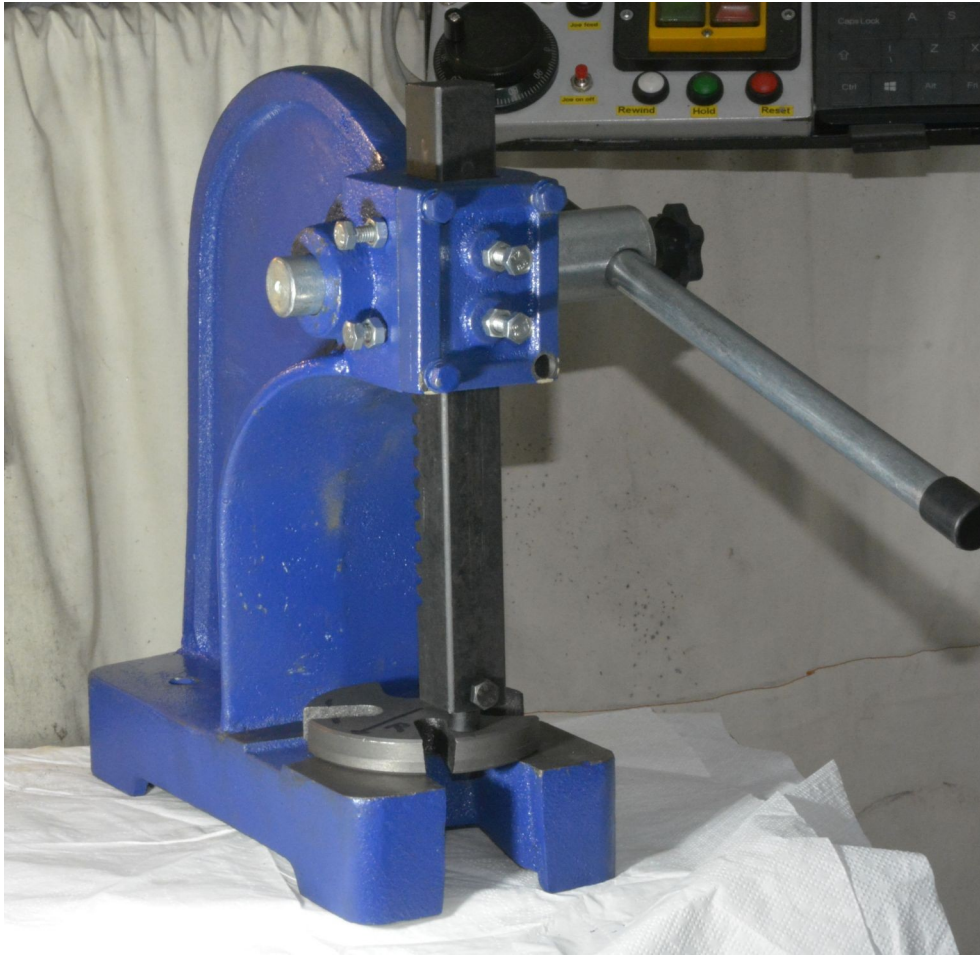
I built an hydraulic press some years ago but for simple and lightweight jobs it is overkill and usually takes time to setup. For those jobs I recently got a cheap 1 ton Arbour Press as shown here:

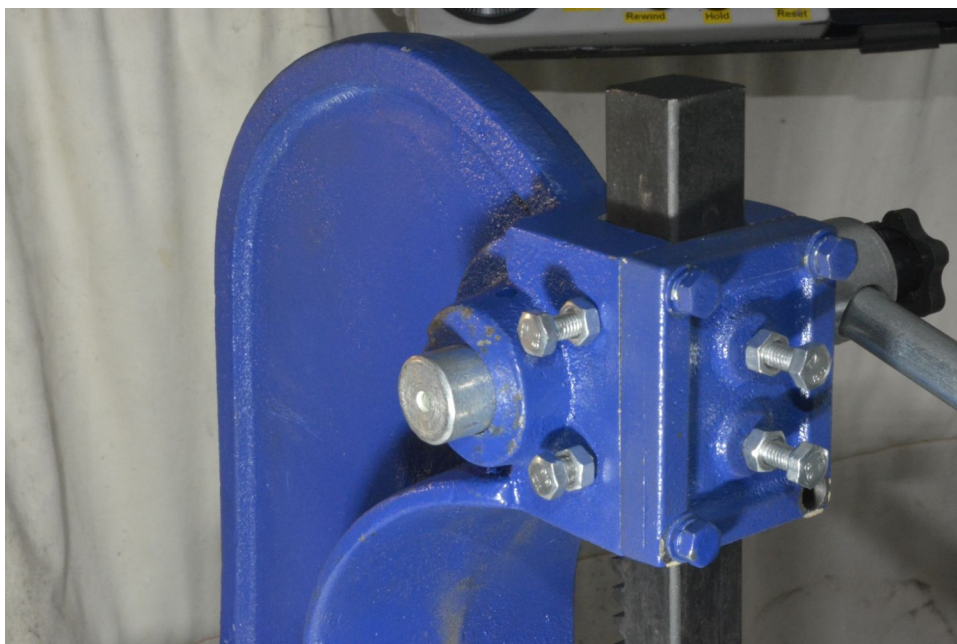
Initially I was very pleased to see the gib adjustments for the ram.

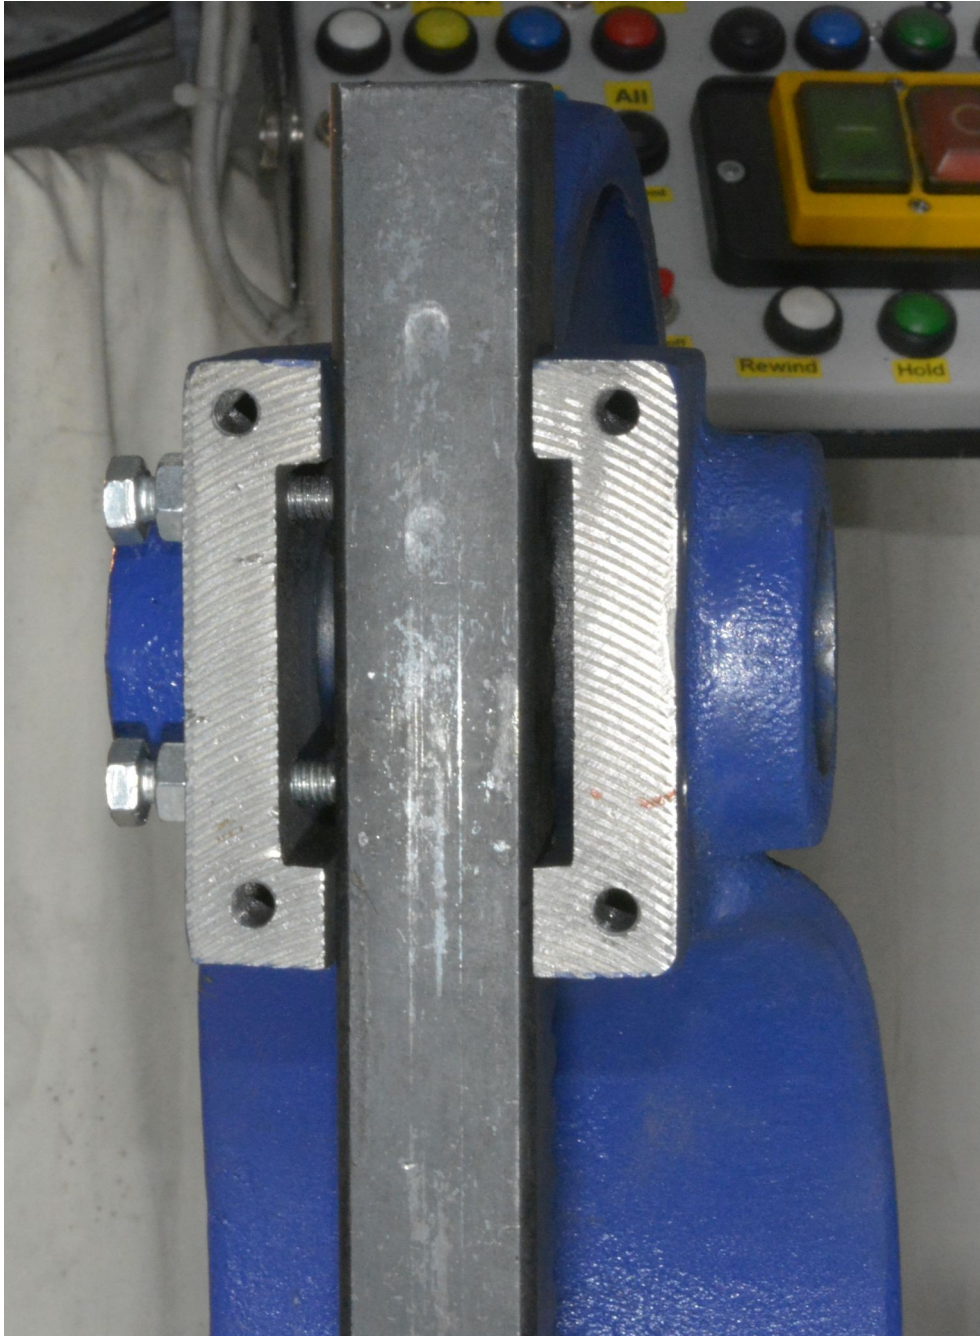
Imagine my horror when I opened it up to reveal that there were no gib strips, the ends of the screws bear directly on the ram. The screws were not even symmetrically disposed. This has to be a joke, where are the cameras?

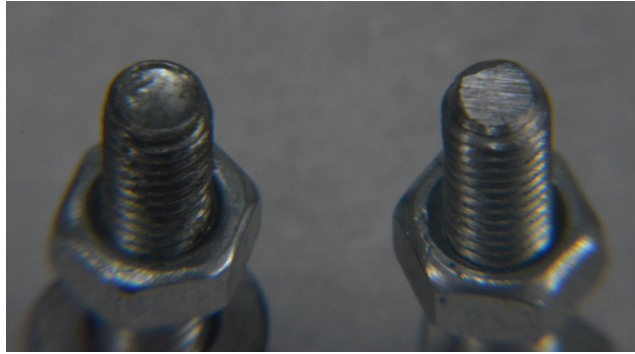
To make matters worse the ends of the screws were “as made” and not smoothed off like the one shown on the right side of the photo below. The ends of the stock screws were dimpled and only made contact with the ram via a thin ring. It is difficult to get a smooth and long lasting motion with such a botched design.

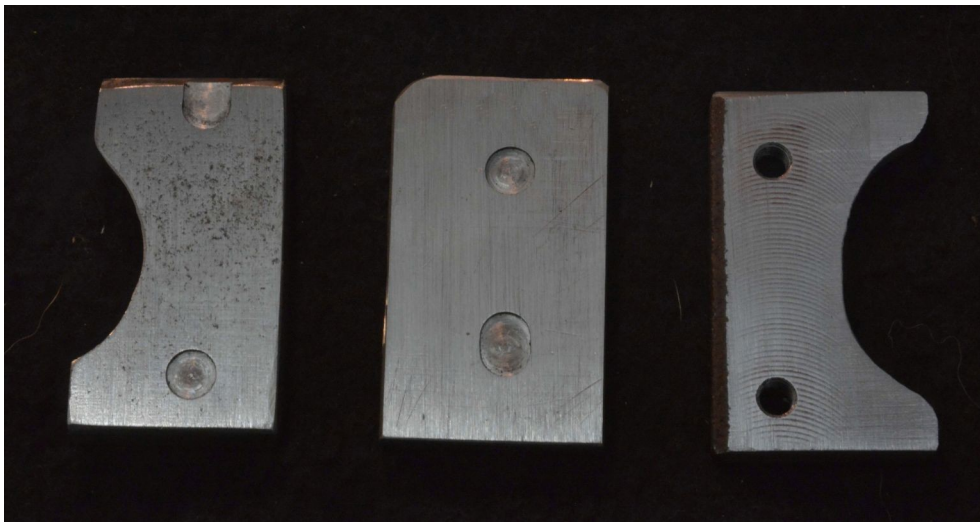
On the left hand side there was enough space for a 6 mm thick gib strip or plate, and by machining the front plate I was able to fit in one of 5 mm. I did not want to thin the front plate too much or I could have machined it deep enough for 6 mm also. The right side had no provision for adjustment and was machined and lapped to sit flush with the casting to give a continuous surface, the thickness came out close to 5.5 mm.

The spot facing on the left and front is to allow the adjusting screws to also act as location for those gibs. The right side is drilled and tapped and gets permanently bolted in place, becoming a permanent fixed part of the press frame. The part circle cutouts on the side gibs are to give clearance for the pinion shaft.

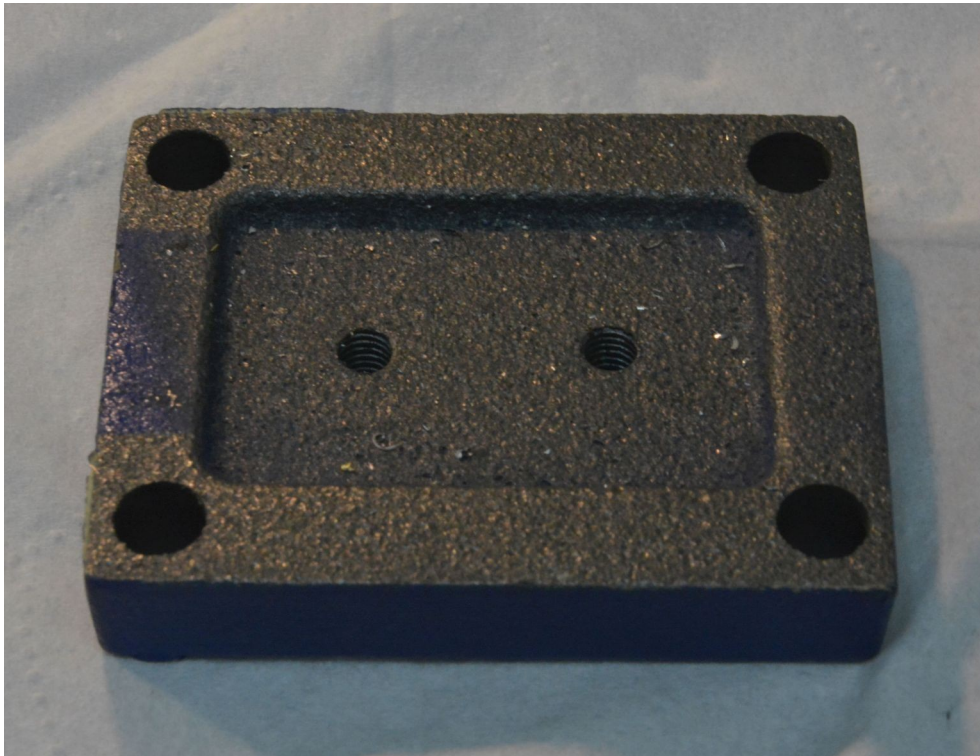
The photo above shows the stock front plate, which except for the holes is totally as cast. The tapped holes are for the adjusting screws.

I minimally faced off the outer surface to give a reliable reference surface and then milled the pocket to a depth of 4 mm for the front gib.

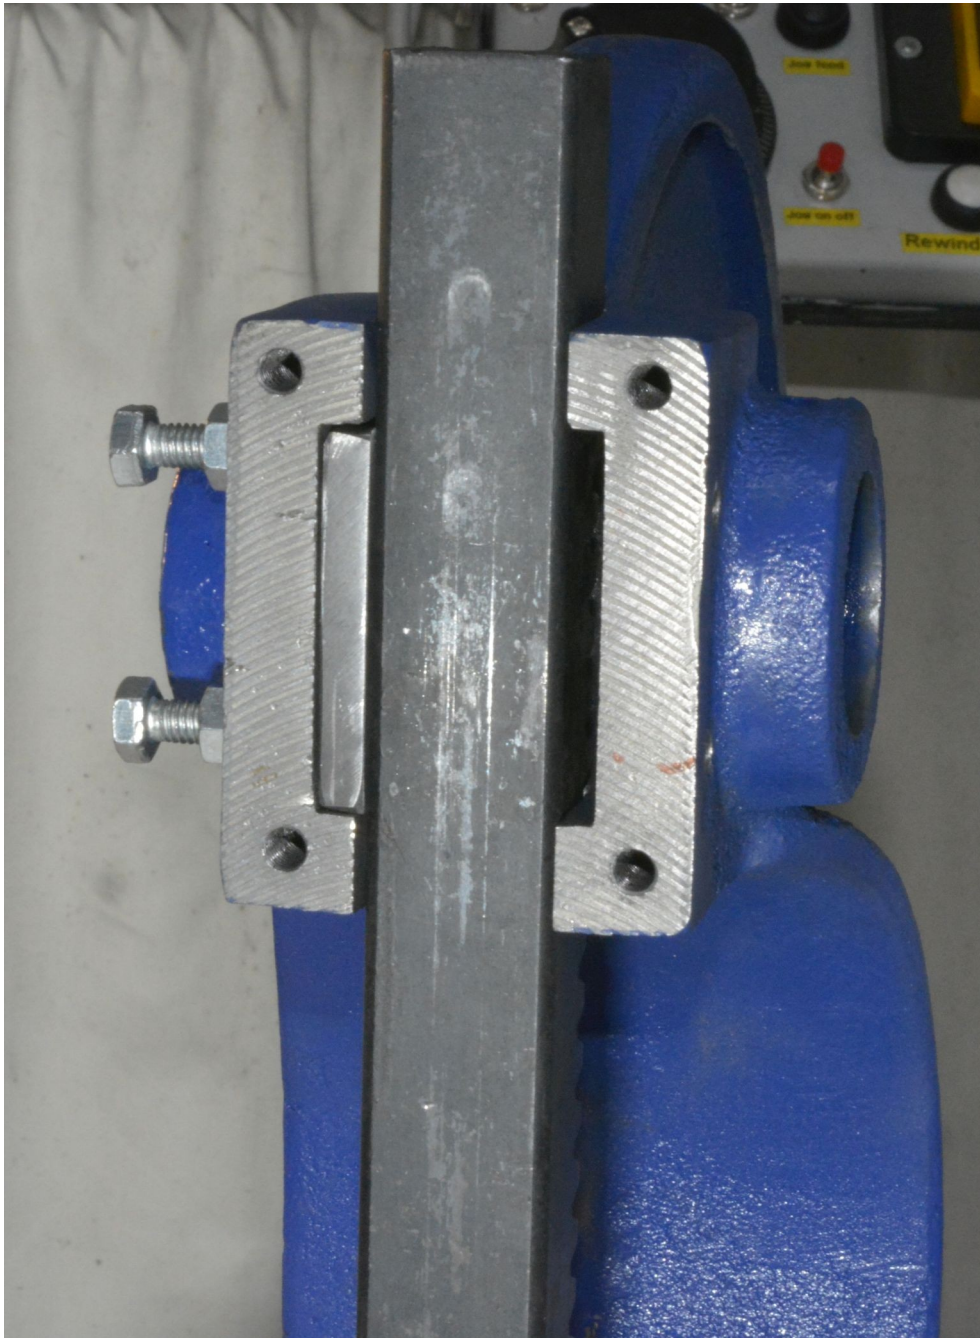
Here we have the left side gib plate in place. I just do not understand why they left space for a gib yet did not fit any.

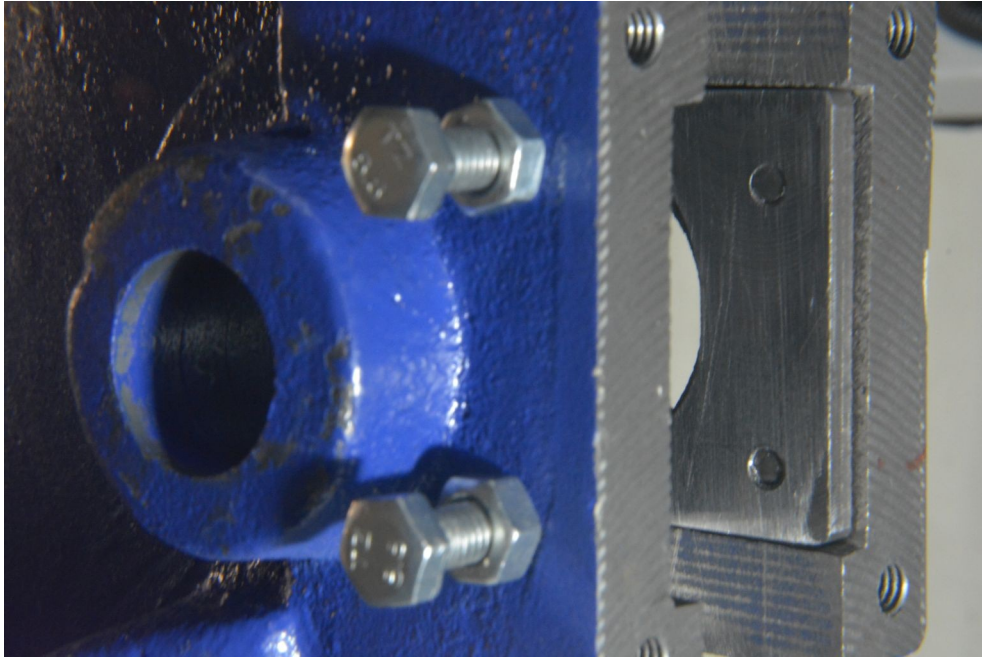
The right side plate is shown here. That is permanently bolted in place with no adjustment, it has been milled and lapped to sit flush with the adjacent surfaces above and below the plate to increase the bearing area for the ram.

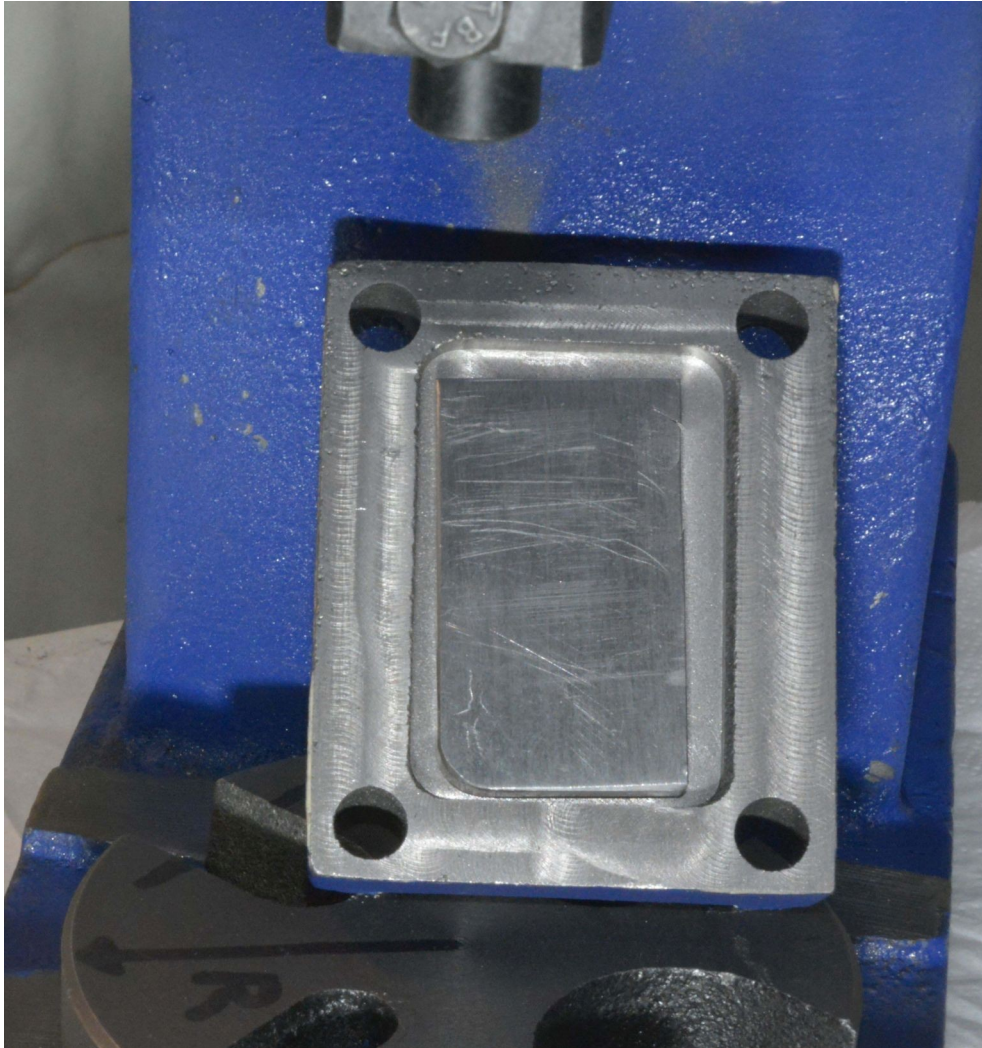
The front plate with gib ready for fitting. The side clearance is to fit inside the side gibs. The height of the plate is determined by the space in the main frame casting. The pocket on the stock front plate casting was larger than required.

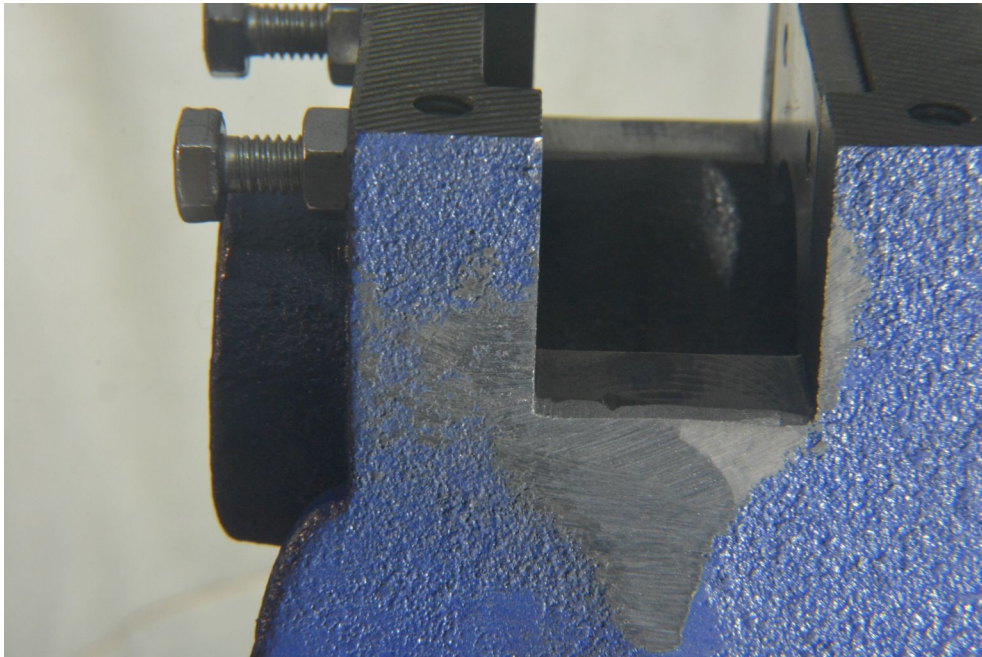
A close look revealed that the casting below and behind the ram exit had not been fettled very well and a point had been left. I ground that smoother and also filed lead-ins on all four edges which the rack teeth pass over as shown in the following photos. Now with the gibs greased and adjusted so that there was minimal play at the end of the extended ram the action was very smooth. A vast improvement over the "as supplied" performance.

View from underneath. Casting flash ground away.

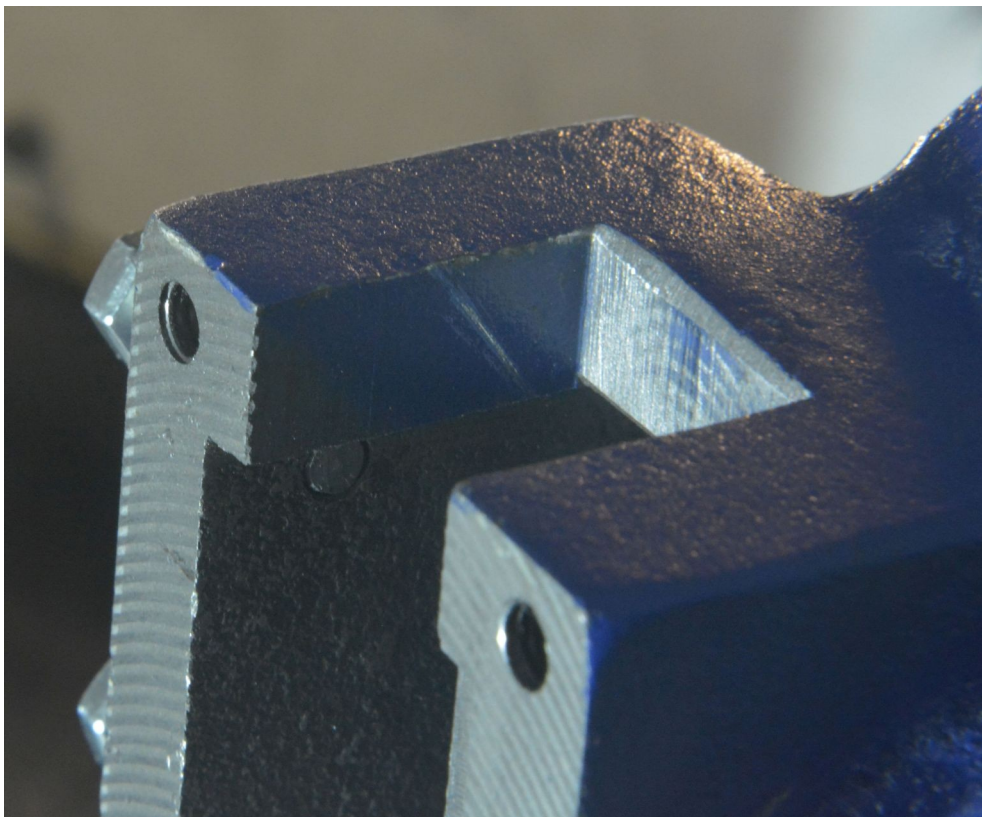
Sharp edge removed to form a lead-in for the rack.

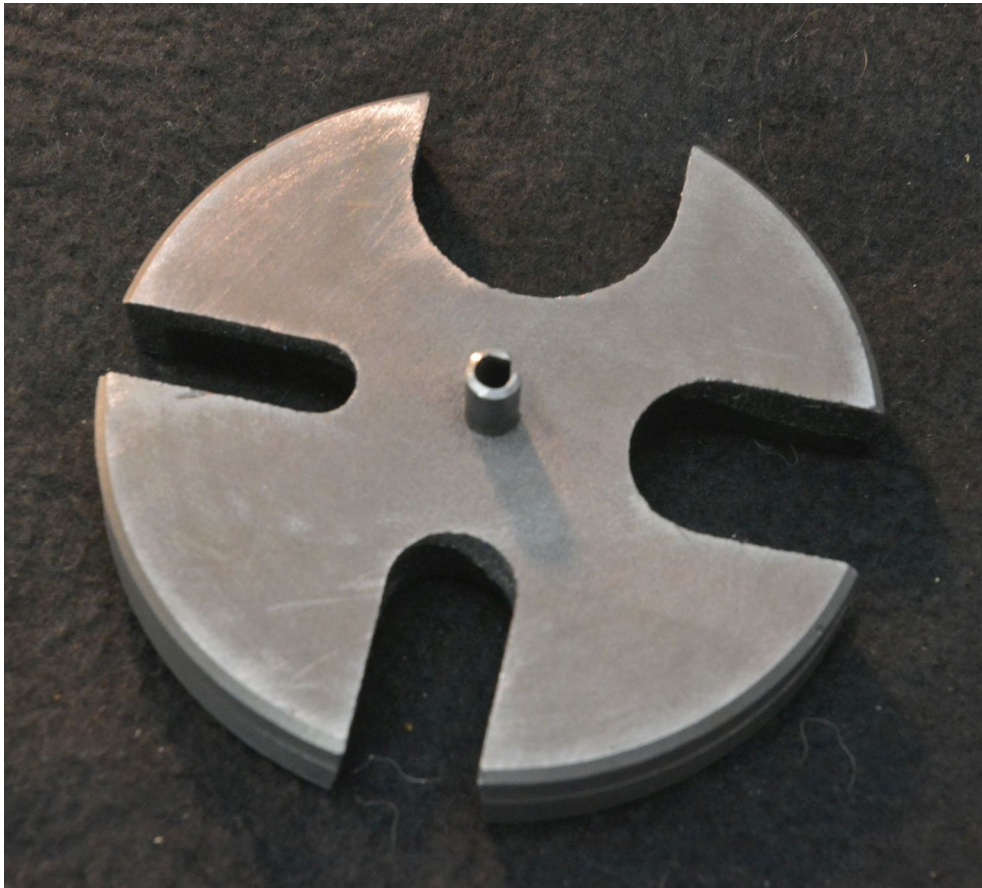
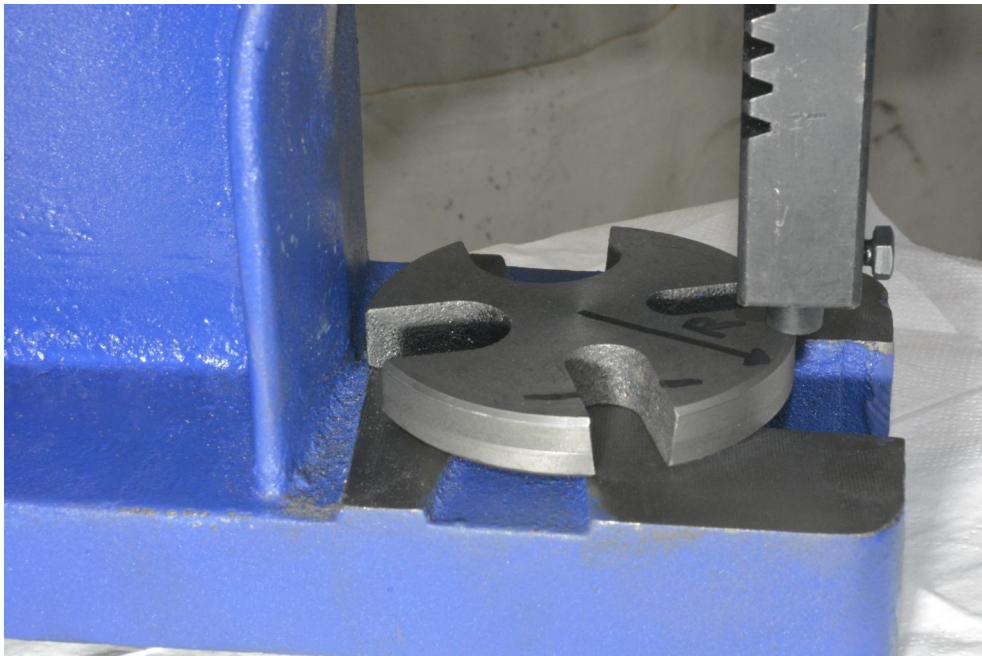
The top photo shows the underside of the supplied press plate. The roll pin is used as location on the base. The lower photo shows it mounted on the base and we can see that the centre of the ram is aligned with the edge of the plate. This does not give proper support for the workpiece. One obvious solution would be to make a plate with a larger diameter but the photo shows that there is little space behind the plate to do that.

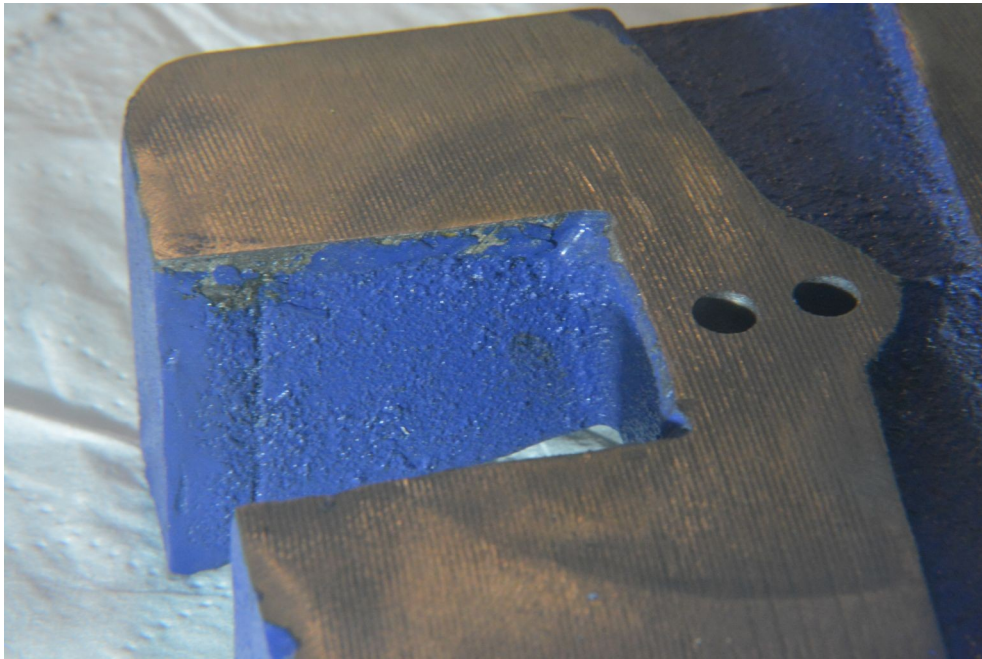
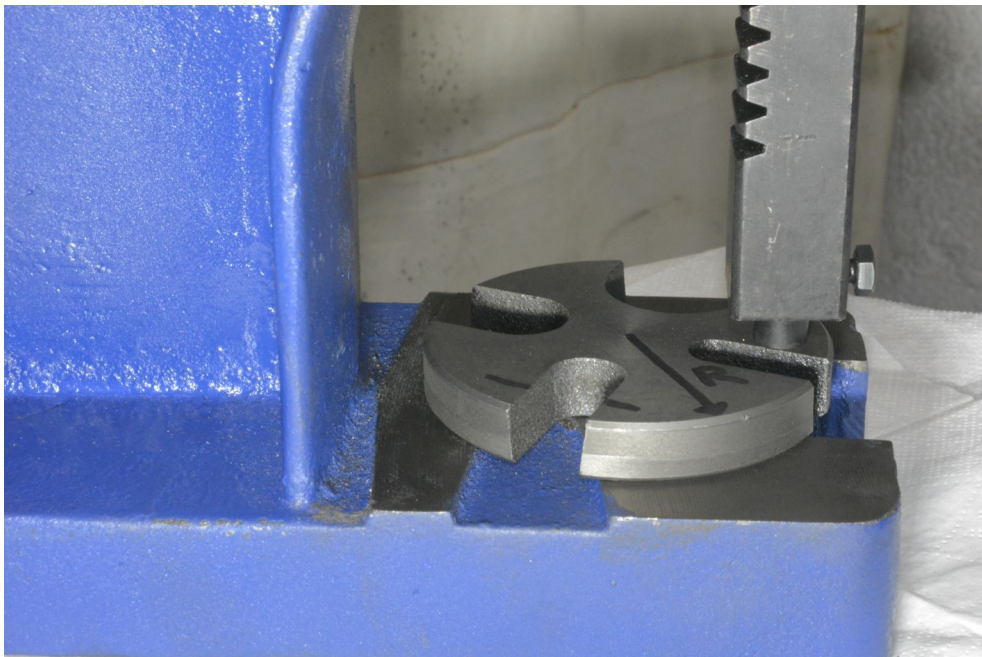
Another solution is to move the whole plate forward, to do that I drilled a new hole to relocate the roll pin as shown next. The hole to the right (rear) is the original, the other hole is the new one towards the front.

Here we can see that with the plate in the new position the ram is well away from the edge giving support to the workpiece. There is now enough space behind the plate to allow a larger plate. I shall make a bigger plate but in steel not cast iron. Steel is more ductile than brittle cast iron and so it will bend rather than break if overloaded. The steel plate will also fix the remaining design fault with the stock plate.

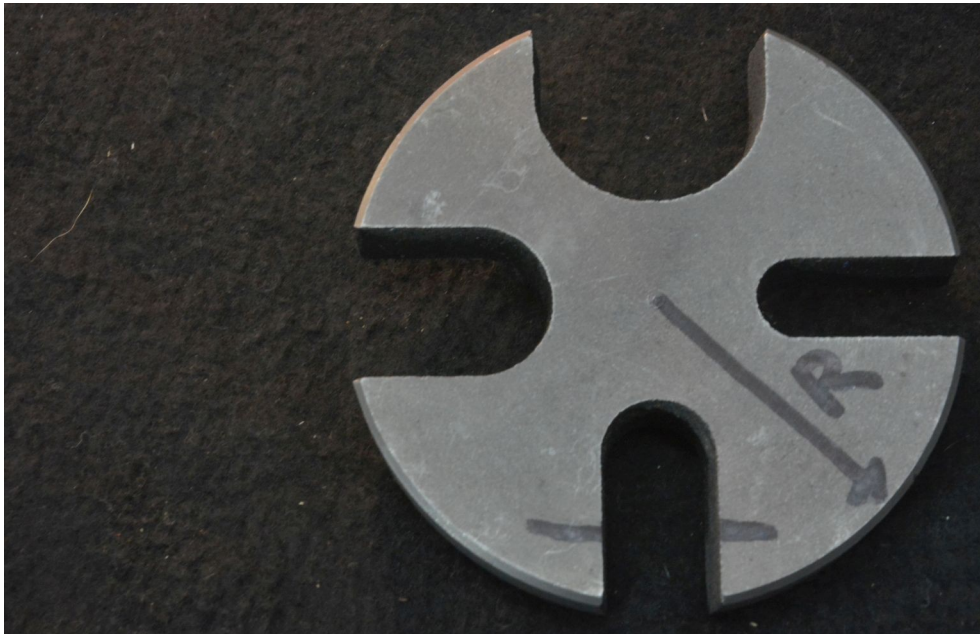
The slots in the plate are to allow for long workpieces to pass through, for example when pushing a shaft out of a bearing. Most such shafts will be round, square or hexagon, in any case they will be axi-symmetric and so there is no point in making the slot any longer than $\frac{1}{2}$ the width of the slot beyond the centre of the ram axis. For one of the slots that is indicated by the cross lines drawn on the stock plate in the next photo. Making the slots any longer only weakens the plate. Of course the wider slots will need more length.

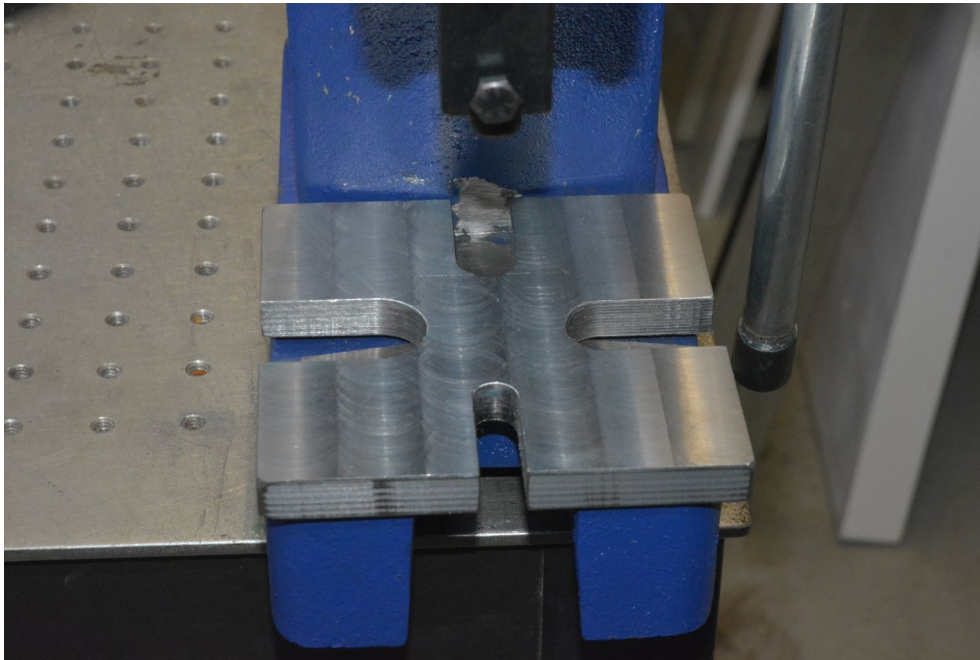
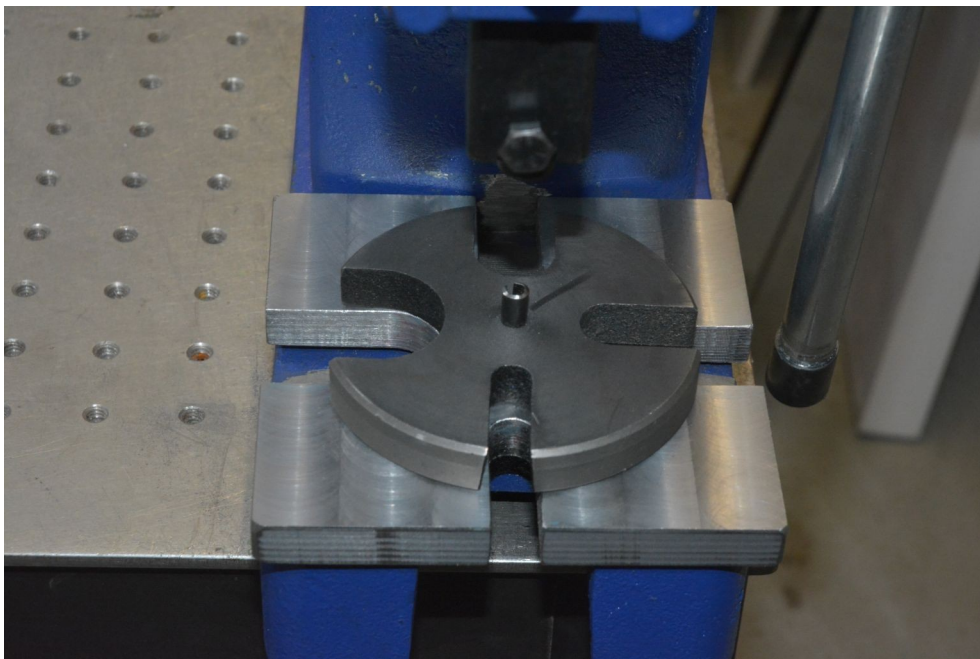
I have made the steel press plate. It is larger as suggested above but I have made it square to give the maximum possible support to the workpiece. I ignored the width of the slots in the original plate and made them to suit what I expect to be most used. I wanted to clear shafts of 10 mm, 12 mm, 15 mm, 17 mm, 20 mm and 25 mm. So I cut slots of 11, 16, 21 and 26 mm each with the minimum necessary length to match the widths.

The following photos show the new plate, firstly just the plate and secondly the plate with the original for comparison.
