# **Causes and Preventative Methods for Rail Seat Abrasion in North America's Railroads**

Russell H. Lutch<sup>1</sup>, Devin K. Harris<sup>2</sup> and Theresa M. Ahlborn<sup>3</sup>

## **ABSTRACT**

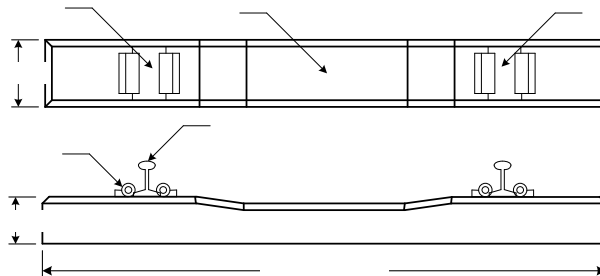
**Figure 1. Typical concrete tie shape and dimensions**

Prior to 1972, it is estimated that 120 million concrete ties were in service around the world (Hanna 1979). The reason for the introduction of concrete railroad ties is their increased durability and capacity when compared to the typical wooden tie which has historically been the standard in the railroad industry. It was not until the early 1970s that concrete ties began being utilized on large scale projects in the United States. The primary reason for the avoidance of this new technology was that the designs originally adopted from Europe were simply not sized for the larger loads within the North American mainline track system. Following the involvement of the Portland Cement Association (PCA) during the early 1970s, standards and designs were created for new concrete ties suited for use on North America's heavy haul railroad system (Hanna 1979). The shape and typical dimensions of a typical North American concrete tie is illustrated in Figure 1.

The primary materials in concrete ties are concrete and prestressing tendons. In addition to the concrete and prestressing tendons, ties include rail seat pads and rail fastening systems to anchor the rail to the tie (Figure 1). In the case of rail seat abrasion, the limiting materials are the concrete and rail fastening systems. These two components have the greatest variation in terms of design, and are typically the first components to fail in the track structure.

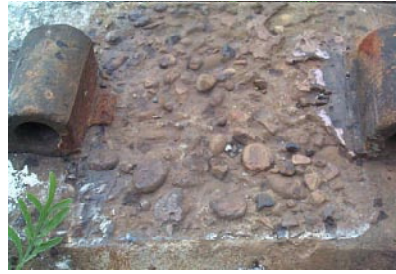
**Figure 2. Rail seat abrasion due to water intrusion (Peters 2003)**

The most common failure mode in the modern prestressed concrete railroad tie is rail seat abrasion. Rail seat abrasion is the gradual wearing away of the cement paste from the concrete, resulting in an uneven aggregate bearing surface beneath the tie pad (Figure 2). Factors contributing to rail seat abrasion include: the presence of water, high tonnage (static wheel loads larger than 25,000 lbs), steep track grades, and

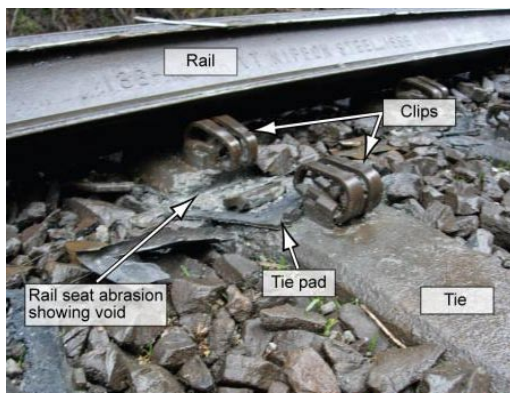
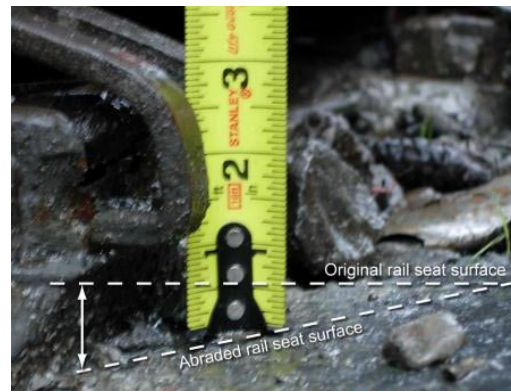
**Figure 4. (a) Rail seat abrasion on curve, which caused derailment due to widening of track gage, (b) Side view of rail seat abrasion (NTSB 2005)**

Similarly, curved track sections experience increased occurrences of rail seat abrasion. Abrasion is due to the uneven loading between the inner and outer rails and the additional lateral forces, generated as the train navigates a curve (Figure 3 (b)).

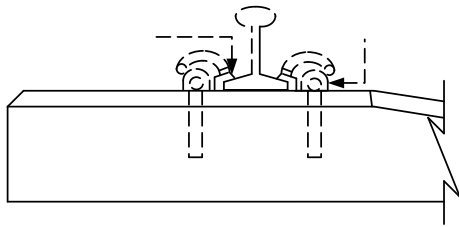
A correlation between rail fastener fatigue failure and rail seat abrasion has also been identified. Cyclic loading applied to the rail causes fatigue failure of fastener components, decreasing the restraining force applied to the rail by the fastener. Components prone to fatigue include polymer insulators and pads and steel shoulders. Figure 5 (a) illustrates a typical fastener configuration utilizing insulator pads and

Many fastener configurations exist, but a commonality is the spring force applied to the rail flange to enforce contact with the tie (Figure 5 (b)) (Hsu and Hanson 1968). Over time relaxation in the steel fastener components occurs due to fatigue loading decreasing the spring force applied. In addition, some fastening systems utilize polymer insulators which suffer from abrasion as well. Insulator material gradually deteriorates, creating voids and allowing excess rail movement. The failure of the fasteners allow for the intrusion of water and rail grit.

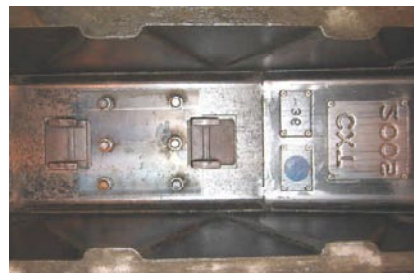
**Figure 6. Steel plate to be cast-in prior to casting (Peters 2003)**

Methods used by railroads and component manufacturers in both design and repair to combat rail seat abrasion include a variety in techniques. However, they share a similar objective of protecting the interface between the steel rail and concrete tie. Adopted in 2002, the CN60E tie was designed during collaboration between Canadian National (CN) and largest tie manufacturer in North America, L.B. Foster CXT, for use on their mainline track. Until the introduction of the CN60E, material degradation of ties due to rail seat abrasion was the leading causes of tie failure. To remedy the issue, CN and CXT set out to develop a method of protecting the concrete in the rail seat region without increasing production and maintenance costs of tie. Several techniques were considered, however the incorporation of a cast-in steel plate in the rail seat region was selected as the best solution (Figure 6) (Peters 2003).

Testing of the CN60E showed no rail seat abrasion after five times the required loading cycles to cause abrasion on other conventional North American tie designs. The steel plate design also increased track component life due to the elimination of fatigue movement of rail fasteners caused by rail seat abrasion.
