## **CN 60E CONCRETE TIE DEVELOPMENT**

Nigel Peters, M.Sc., P. Eng., CN

Steven R. Mattson, P.E., CXT Incorporated

CN recently redesigned its standard prestressed concrete monoblock crosstie. This paper presents the key differences in the prior designs versus the new CN 60E design and the testing, installation, and performance benefits of the CN 60E.

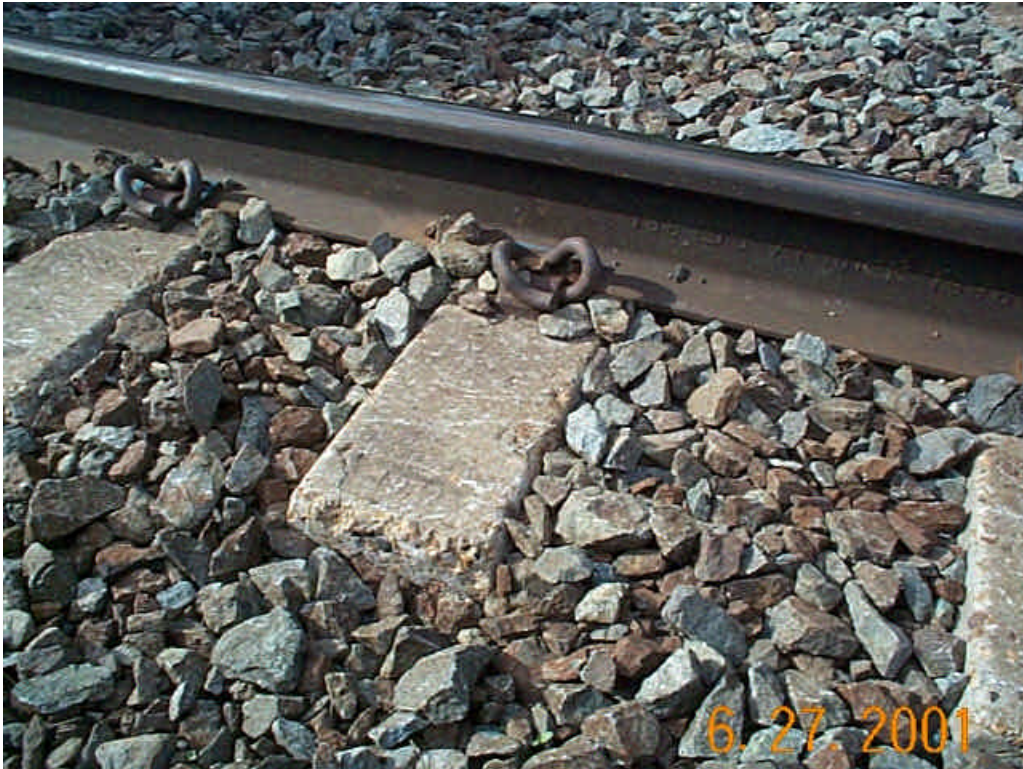
Figure 1 – Original 1972 CC241 (BR F23) Tie in Jasper Test Track

In 1972 Rudi Rotter, then CN System Engineer of Production, was put in charge of finding ways to efficiently install concrete ties. Thus, the “Jasper Test Track” was born and 10,000 Costain Concrete CC241 (designed to BR F23) were installed from MP 22.9 to MP 26.9 on the Albreda Subdivision. Approximately 6500 of these original 10,000 non air-entrained ties remain in track today (see figure 1). CN began installing concrete ties in a large scale production mode in 1974, continuing through the late 1980’s. Within this period, CN installed nearly 4 million concrete ties.

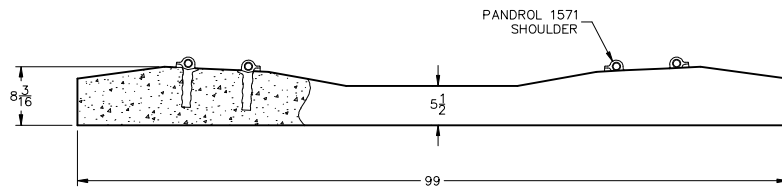
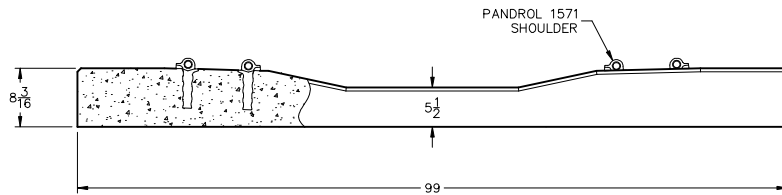
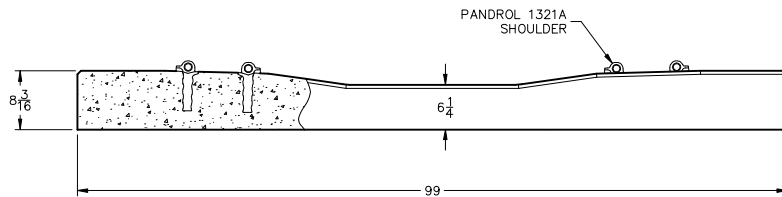
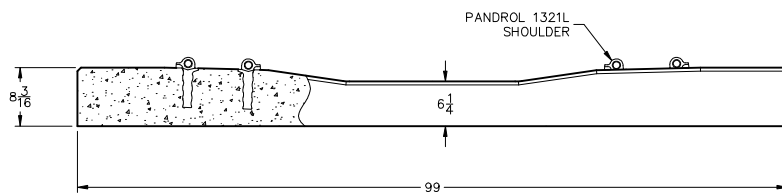
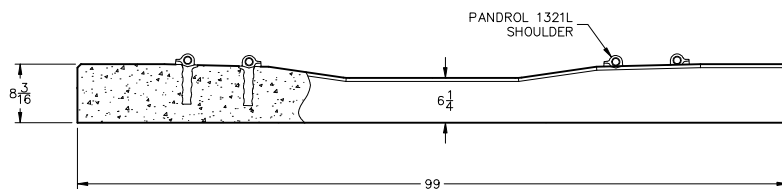
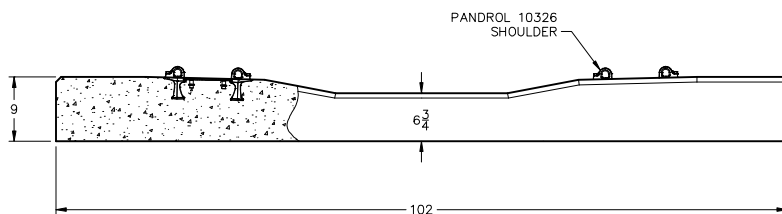
Figure 2 – CN Monoblock Concrete Tie General Comparisons

Over the years, CN has installed a total of four different concrete tie designs, as follows: CN 60A, CN 60B, CN 60C, and CN 60D. The CN 60A, B, and C designs were all designed for use anywhere in mainline track, while the CN 60D was a lighter, less costly tie developed strictly for use in tangent track. The CN 60B and 60C designs provide greater center negative bending strength over the CN60A design.

By far, the CN 60B and CN 60C designs were the most widely installed. Figure 2 shows a comparison between the different designs, including the CN 60E.

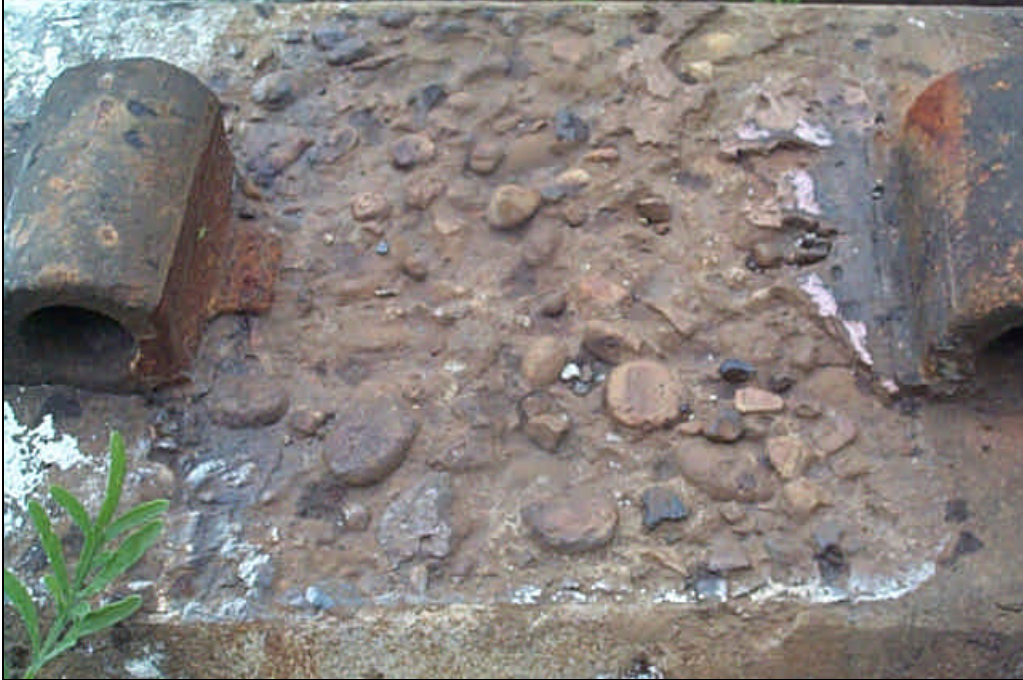
Figure 3 – Railseat Abrasion

Railseat abrasion is a gradual wearing away of the concrete paste and aggregate from the concrete beneath the tie pad (see figure 3). Railseat abrasion occurs due to the presence of water, high tonnage, steep grades, and predominantly in curves greater than two degrees. CN has many such curves throughout the lines that traverse the rugged Canadian Rockies. Since railseat abrasion was first discovered in the late 1980's, CN has been aggressively repairing ties in curves to restore their original railseat geometry to ensure proper longitudinal rail restraint, cant, and gauge. Some curves have undergone more than one repair cycle, with some curves currently undergoing their 3<sup>rd</sup> rail seat repair.

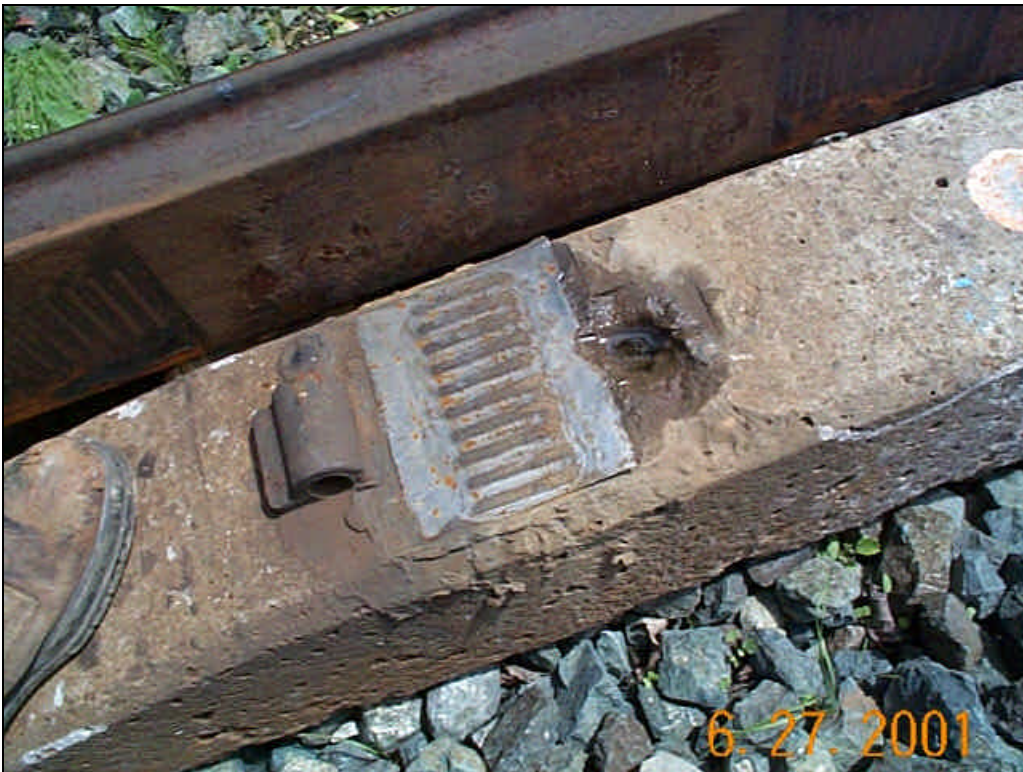
Figure 4 – Tie with Broken Ductile Iron Shoulder

The problem of fatigue failure of the cast-in ductile iron shoulder in curves poses significant derailment risk (see figure 4). Shoulder breakage occurs at a depth of approximately two inches below the top of the tie. Laboratory testing indicates that

the cause of this failure is low cycle fatigue due to the shoulder geometry and shoulder material properties.

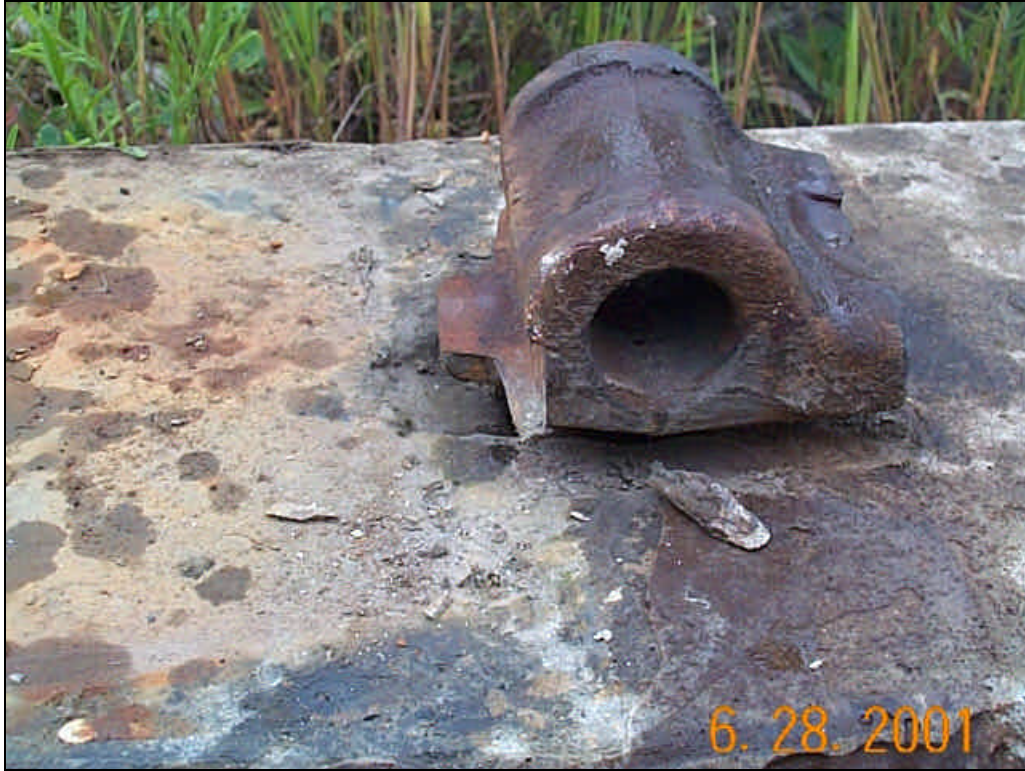
Figure 5 – Shoulder Showing Signs of Stem Fatigue, Heel Wear, and Face Wear

Lastly, there has been some loss of toe load due to the heel of the shoulder wearing from repeated clip removals and insertions necessary for rail, pad, and/or insulator replacements (see figure 5).

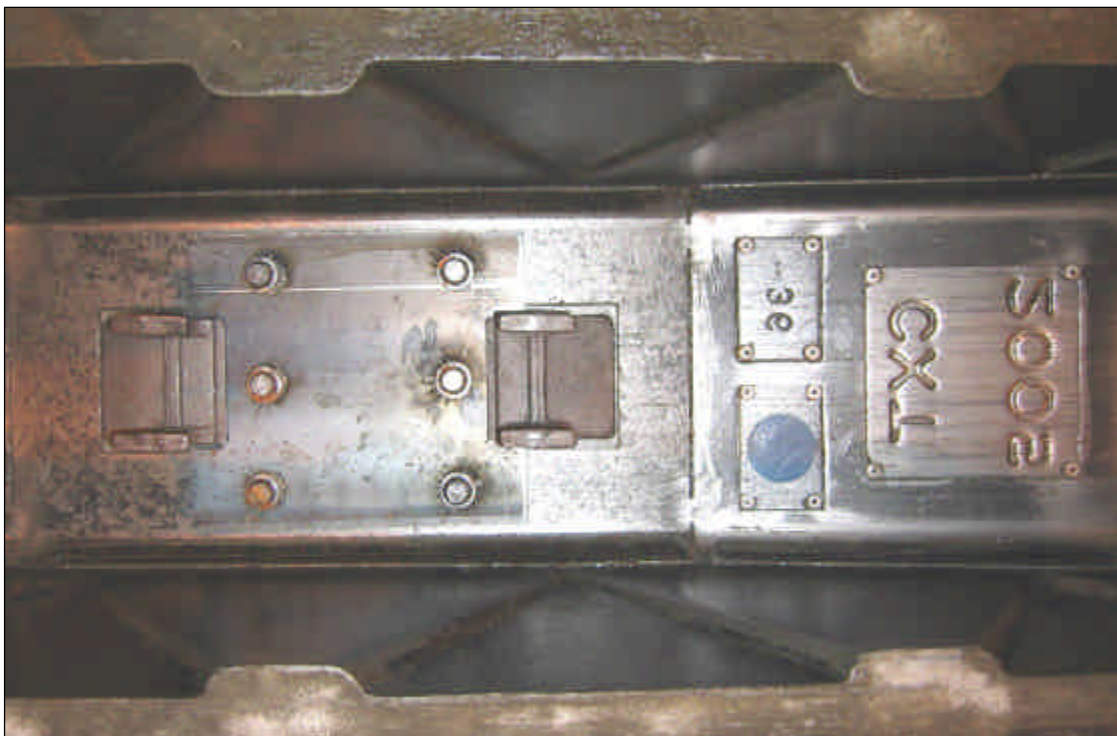
Figure 6 – Studded Steel Plate In Tie Form Prior to Casting

Since the shoulder geometry was being redesigned and therefore new patterns required, additional features were added to further improve performance. These included adding a clip anti-backout feature and skirts to reduce grout leakage and secure the cast-in-place steel plate during manufacture (see figure 6). In addition, an anti-rotational fin and more area under the heel was added to better distribute rotational and overturning moments into the concrete tie.

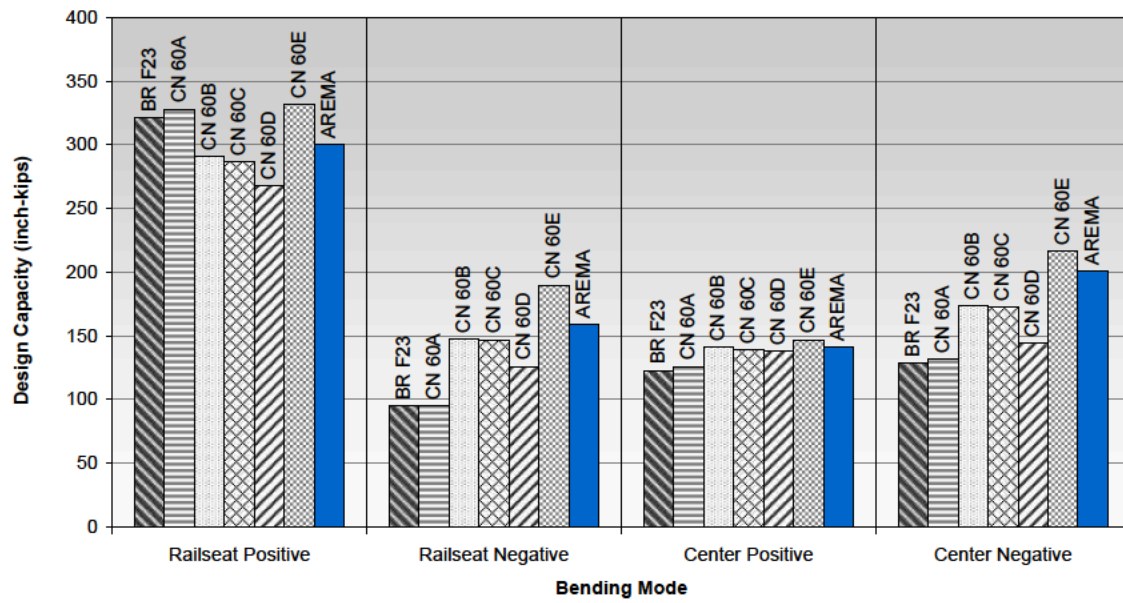
Figure 7 – CN Monoblock Concrete Tie Structural Comparisons

Since new tie designs were being considered, CN and CXT reviewed current concrete tie designs in use by other heavy haul Class 1 Railroads. Most of the railroads using concrete ties have migrated to 8'6" long ties to reduce ballast pressures by approximately 10% versus 8'3" long ties. Current use also indicated prevalent use of a multiplicity of indents along the sides of tie to improve lateral resistance in track. As such, an 8'6" tie with multiple side indents was selected, with structural performance also increased from existing to meet current AREMA Chapter 30 requirements (see figure 7 for structural comparison).

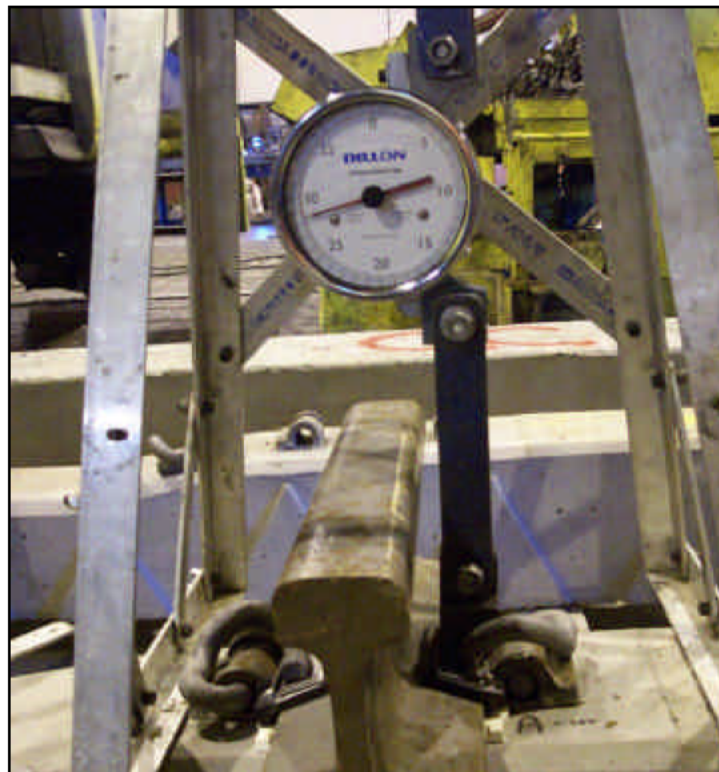
Figure 8 – Pandrol Toe Load Testing on CN 60E Tie

Pandrol Canada and CXT Incorporated jointly validated the toe loads provided with the improved twin stem shoulder using both the older style PR 631 clip and the proposed e2009L clip (see figure 8). This testing showed that the CN 60E tie provides the anticipated toe loads with either clip type, which allows for flexibility in the field.

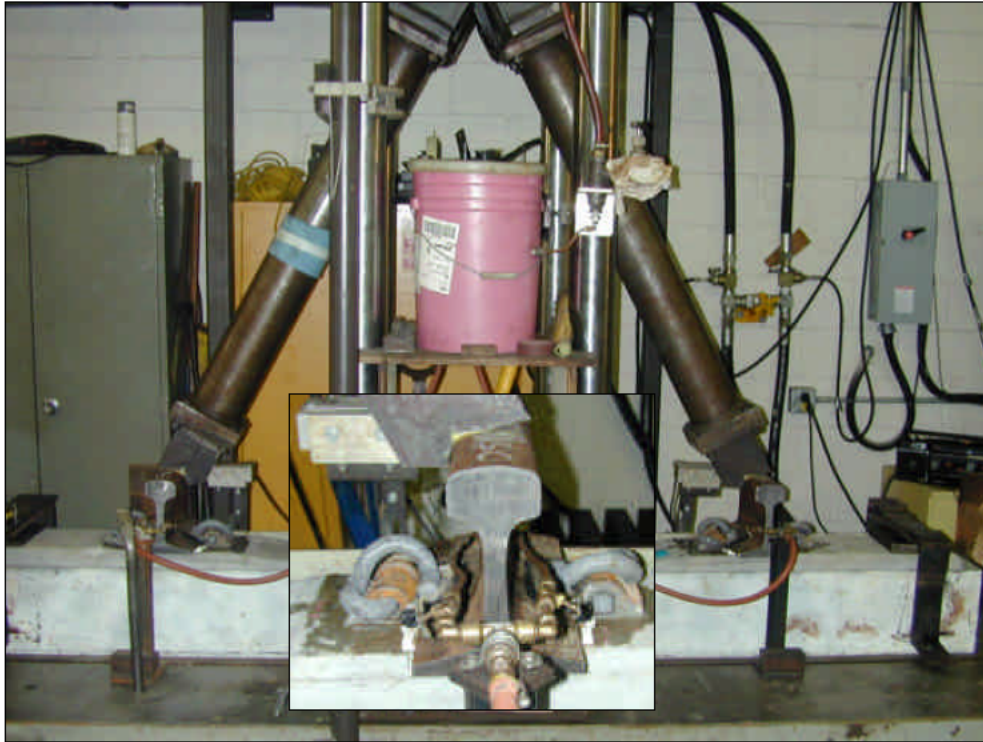
Figure 9 – Bodycote Repeated Load Test Apparatus with Sand and Water Drip, 70,000 lbs Load at 0.52 L/V. Inset Shows Railseat Configuration.

To prove the chosen CN 60E fastener design, Bodycote was again commissioned to provide testing. Since the tie shape and structural design were already proven for other Class I Railroads, the testing regime was setup solely to qualify the chosen shoulder material, shoulder geometry, cast-in-place studded steel railseat, pads, clips, and insulators. This test subjected the complete assembly to a load distribution of 35,000 lbf vertical and 18,200 lbf lateral ( $L/V$  ratio=0.52) per railseat at a rate of 2.5 cycles per second. Throughout the test, traction sand and water were applied continuously to both railseats to simulate in-track abrasion conditions (see figure 9).

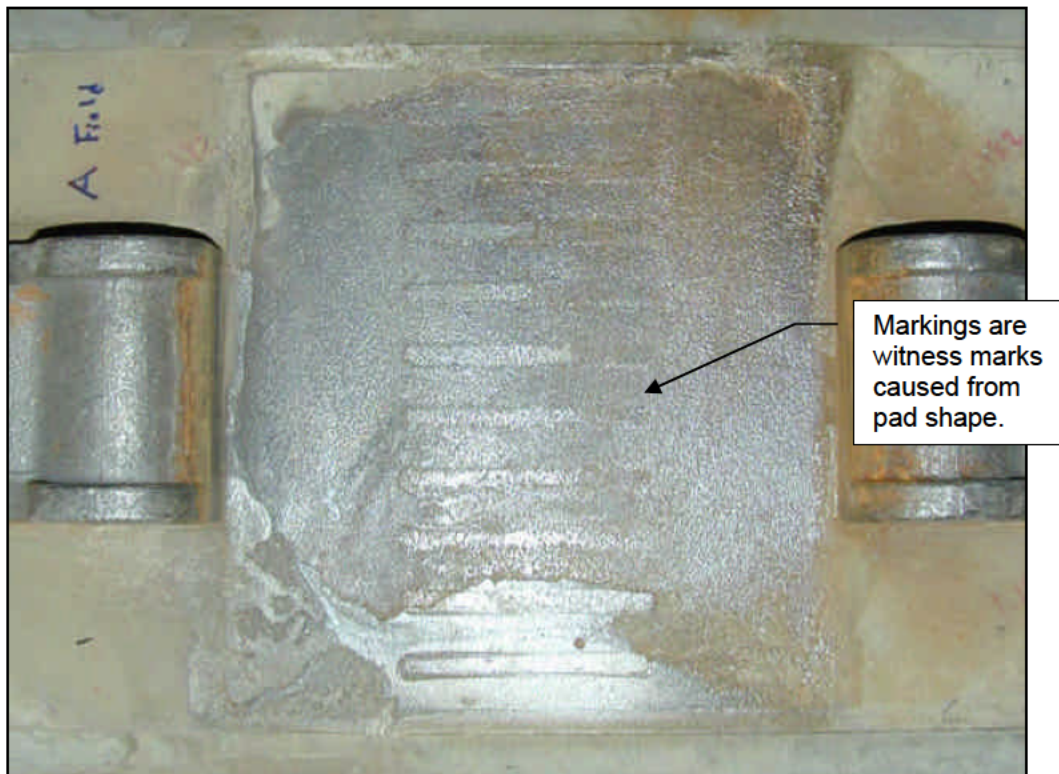
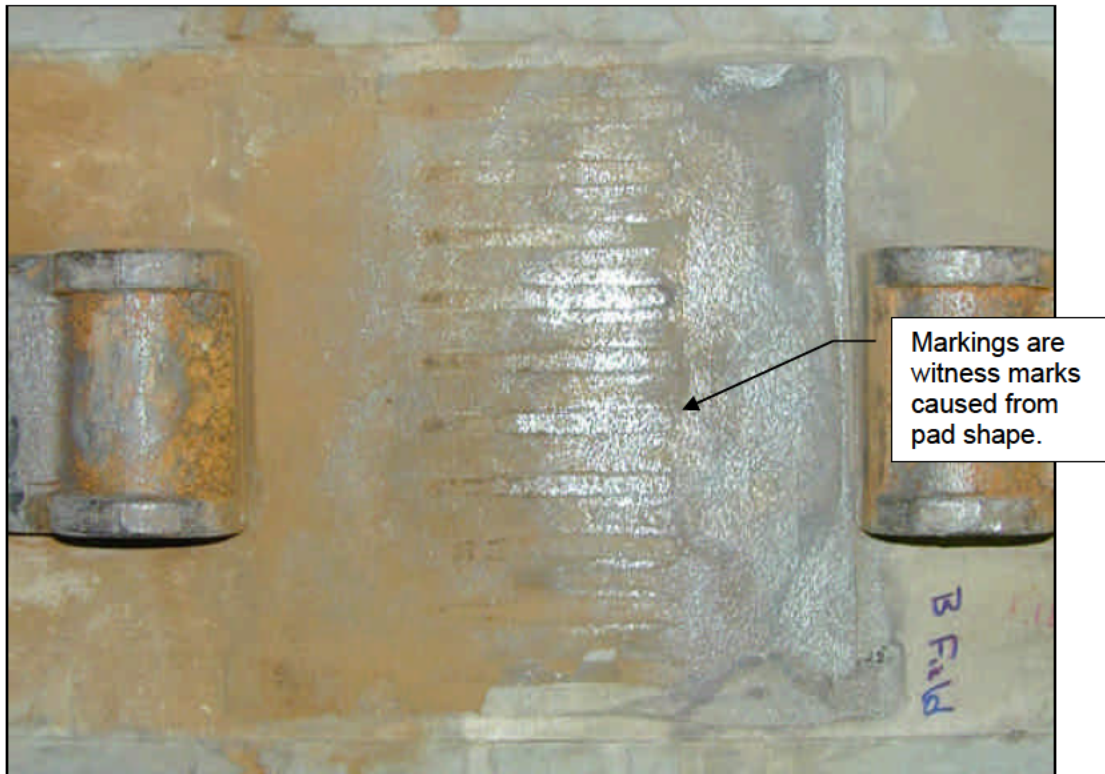
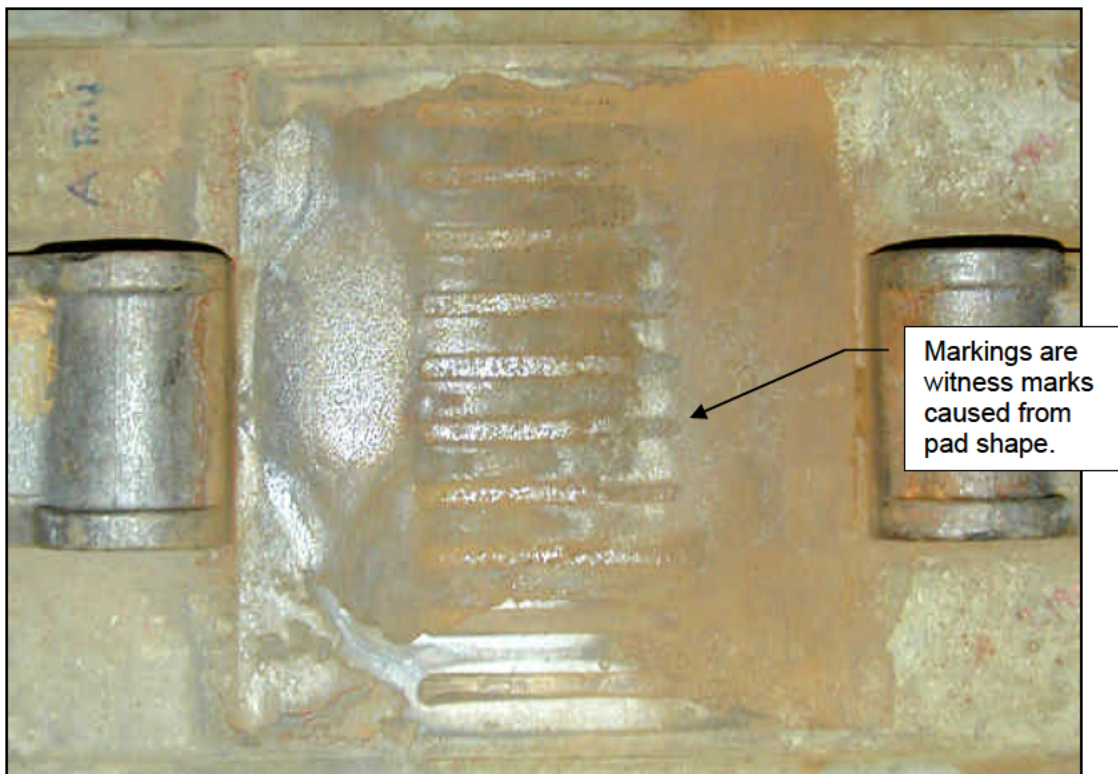
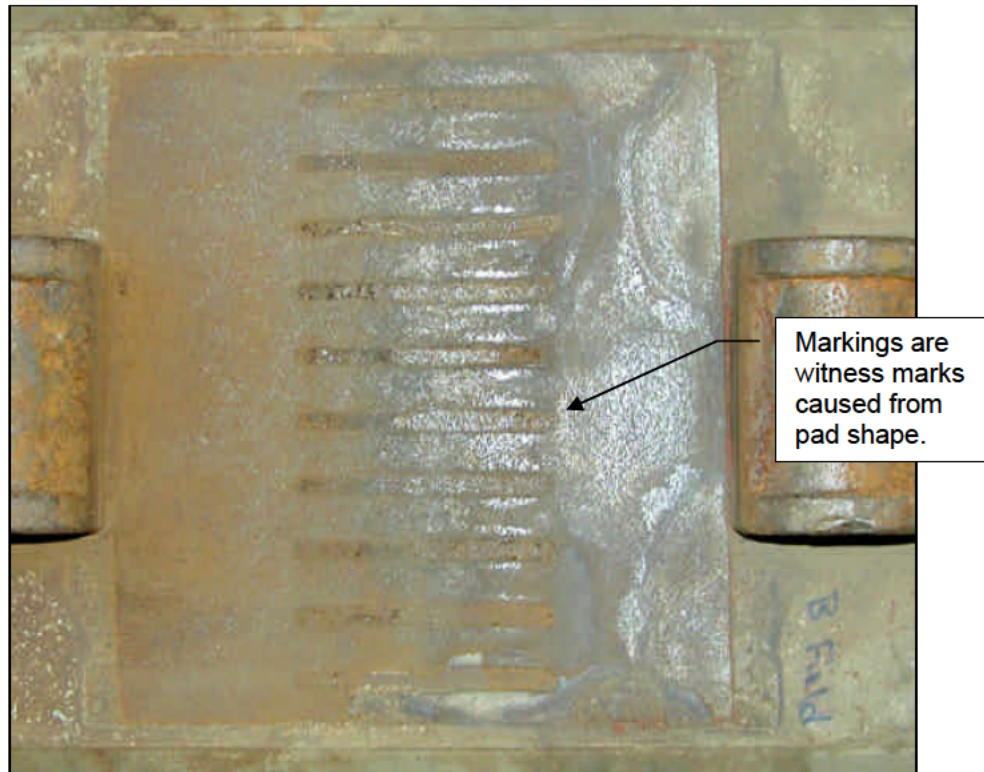
Figure 10A – Railseat A After 3.8 Million Cycles

Figure 10B – Railseat B After 3.8 Million Cycles

Figure 10C – Railseat A After 10 Million Cycles

Figure 10D – Railseat B After 10 Million Cycles

The test ran for 10 million cycles with no shoulder loosening and no railseat abrasion on the cast-in-place steel plate (see figures 10A through 10D). Similar tests run on other accepted North American concrete tie designs generally show detrimental railseat abrasion and/or shoulder loosening within 2.5 million cycles.

An unexpected benefit discovered as a result of this testing was improved component wear life. The condition after 3 million cycles was found to be representative of the condition typically observed after only 1 million cycles. This threefold improvement in component life is most likely due to the complete assembly being held tightly together in

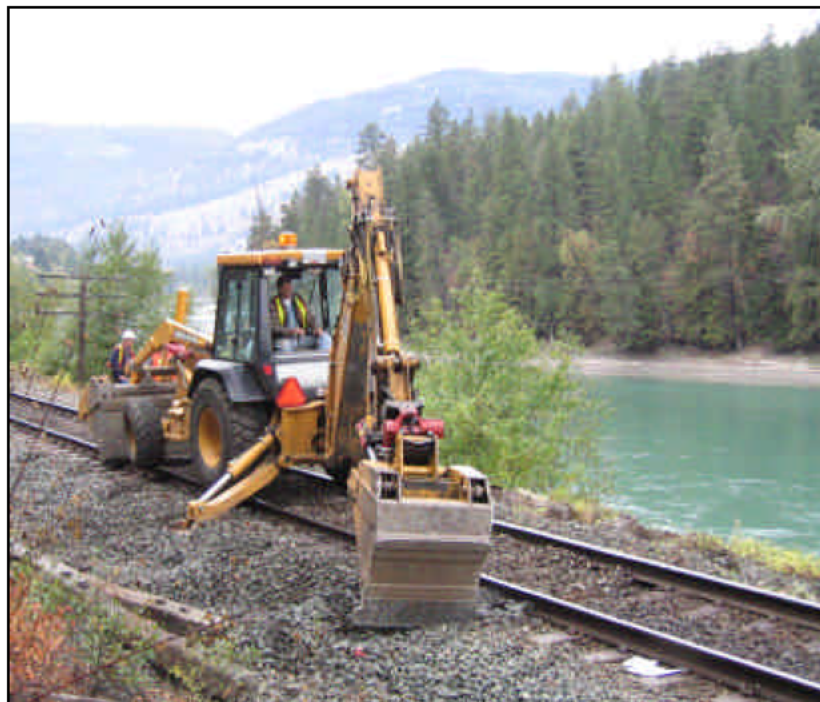
Figure 11 – Hi Rail Backhoe Replacing Every 6<sup>th</sup> Tie in Front of Main Gang

The concrete tie replacement concept is to replace the ties in an out of face operation. In preparation for the installation, the new concrete ties are laid out ahead of time (usually several weeks in advance) on the opposite side of the track from where the existing ties will be removed. A rubber tired backhoe with hi-rail attachments and a special designed claw bucket was used to replace every sixth tie with a new 60E concrete tie, being careful not to lift the track (see figures 11 and 12). This is usually performed a few days ahead of the main tie gang arriving.

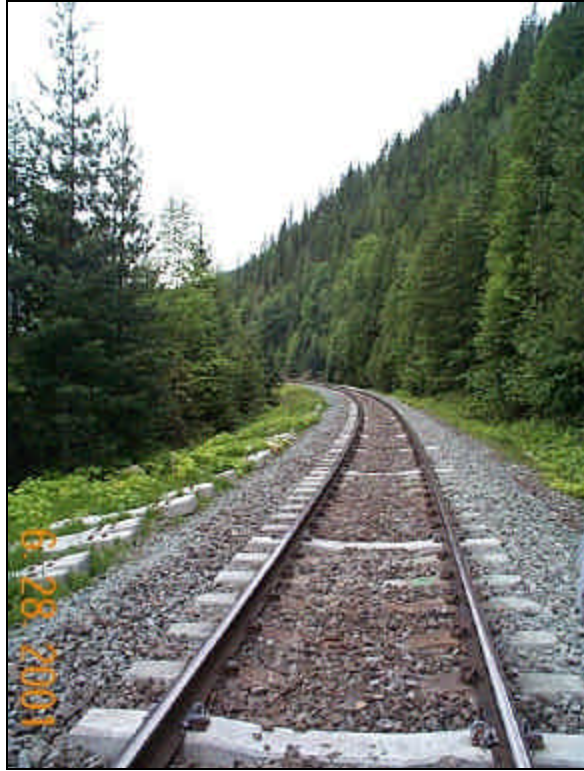
Figure 12 – Track After 1:6 Replacement by Backhoe

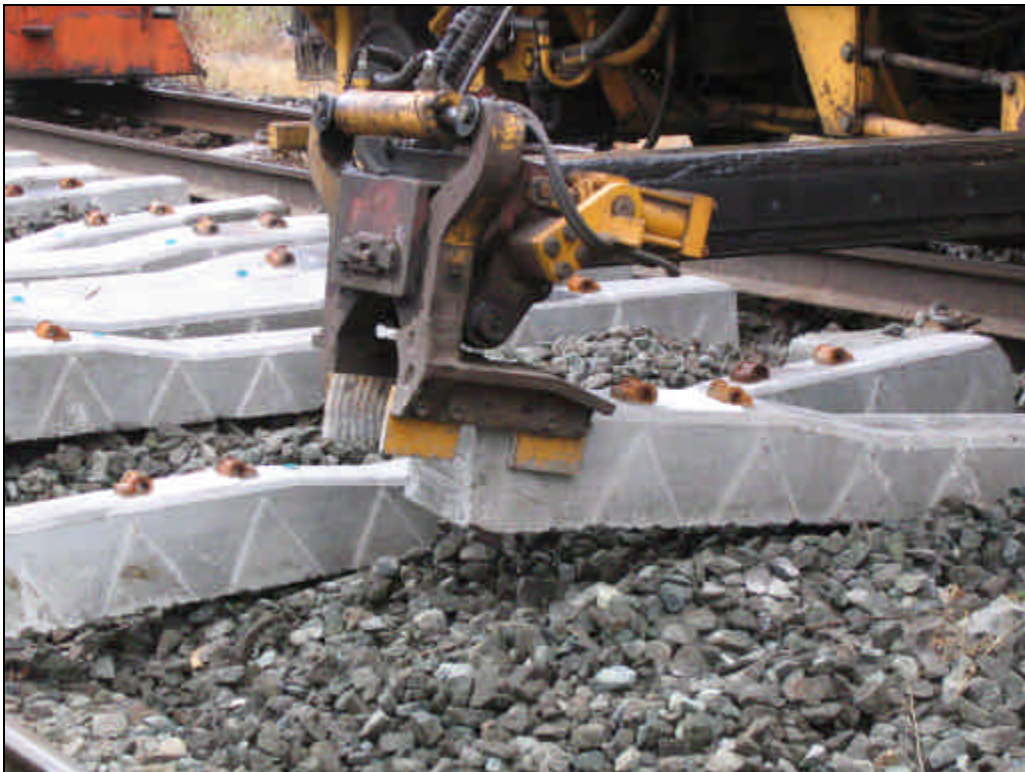
Figure 13 – TR-10 Tie Insertion

Other tie cranes transfer the new ties to the other side of the track in preparation for installation. A following TR-10 installs the new concrete ties (see figure 13). A rail lifter then lifts the rail so that the rail seats can be cleaned of ballast by compressed air and the pads installed (see figure 14). A production tamper then tamps the ties so they are snug to the rail (see figure 15). The insulators and clips are then installed (see figure 16). The track is then tamped, regulated and stabilized (see figure 17).

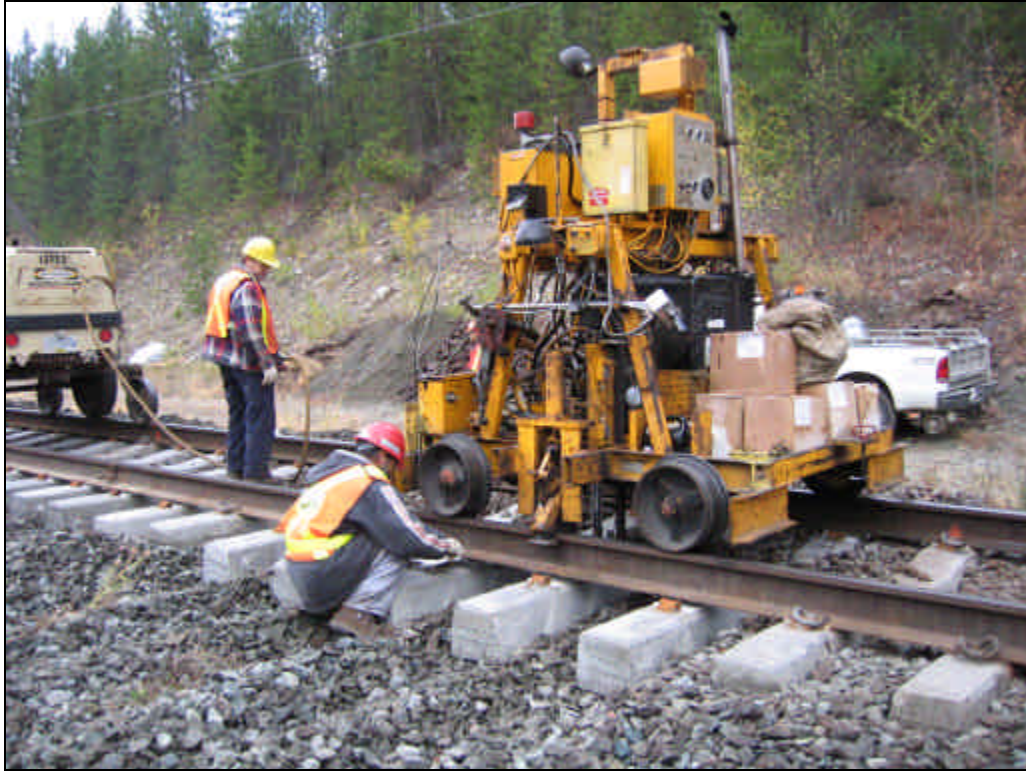
Figure 14 – Pad Installation

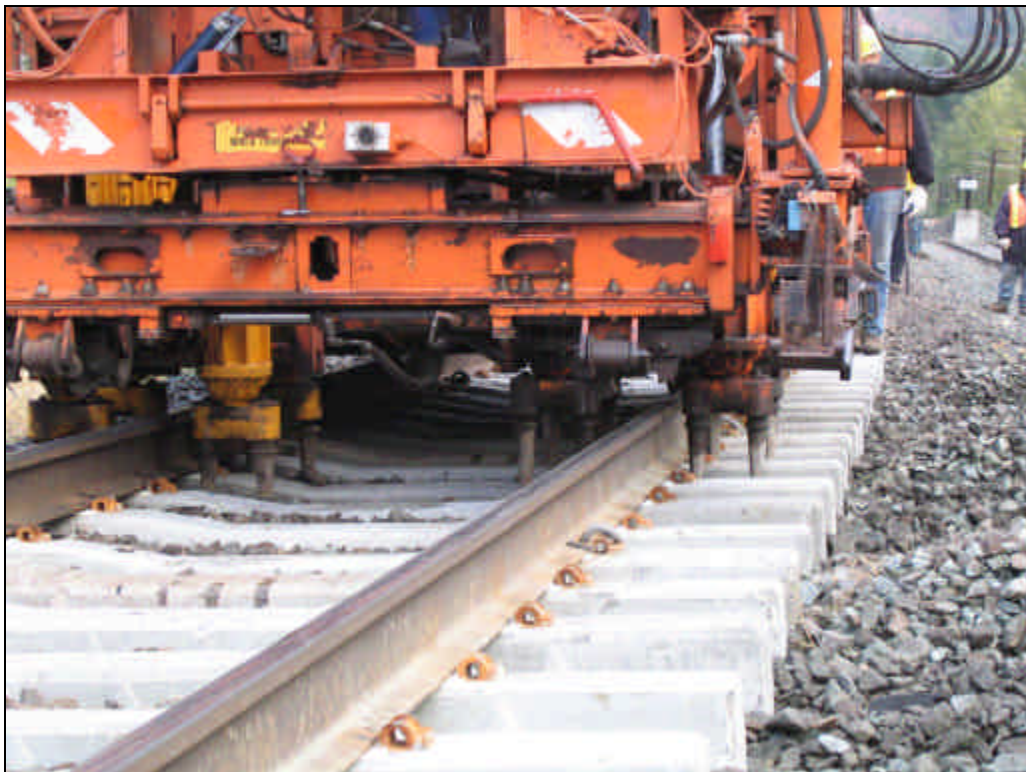
Figure 15 – First Pass Tamp to Nip Ties

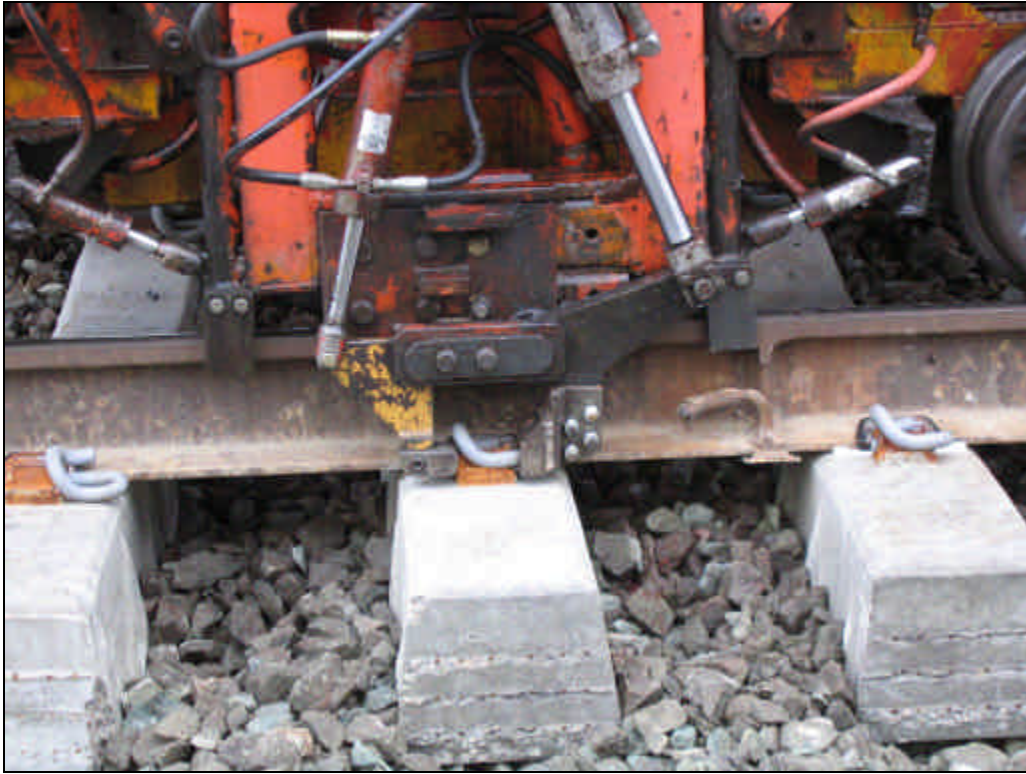
Figure 16 – Clip Installation

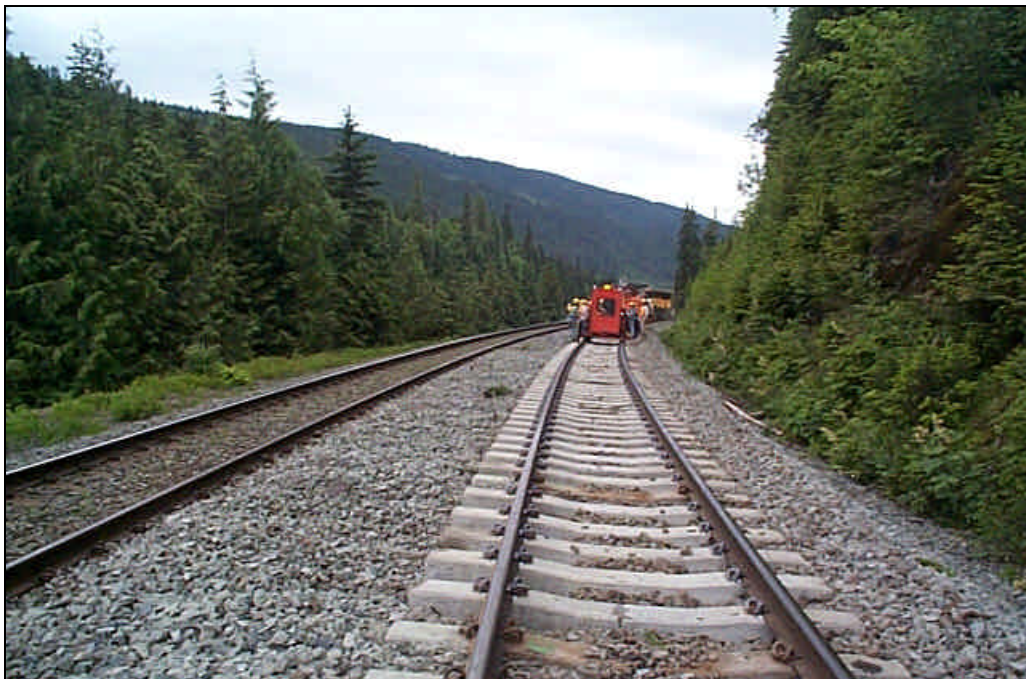
Figure 17 – Track Clipped and Ready for Ballast and Final Tamping
