## JRCICE2007-40096

### Prevention of Derailments due to Concrete Tie Rail Seat Deterioration

#### ABSTRACT

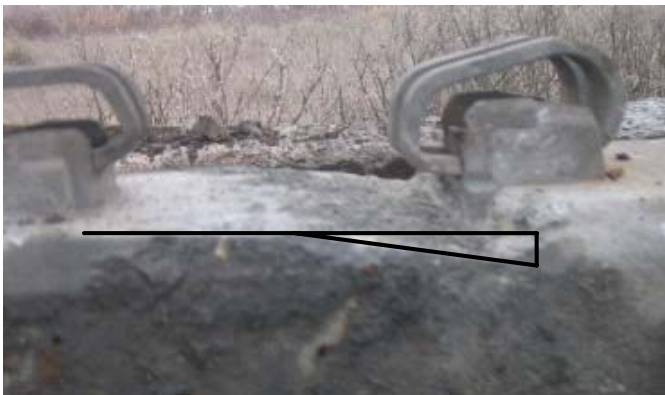
Photographs from concrete ties removed from the derailment site and other areas in the railway industry show a wear pattern that has a triangular shape with loss of material on the field side of the tie. This shape and the type of abrasion shown indicate that the tie was over loaded on the field side and only one-half of the available bearing area was taking up the applied loads. Figure 1 shows the triangular abrasion pattern with the black lines highlighting the abrasion shape. Figure 2, from an internal BNSF report, is the measured profile of an abraded concrete tie from a recent Amtrak derailment showing that the abrasion, still in a triangular pattern, within one inch from the gage side shoulder [6].

**Figure 1. Triangular abrasion pattern in a concrete tie with black lines outlining a triangular pressure distribution assumed for this analysis.**

Figure 4 represents the pressure on the field and gage side around a recent Amtrak derailment. The derailment is around the 1560-foot marker. At this location, the concrete stress contact from the wheel rail load predictions excides the allowable concrete stress. Under these conditions, it would be expected that the concrete would begin to fail and produce a pattern as those seen at the site and depicted in figure 1. For worn

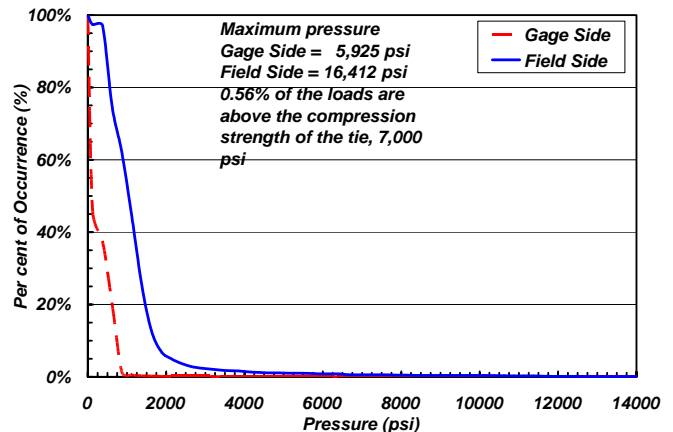
Figure 5 presents a distribution of the pressure versus the number of occurrences over this 1000 foot track section. Figure 6 is a plot of percent occurrence of the field and gage side pressures.

**Figure 6. Field and gage rail seat pressure distribution as percent of occurrence.**

The maximum pressures based on this analysis and assumptions were 5,925 psi for gage and 16,412 psi for field side. While the gage side pressure is within the design limits of most concrete ties, 7,000 psi [9], the field side maximum pressure exceeds this limit by a factor greater than 2. Average pressure for the gage side is approximately 400 psi with similar values for the field side with the exception of a secondary peak around 1,200 psi and higher pressures beyond the design limit. It is believed that these pressures beyond the design limit are the driving forces for rail seat deterioration.

The percentile of pressure that exceeded the design limit, 7,000 psi, is 0.56%. This is a small number but it is consistent with isolated locations where this type of deterioration has been found. The breakdown of concrete due to exceeding the concrete compressive strength under repeated loadings would occur at isolated locations where geometry irregularities caused high load levels. The correlation of excessive pressures due to track geometry imperfections and abraded ties at this site provides an explanation why RSA is occurring. Even at lower load levels, concrete tie rail seat abrasion is initiated. Once abrasion is initiated then other factors such as foreign material between the concrete tie pad and tie and moisture will accelerate this process.

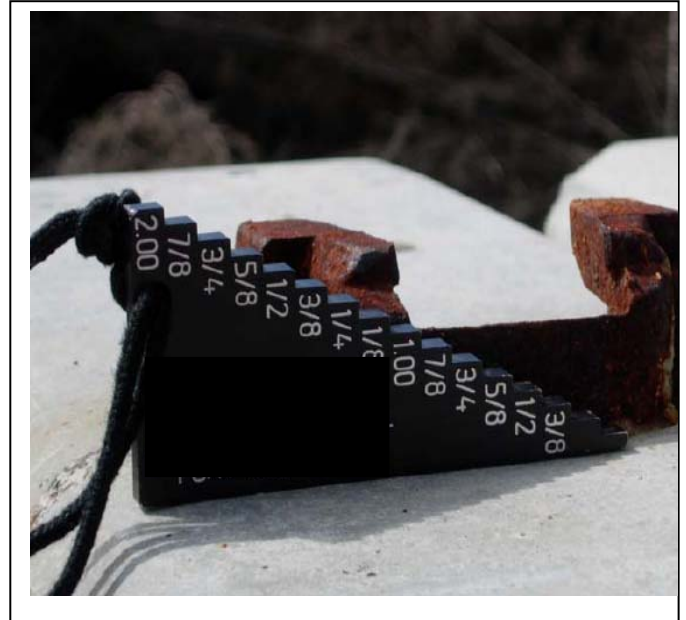
Figure 7, shows one rail seat abrasion measurement device currently available. Other similar devices or a rules/tape can be used to measure concrete tie abrasion. This gage fits between the abraded tie and the rail base to measure concrete tie abrasion. Other similar feeler gages or a ruler can be used in the absence of a specific measuring device.

**Figure 7. A Typical rail abrasion measurement device**

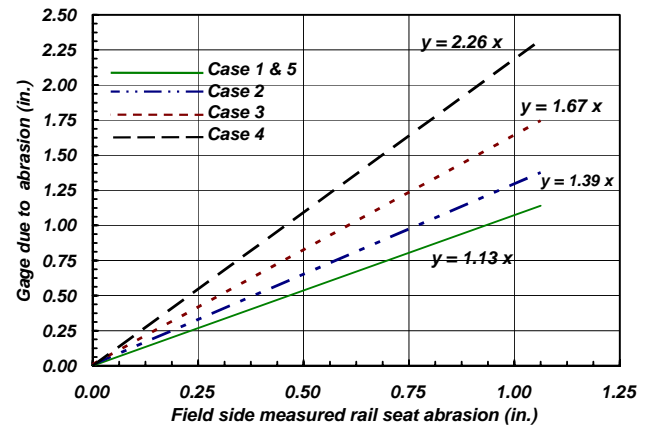
The curves indicate that the worst case is when the rail pivots about the centerline of the rail while the pivot point at the gage side rail base is the most benign of all the cases. The affected rail base length controls this change as the pivot point moves from gage side to the centerline of the rail. Regardless of which case of abrasion is considered if there is an inch measured rail seat abrasion there could be an addition of  $1\frac{1}{8}$  to  $2\frac{1}{4}$  in. gage widening.

Figure 9. Recommended charts to calculate loaded gage at location with concrete tie rail seat abrasion.

Results from a parametric study to analyze the variation between four different rail sections and the pivot point at the rail centerline (case 4) are shown in Figure 10. The differences between the various rail sections are very small. Maximum difference at 1.0 inch measured rail seat abrasion is less than  $3/16$  of an inch or approximately 4.7 percent. The same was found for the pivot point at the gage corner with the maximum difference of less than  $1/16$  of an inch or approximately 4.9 percent. Based on this result, one curve was developed for each level of abrasion for all the rail section and each curve is presented in Figure 9 along with an equation of the line.

gage to calculate the loaded gage. However, if the field gage was  $\frac{1}{2}$  inch by subtracting the gage side measured abrasion there is a net  $\frac{1}{4}$  inch abrasion on the field side. Using the net measured abrasion and case one the additional gage added to the measured track gage from Figure 9, is approximately  $\frac{1}{4}$  inches.

The conditions described and the values given in table 2 are based on case 4, worst-case scenario, and three rail wear limits, new,  $\frac{1}{4}$ , and  $\frac{1}{2}$ . These values are somewhat restrictive, but due to the uncertainty of the pivot point location on the abraded rail seat, these values are warranted at this time. As measurement methodologies improve, either from automated inspection vehicles or hand held devices, then the curve given in Figure 9 and values in Table 2 can be adjusted to reflect the new field data.

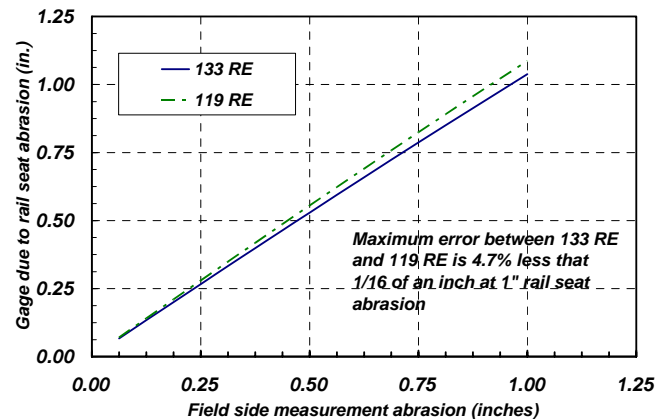
Figure 10. Additional Track gage comparison between rail sections with the rail pivot point at centerline.

With the measured abrasion value and pivot level use Figure 10 or use the equation to determine an additional gage under vertical and lateral loads. As an example, if the measured abrasion is  $\frac{1}{2}$  inch and the pivot is determined that the pivot point is 1 inch away from rail base gage side then the additional gage added to the measured track gage is  $\frac{5}{8}$ ".
