General Summary

Affordable Inspections, Inc.

Karen Brown

15 Keasler Rd

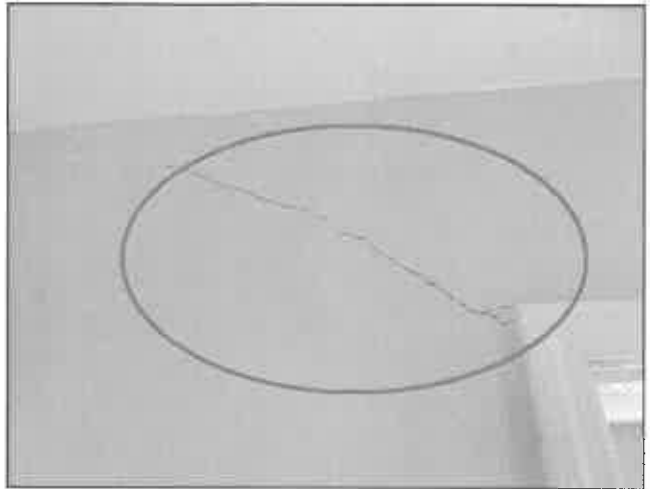
1.1 Item 2(Picture)

(1) In the master bedroom at the bathroom door, there is significant cracking at the corner of the door frame. I believe this is associated with the deterioration of the floor structure under the bathrooms as commented below in section 1.3. Recommend further investigation by licensed general contractor and repair as/if necessary.

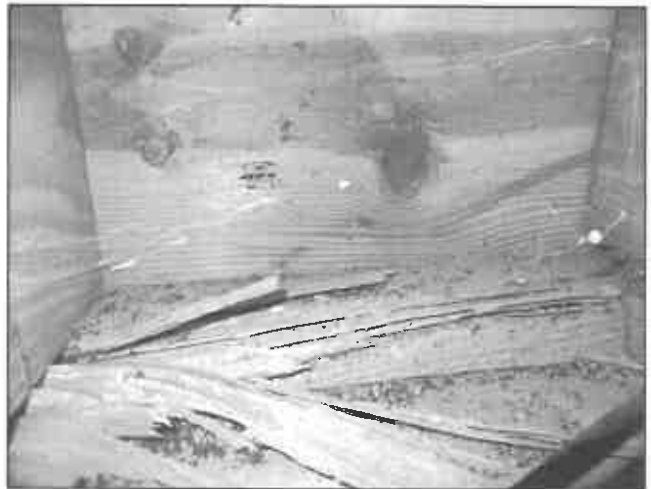
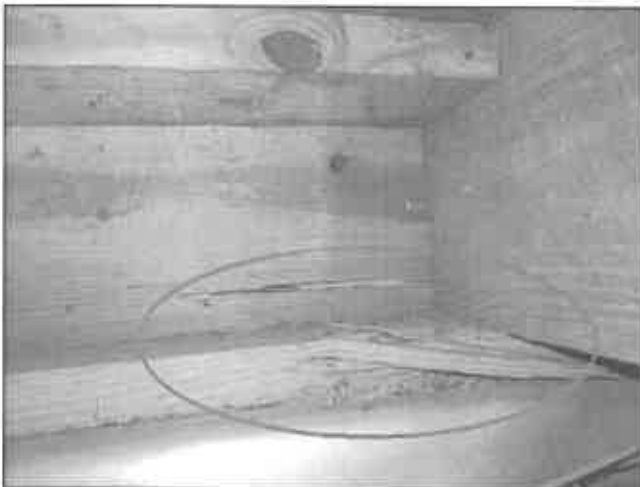
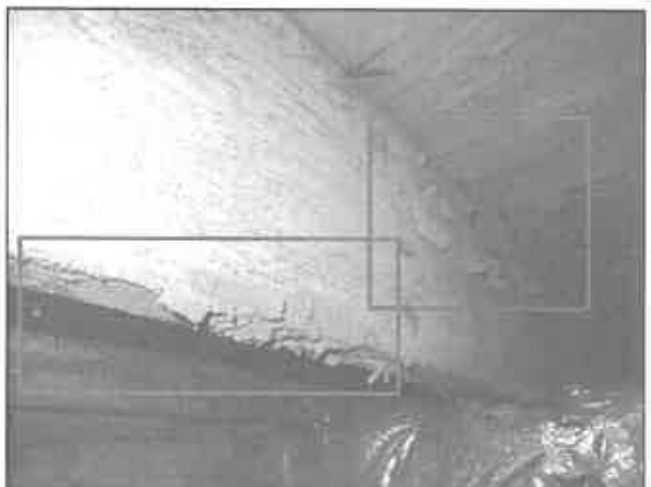
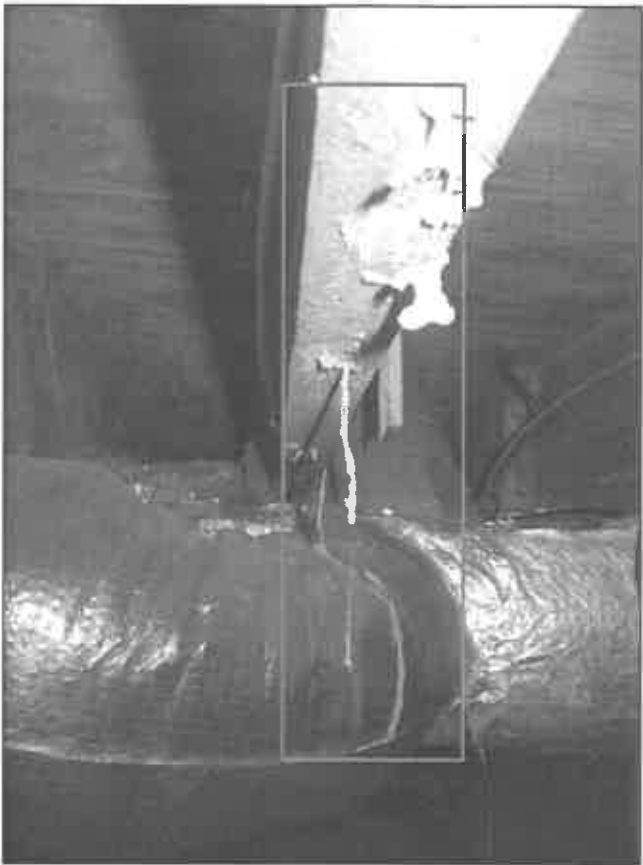
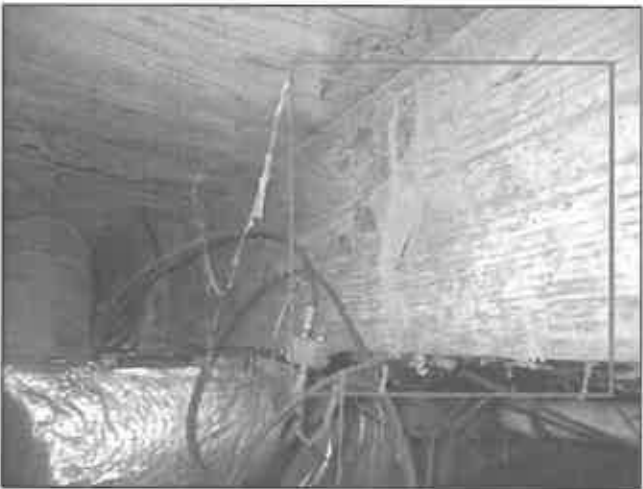
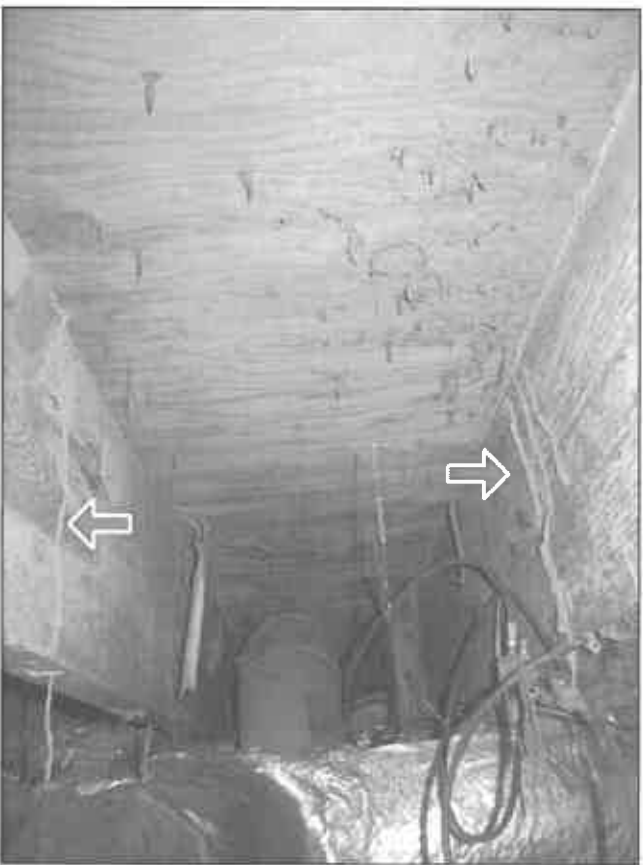
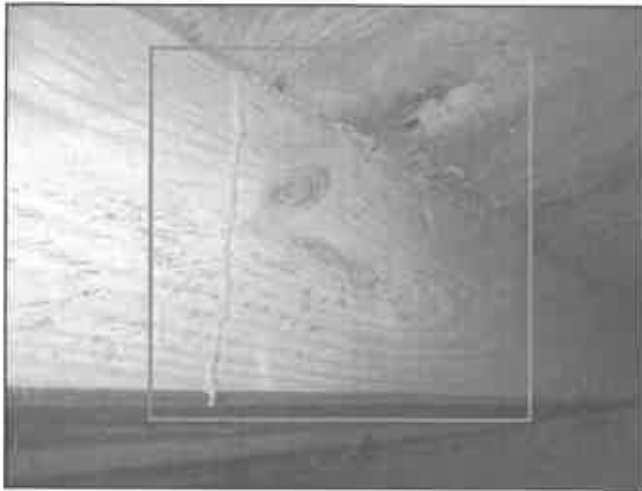
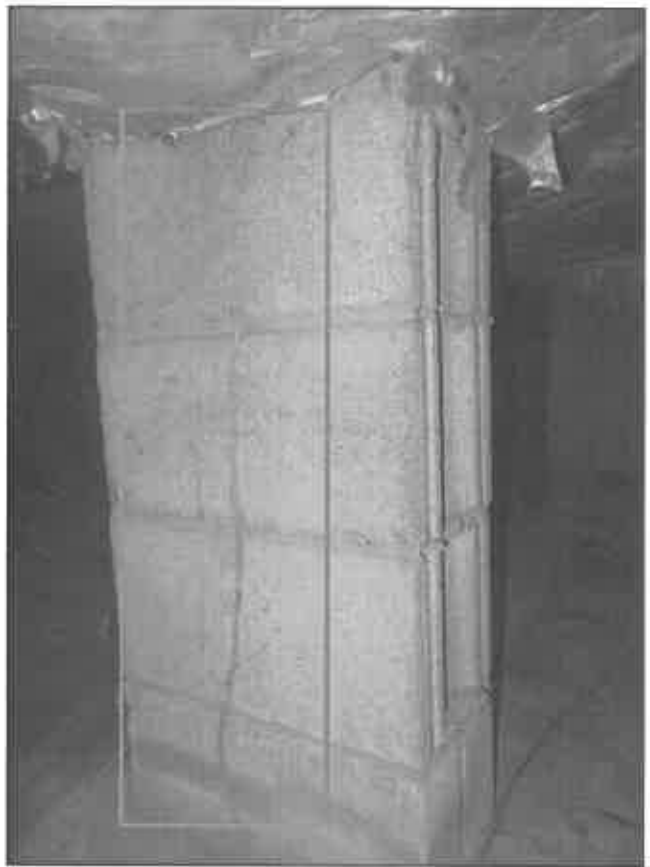
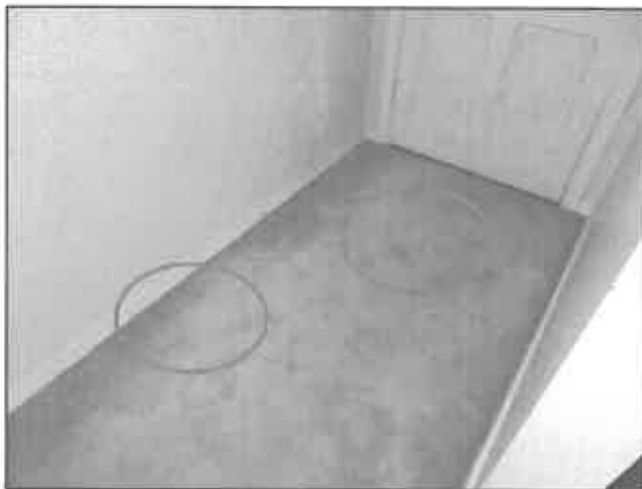
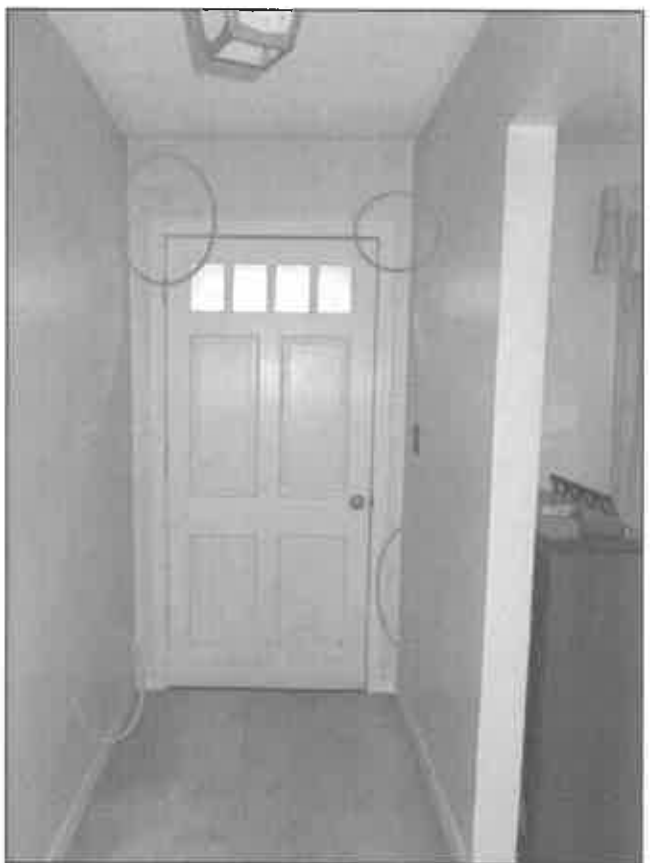
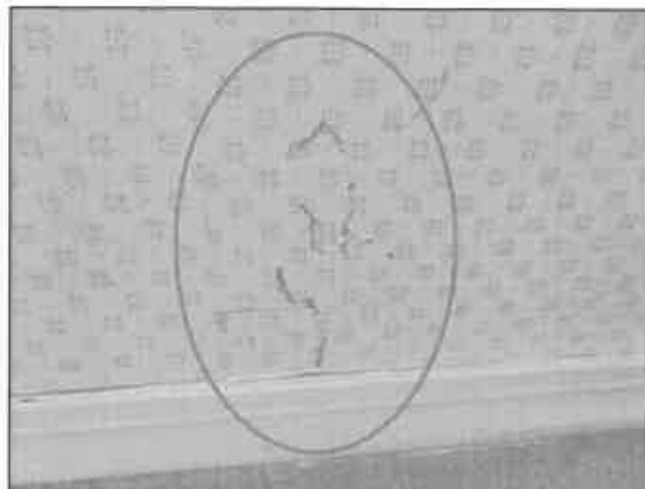
from the front door over in the crawlspace) have been attacked by wood destroying insects. They weaken the wood, eventually causing it to deteriorate completely. There was evidence of prior treatment of the house. I did not see any active wood destroying insects during the time of the inspection. This damage was also noted in the interior with weak spots in the floor and evidence of prior activity on the wall paper near the front door area as well as on the floor in the first bedroom. We would recommend further inspection and repair by licensed general contractor of any compromised wood members.

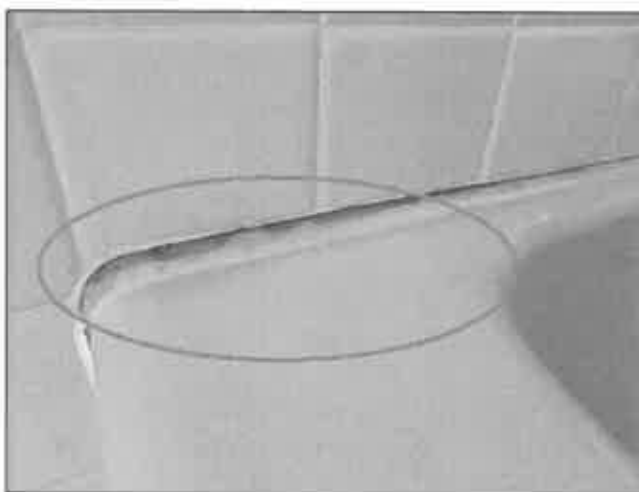
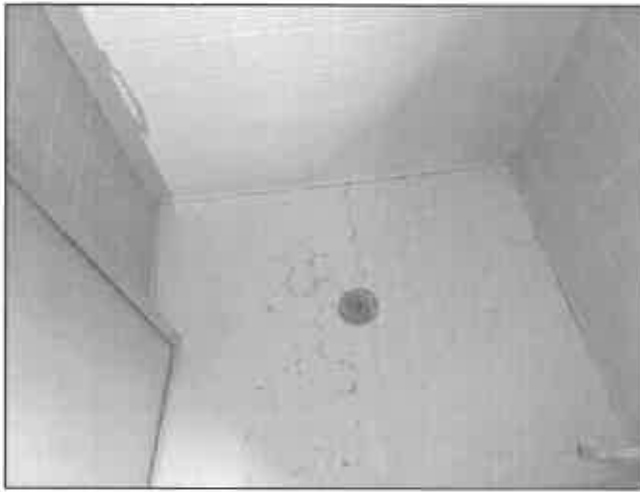
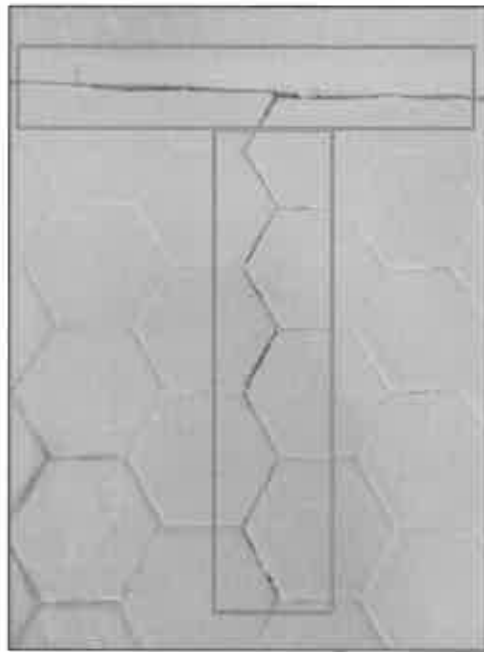
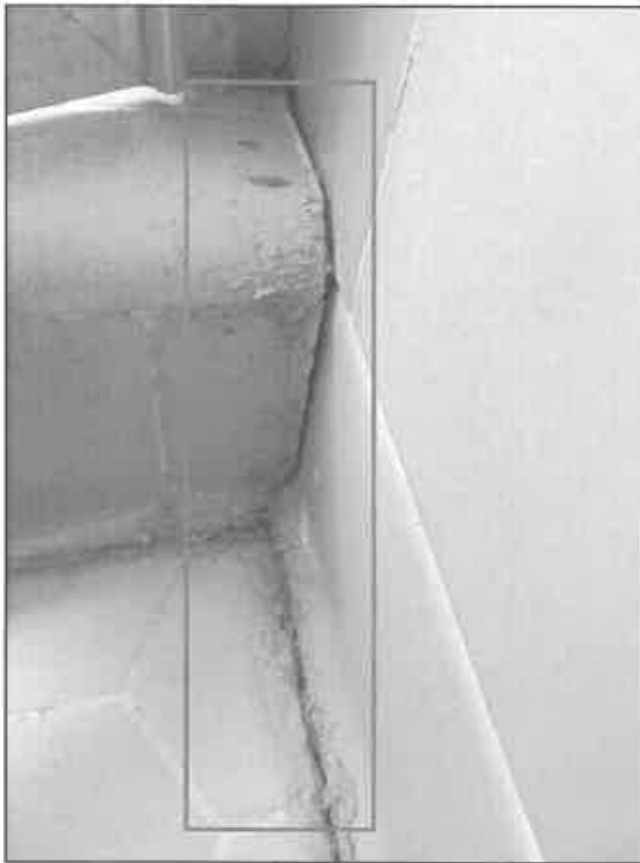
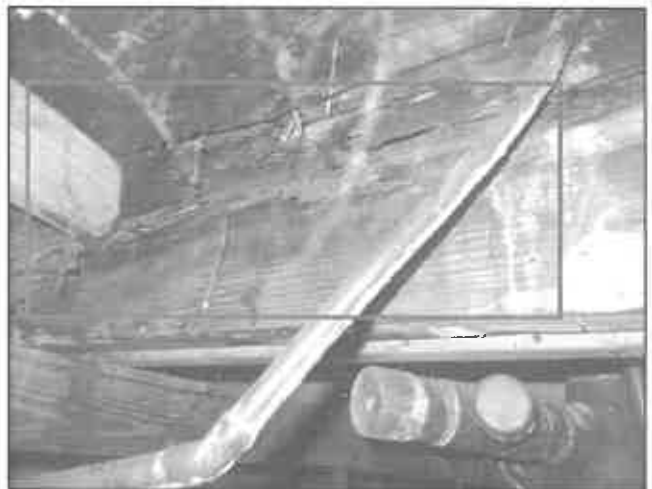
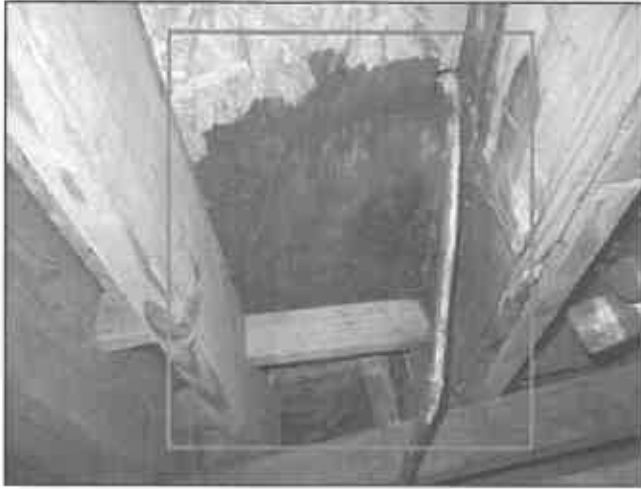
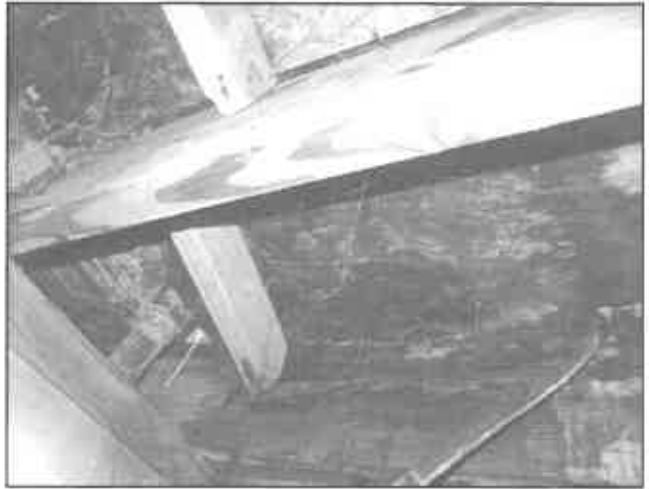
(2) The floor under the master shower area was heavily deteriorated and there was movement of the floor structure in front of the hall tub when stepped on. The deterioration and movement has lead to cracking of the hall bathroom floor with loose tiles in areas along with settling of the tub and cracking and displacement of the master shower floor. I believe there is continued leaking of the master bathroom shower as there are significant gaps/cracks in the grout between the tile walls and tile floor with no evidence of repairs in this area. There is evidence of prior repairs under the tub area, however the continued movement of the floor indicates that the repair is not sufficient. Recommend further evaluation and repair as needed by a licensed general contractor.

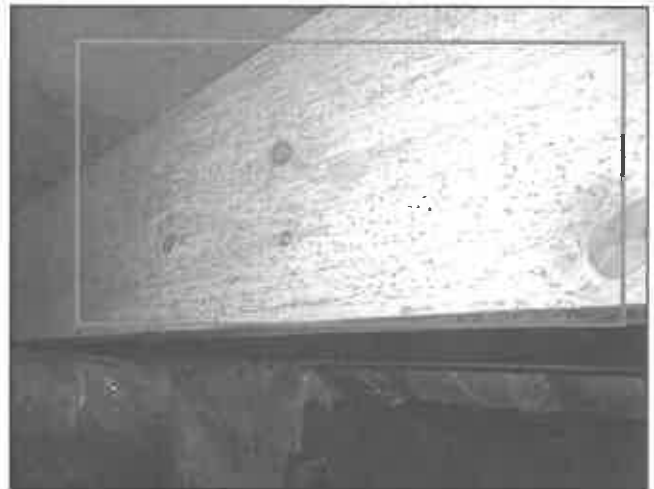
1.3 Item 25(Picture)

(3) There is surface growth on many of the floor joists in the crawlspace. No damage to the wood joists was visible from this growth, but the surface growth is indicative of a damp atmosphere which can be fertile ground for more destructive organisms. Recommend further investigation by crawlspace contractor specializing in moisture control.

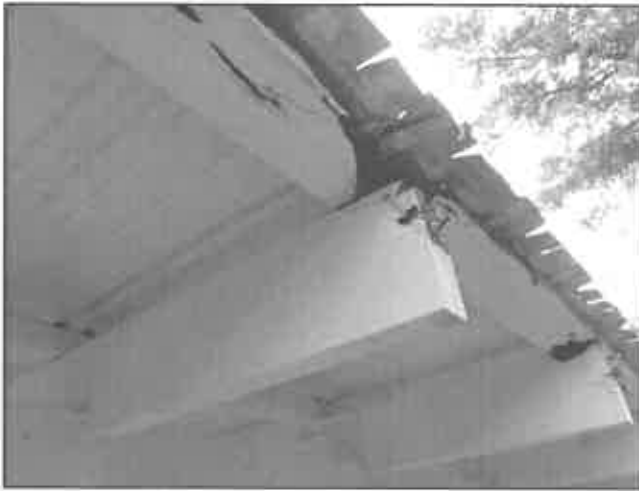
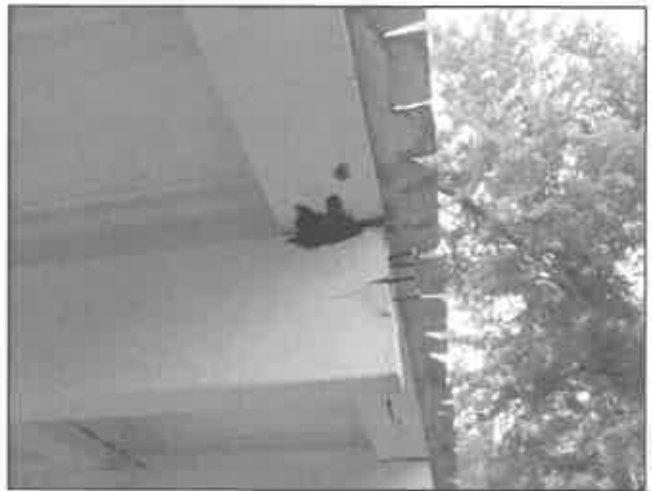
(1) The rafter tails of the rear porch structure are deteriorated. It appears that there used to be a fascia board that went across this area that presumably rotted away. Recommend further evaluation and repair/replace as needed by a capable person or a qualified contractor.

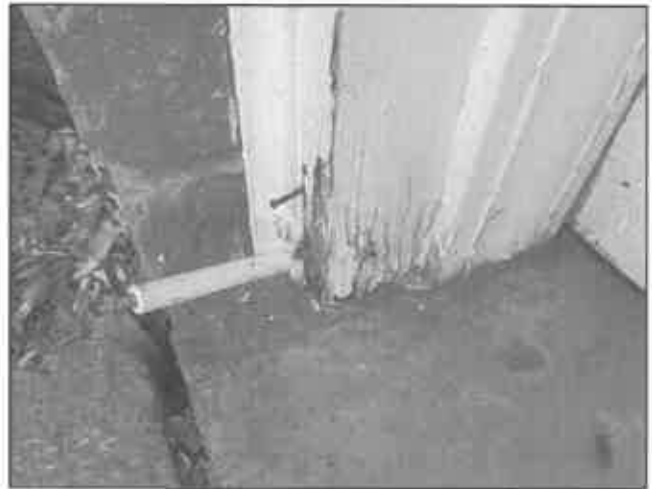
2.0 Item 2(Picture)

The bottoms of the jamb and trim of the garage door are deteriorating. Damaged exterior components can allow for infiltration of moisture and further damage to framing or other interior materials. Recommend repair or replacement by a capable person or a qualified contractor.

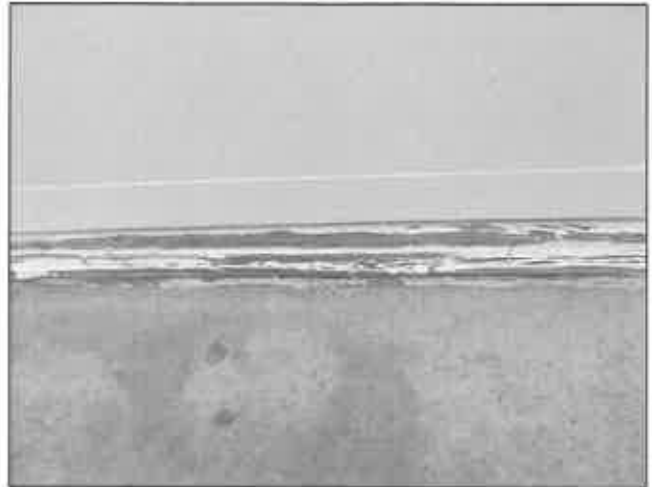
2.1 Item 4(Picture)

(1) The siding is deteriorated at the back of the house under the kitchen window area. Be advised that we are unable to see behind the siding to determine if any damage has occurred to concealed building components. Recommend further evaluation and repair as needed by a capable person or a qualified contractor.

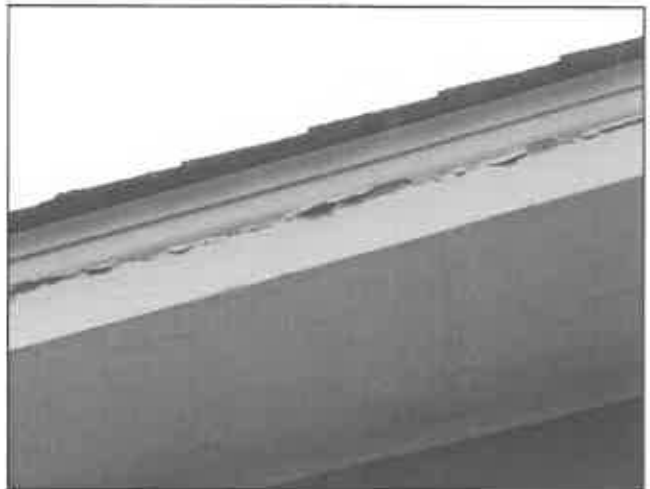
2.2 Item 2(Picture)

As a general note, the wooden soffits and fascia are in need of general maintenance and painting. Recommend further evaluation and repair by a capable person or a qualified contractor.

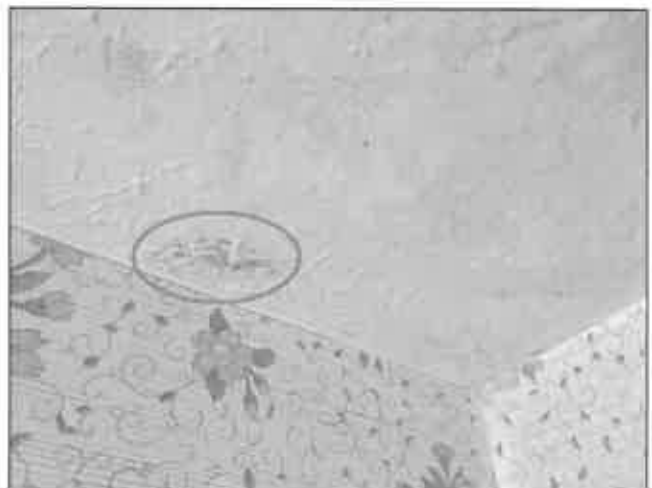
8.0 Item 2(Picture)

(1) There were two areas on the hall bathroom ceiling that appear to have come from moisture. Both of these areas measured dry at the time of the inspection despite it having rained at the start of the inspection. I suspect that this is from a prior roof issue that no longer seemed present. It was noted that the spot in the corner appeared to have some dark fungal growth present. I can not determine if there was other fungal growth behind this area. Recommend further evaluation and repair as/if needed by a qualified contractor.

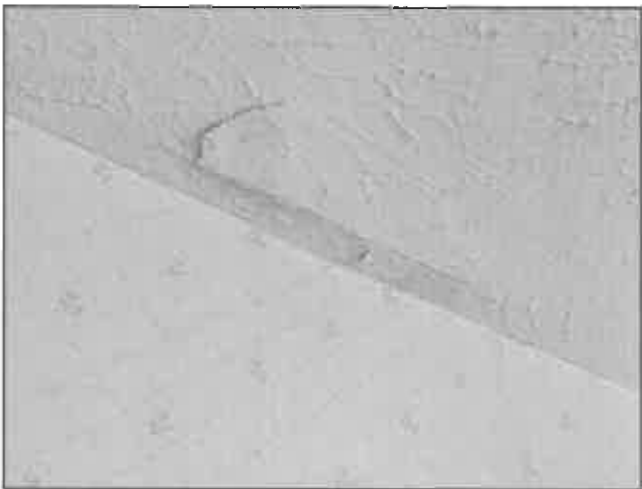
8.0 Item 5(Picture)

(2) In the dining room, there were two spots on the ceiling with damage. These appeared to be a bit more than just a nail pop. Below at the door frame was a crack. This indicates some potential movement at this area. This is on the opposite side of the house as the WDI damage noted above in the structural section. Recommend further evaluation and repair as/if needed by a capable person or a qualified contractor.

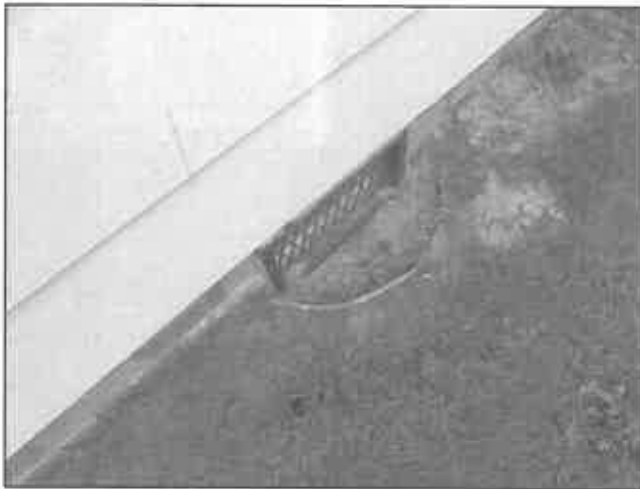
9.1 Item 3(Picture)

All of the foundation vent and window "wells" around the house are filled with debris above the level of the vents/windows. This can provide a direct path for water to enter the crawlspace/basement areas. The bottom of wells should be a minimum of 4" below the vent and preferably filled with gravel to aid in drainage. Recommend repair by a capable person.
