## Operational Assessment of ANO-2 Steam Generator Tubing for the Remainder of Cycle 14

February 3, 2000

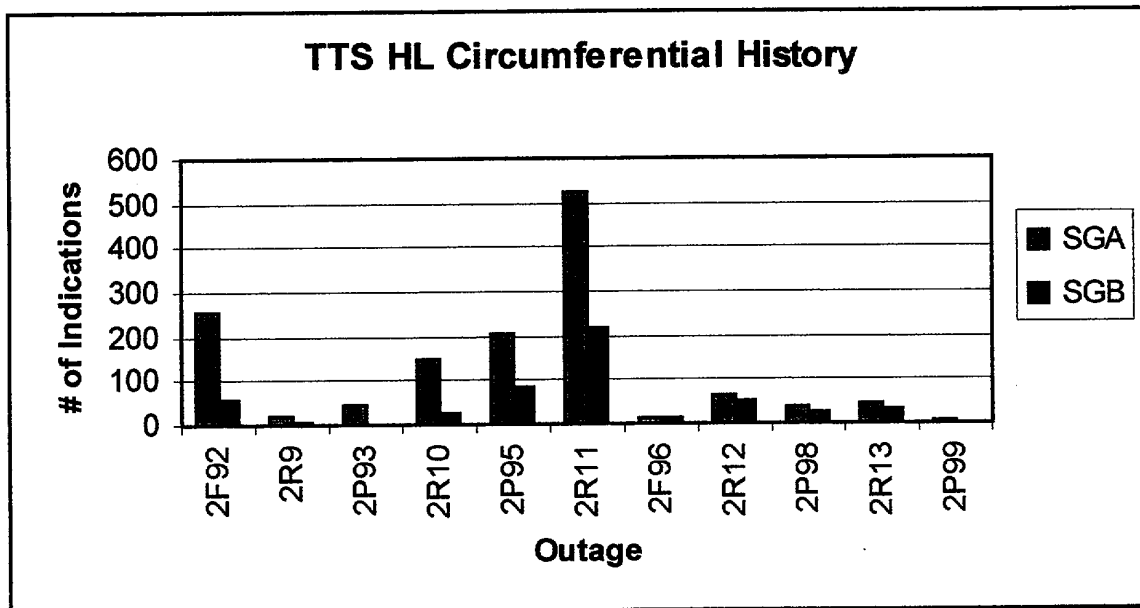
Figure 3.1

Graphic displays of the above data are presented below:

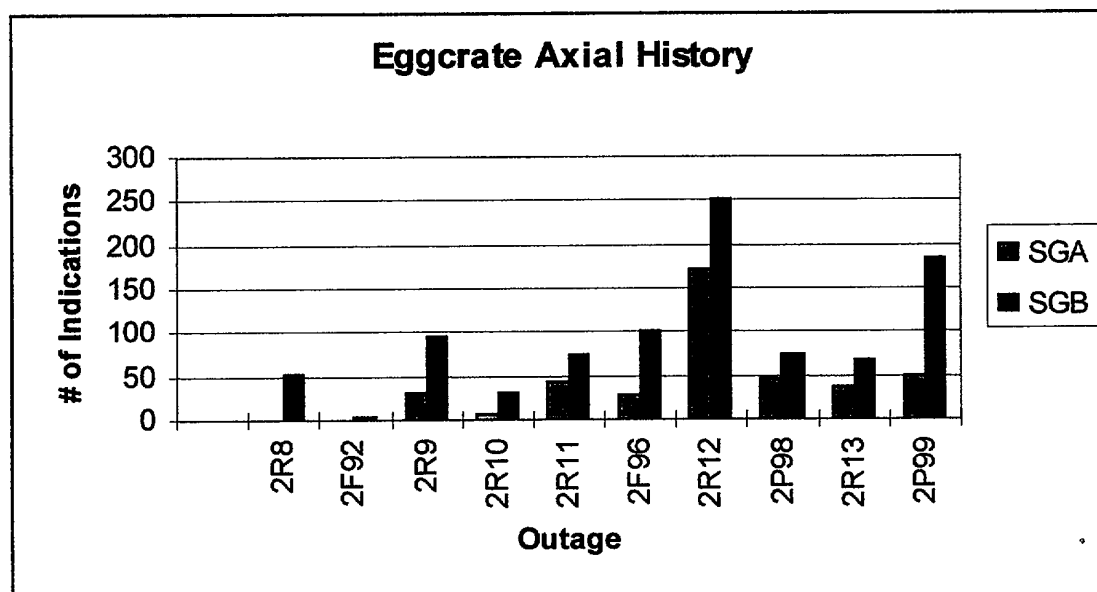
Figure 3.4

As noted in the condition monitoring report<sup>3</sup>, a higher than expected number of eggcrate axial indications were identified in SGB

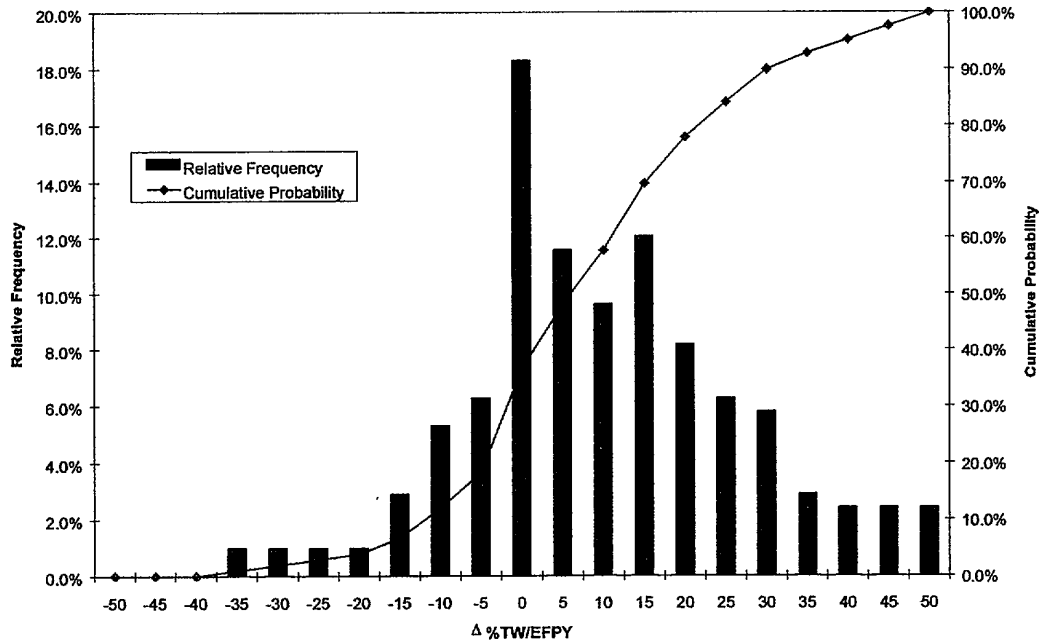
**Figure 5.1**  
**ANO Axial Flow Growth/EFPY (2P99 – 2R13)**

A depiction of the ANO growth data from 2P99 is presented as Figure 5.1 where negative growth values are explicitly indicated. Data from both SGA and SGB are included in Figure 5.1.

Figure 5.1 is normalized to the 1.48 EFPY of operation from 2P98 to the most recent inspection at 2P99. The data suggests the presence of a significant non-destructive examination (NDE) uncertainty component. That is, the overall shape of the distribution, its symmetry about a small growth value near zero and the preponderance of negative values, are consistent with a measurement process where NDE uncertainty is the dominant statistical component for the bulk of the distribution. The empirical data therefore suggest that apparent growth is the superposition of an NDE uncertainty distribution and a "true" depth growth distribution.

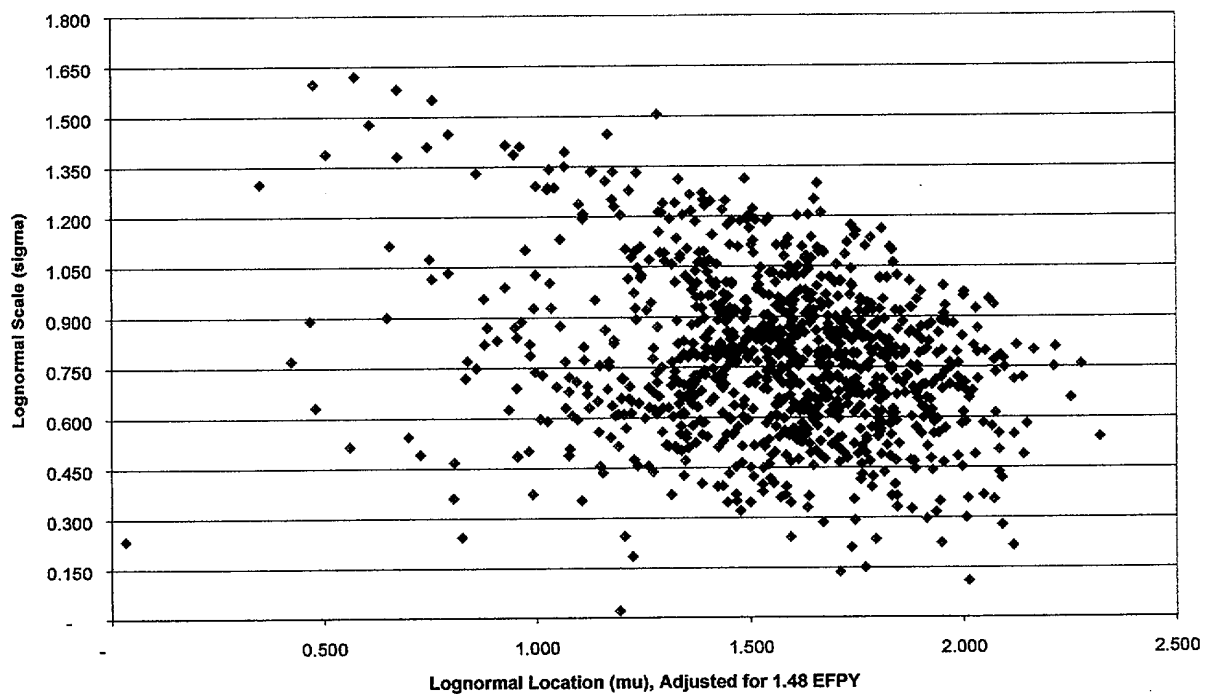
**Figure 5.2**

To eliminate the uncertainty of sizing, a series of 1000 models were performed using the ANO-2 data from SGB during 2P99. From this data set, an optimization process was performed to minimize the effects of the negative growth rates or uncertainty in sizing. The resulting actual growth parameter super-set is indicated in Figure 5.2. If the center value was taken from the scatter plot, the value taken would be consistent with values seen at other Combustion Engineering plants.

**ANO-2 Axial Flaw Growth Rate Model Parameters**  
**ITERR=20, JMAX=50**

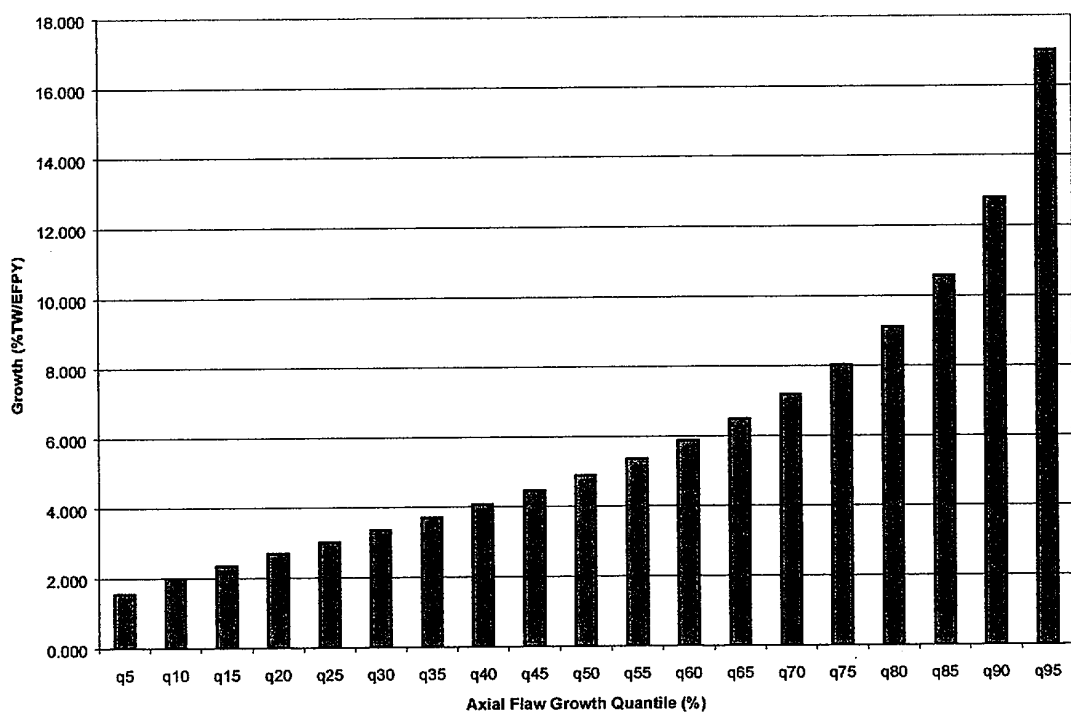
**Figure 5.3**  
**ANO Axial Flaw Actual Growth Model**

The superset of ANO-2 axial flaw growth model parameters are an important input to the probability of burst calculation. This family of lognormal models accounts for uncertainties in the relative contribution to the observed (apparent) growth data from NDE uncertainty and actual growth. The equivalent distribution of actual growth rates that corresponds to this model is provided in Figure 5.3.

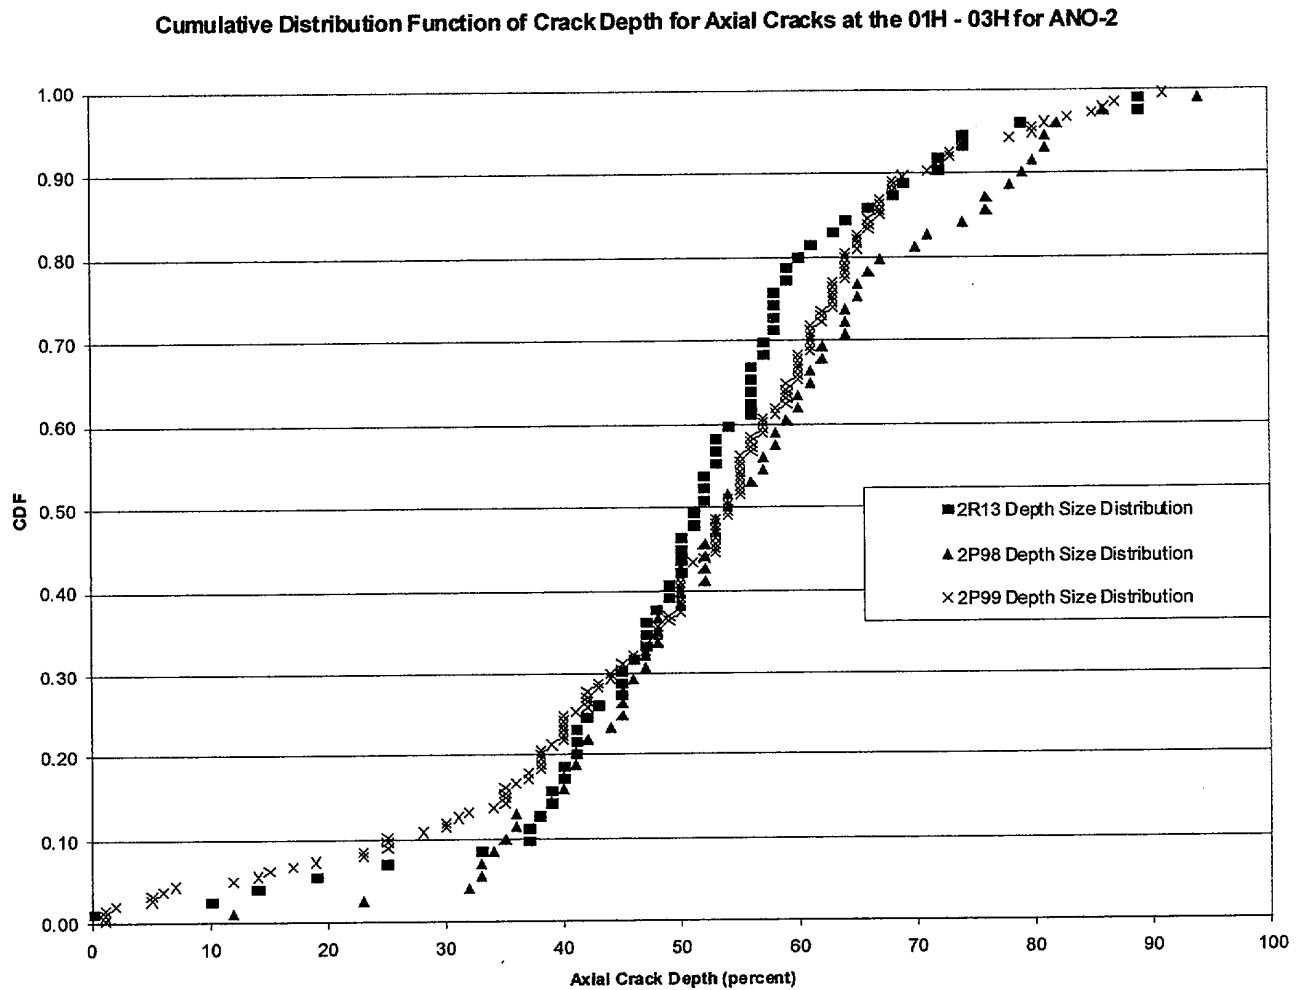
**Figure 5.6**

Figure 5.5 represents the distributions of maximum depths as measured by MRPC for the last three outages which was previously submitted in the condition monitoring report (2CAN129911)<sup>3</sup>. It is apparent in this figure that in the most recent outage (2P99), the depths were approximately 10-15% deeper than those sized in previous outages. Further investigation into the rationale for this result determined that several of the analysts were using channel 1 (300 KHz) instead of the mix channel P1 (300/100 KHz) to perform sizing of the flaws. This data was re-analyzed using the P1 mix. Both the 2P98 and 2R13 outages were performed using the P1 channel for sizing. This resulted in a reduction in depth consistent with the two previous outages. This is depicted in Figure 5.6:
