Declaration of Rachel J. Watters on Authentication of Publication

JRC/ICE2007-40096

Prevention of Derailments due to Concrete Tie Rail Seat Deterioration

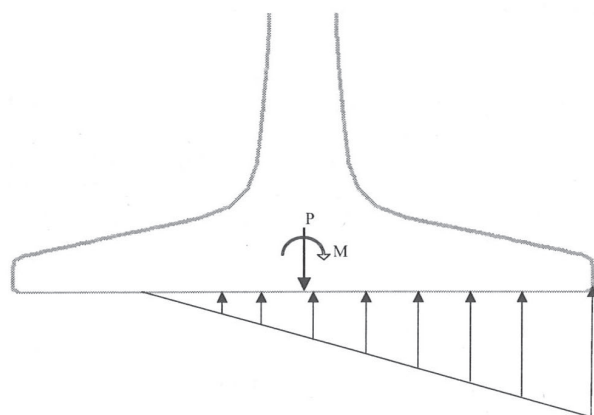
Calculation for the rail seat pressure was modeled similar to a foundation footing with a vertical load and a moment applied at the centerline. As modeled, the rail base was considered the footing resting on the foundation, the rail seat. Depending on the vertical load magnitude and direction of applied moment, as determined by the location and magnitude of applied vertical and lateral loads, the pressure distribution can vary from triangular to trapezoidal to rectangular [7]; a triangular shape is shown in Figure 3. When the rail moment is zero the pressure distribution is rectangular and is equal to the applied vertical load divided by the bearing area. If the eccentricity (e = applied moment divided by total vertical load) falls within the middle third of the rail base the pressure distribution is trapezoidal, given by equation (1) for gage side and equation (2) for the field side. When the eccentricity falls outside the middle third of the rail base then the pressure distribution has a triangular shape and is given by equation (3).

Figure 3. Vertical, moment, and an assumed rail seat pressure distribution on a concrete tie, L/V resultant is outside the middle third of the rail base.

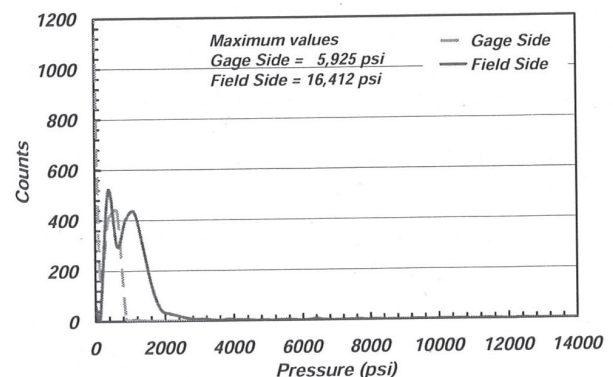
Figure 5 presents a distribution of the pressure versus the number of occurrences over this 1000 foot track section. Figure 6 is a plot of percent occurrence of the field and gage side pressures.

Figure 5. Concrete tie field side and gage side rail seat pressure distribution.

The maximum pressures based on this analysis and assumptions were 5,925 psi for gage and 16,412 psi for field side. While the gage side pressure is within the design limits of most concrete ties, 7,000 psi [9], the field side maximum pressure exceeds this limit by a factor greater than 2. Average pressure for the gage side is approximately 400 psi with similar values for the field side with the exception of a secondary peak around 1,200 psi and higher pressures beyond the design limit. It is believed that these pressures beyond the design limit are the driving forces for rail seat deterioration.

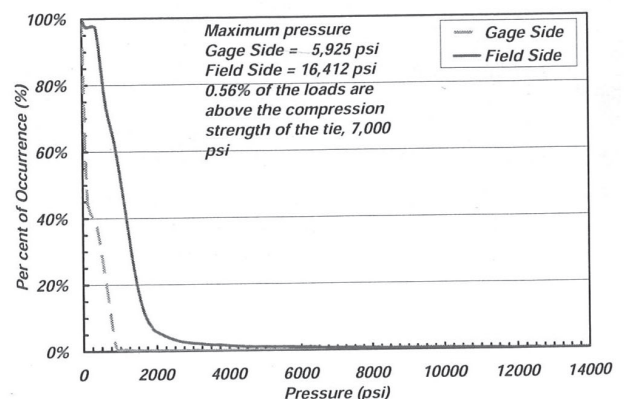
Figure 6. Field and gage rail seat pressure distribution as percent of occurrence.

The percentile of pressure that exceeded the design limit, 7,000 psi, is 0.56%. This is a small number but it is consistent with isolated locations where this type of deterioration has been found. The breakdown of concrete due to exceeding the concrete compressive strength under repeated loadings would occur at isolated locations where geometry irregularities caused high load levels. The correlation of excessive pressures due to track geometry imperfections and abraded ties at this site provides an explanation why RSA is occurring. Even at lower load levels, concrete tie rail seat abrasion is initiated. Once abrasion is initiated then other factors such as foreign material between the concrete tie pad and tie and moisture will accelerate this process.

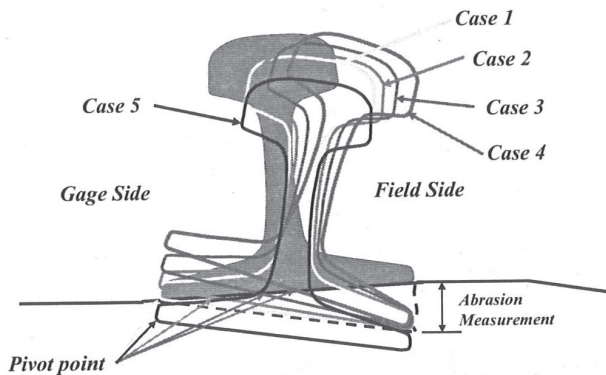
The Charts developed here are designed to convert measured concrete tie rail seat abrasion, measured by a feeler gage or any other similar device, to expected gage when the rail is seated under vehicle loads. This is accomplished by adding the gage change due to the rail roll caused by the rail seat abrasion to the static measurement of gage and comparing it to the gage limit. The rail rotation due to rail seat abrasion is shown in Figure 8 for the five possible cases of concrete tie rail seat abrasion that are found in high curvature track. A description of each case is given in Table 1. Figure 9 is a chart that converts the measured rail seat abrasion to additional track gage for the five different cases of concrete tie abrasion. All cases described here are subject to the abrasion measurements taken at the field side between the rail base and the concrete tie. Two readings are required one on each side of the concrete tie as viewed from the field side to the centerline of the track.

Figure 8. Five possible cases of concrete tie abrasion.

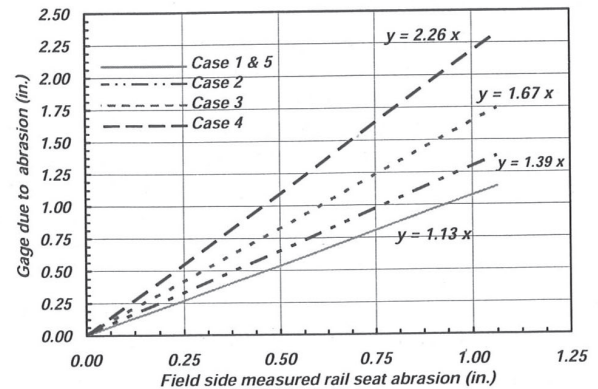
Figure 9. Recommended charts to calculate loaded gage at location with concrete tie rail seat abrasion.

Results from a parametric study to analyze the variation between four different rail sections and the pivot point at the rail centerline (case 4) are shown in Figure 10. The differences between the various rail sections are very small. Maximum difference at 1.0 inch measured rail seat abrasion is less than 3/16 of an inch or approximately 4.7 percent. The same was found for the pivot point at the gage corner with the maximum difference of less than 1/16 of an inch or approximately 4.9 percent. Based on this result, one curve was developed for each level of abrasion for all the rail section and each curve is presented in Figure 9 along with an equation of the line.

gage to calculate the loaded gage. However, if the field gage was $\frac{1}{2}$ inch by subtracting the gage side measured abrasion there is a net $\frac{1}{4}$ inch abrasion on the field side. Using the net measured abrasion and case one the additional gage added to the measured track gage from Figure 9, is approximately $\frac{1}{4}$ inches.

The conditions described and the values given in table 2 are based on case 4, worst-case scenario, and three rail wear limits, new, $\frac{1}{4}$, and $\frac{1}{2}$. These values are somewhat restrictive, but due to the uncertainty of the pivot point location on the abraded rail seat, these values are warranted at this time. As measurement methodologies improve, either from automated inspection vehicles or hand held devices, then the curve given in Figure 9 and values in Table 2 can be adjusted to reflect the new field data.

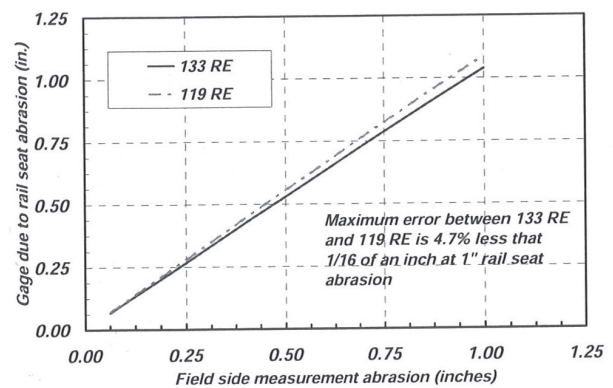
Five new rail sections were considered for evaluation, 119, 132, 133, 136, and 140 RE. Two of the five rail sections, 119 and 133 RE, for case 3, pivot at the centerline are shown in Figure 10. The curves for the remaining rails fall between these two curves shown in the figure. All rails show the same trend with small variation due to rail base and rail height dimensions. The variations are sufficiently small that one curve can be developed from all rails under consideration. Based on the small variations between rail sections, 136 RE rail was selected for the analysis of each of the five cases given in Table 1 and the results are given in Figure 9. Rails of smaller section, i.e., 115 RE and smaller are not usually used on concrete tie track and are excluded from this study.

The curves indicate that the worst case is when the rail pivots about the centerline of the rail while the pivot point at the gage side rail base is the most benign of all the cases. The affected rail base length controls this change as the pivot point moves from gage side to the centerline of the rail. Regardless of which case of abrasion is considered if there is an inch measured rail seat abrasion there could be an addition of 1 1/8 to 2 1/4 in. gage widening.

Figure 10. Additional Track gage comparison between rail sections with the rail pivot point at centerline.

With the measured abrasion value and pivot level use Figure 10 or use the equation to determine an additional gage under vertical and lateral loads. As an example, if the measured abrasion is $\frac{1}{2}$ inch and the pivot is determined that the pivot point is 1 inch away from rail base gage side then the additional gage added to the measured track gage is $\frac{5}{8}$ ".
