# AN EVALUATION OF REMEDIATION TECHNIQUES FOR CONCRETE TIE RAIL SEAT ABRASION IN THE FAST ENVIRONMENT

By: Richard P. Reiff\*

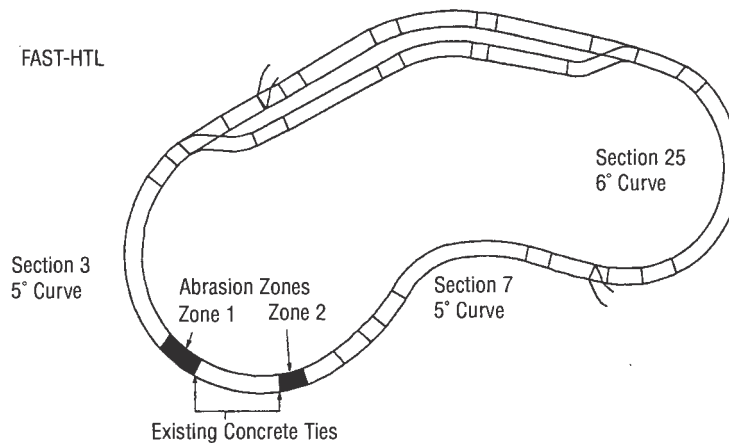
Figure 2. Concrete Tie Rail Seat Abrasion Experiment.

Two test zones at FAST which surround the existing concrete tie test zone in Section 3 (a 5° curve) were selected. (See Figure 2.) The relatively sparse natural moisture normally available in the Pueblo area required supplemental tie watering once every second day of operation. After committee members inspected the test at 30 MGT, watering was increased to twice during each shift of train operation. Using a specially fitted truck to spray the additional water, approximately 21 inches of annual effective moisture was added to the natural 11 inches per year. Thus FAST abrasion zones simulate an environment where approximately 32 inches of rain falls on the track annually.

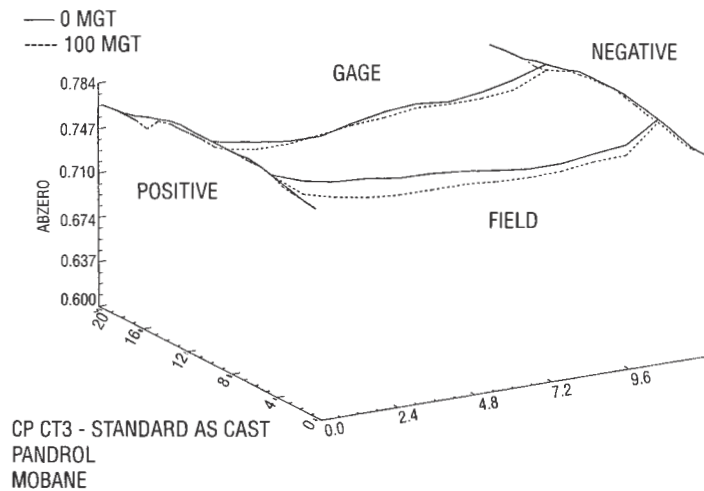
Figure 3. Average Depth Profile

A modified version of an existing abrasion gage utilizing a dial indicator was fabricated. This modification improved the data resolution of a tie pad footprint on the rail seat, which is measured with respect to depth relative to the non-wearing tie surface. Initially, the data was collected with mechanical dial indicator gages, however, updated versions now permit automated and continuous data collection. Nonetheless, this measurement is time consuming and conducted only at infrequent (50-100 MGT) intervals. A sample data plot showing two successive measurements is shown in Figure 3.
