Railroad Accident Brief

Accident No.: DCA-05-FR-010
Location: Home Valley, Washington
Date: April 3, 2005
Time: 9:35 a.m., Pacific daylight time¹
Railroad: BNSF Railway Company
Property Damage: \$854,000
Injuries: 30
Fatalities: None
Type of Accident: Amtrak passenger train derailment

NTSB/RAB-06/03

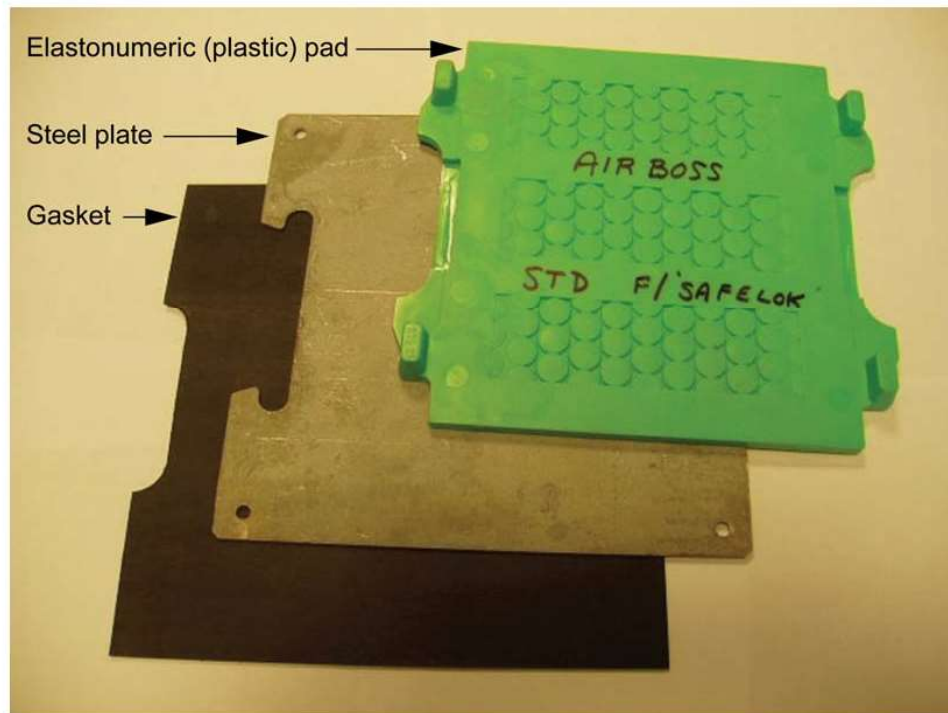
The track structure was built with 136-pound sections of continuous welded rail (CWR)¹⁰ on concrete crossties. The CWR was affixed to the crossties with “Safelok” clips and insulators. A special concrete tie pad separated the CWR from the concrete crosstie rail seat. (See figure 3.) The concrete tie pad consists of a three-piece pad system. The polyethylene gasket pad is about 1.5 millimeters (mm) thick, and it is placed on the seat of the concrete crosstie underneath a layer of 1.4-mm thick steel and a 6.0-mm heavy-duty plastic pad beneath the base of the rail.

Figure 3. Three-piece tie pad system.
