TECH NOTE

No. 003

CessnaPilots Association™

Uneven Fuel Feeding in Single Engine Cessnas

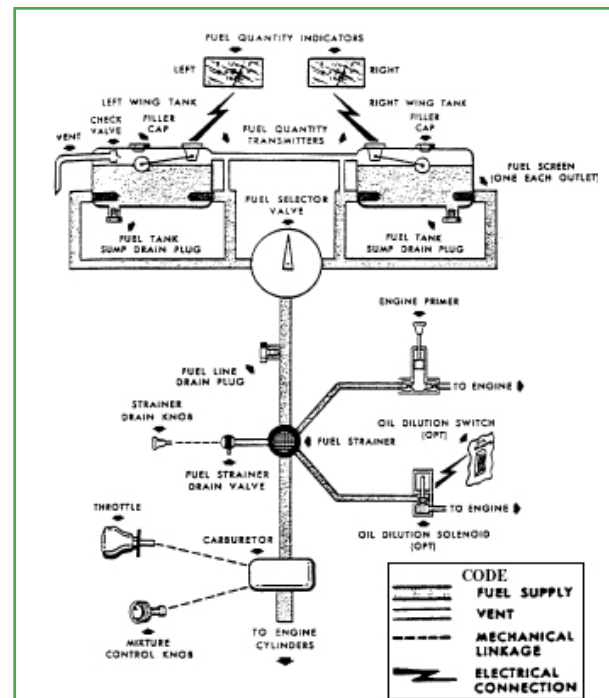
NOTE: The fuel system shown in this schematic is applicable to the Model 182, beginning with serial # 18255786, as well prior serials on which Service Kit No. SK182-38 (thru serial # 18255785) or SK182-41 (thru serial # 18256144)

have worked fairly well except that about the same time, beginning with s/n 18255786 and on, the engineers made another change to the 182's fuel system. Having suspicions that the problem was related to unequal pressures in the tanks, they made an attempt to equalize pressure throughout the system as much as possible by venting the forward

fuel feed lines to the vent interconnect line running across the top of the fuselage. What this actually does is permit fuel to move from one tank to the other any time there is different head pressure in the tanks, even if the fuel level in the tank is below the height of the vent interconnect line. What will happen is that the tank with the higher head pressure will push fuel through the forward fuel feed line up to the vent interconnect line, across the top of the cabin and down into the vent line for the forward fuel feed line of the other tank (See Drawing). There can be a number of causes of this uneven head pressure which will be discussed a little further on.

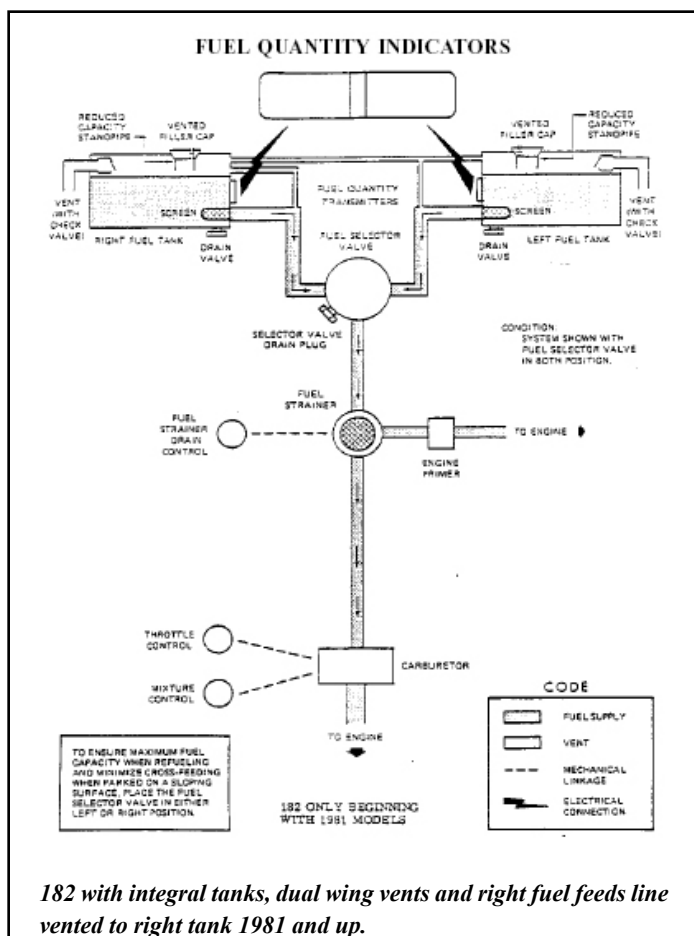
182 with integral tanks, dual wing vents and right fuel feeds line vented to right tank 1981 and up.

Again with the 182 series aircraft Cessna made another change. Beginning in 1981 with serial number 18267716 Cessna rerouted the vent line for the forward fuel feed line on the left tank. No longer did it connect with the vent in-

terconnect line, rather the forward fuel feed line was vented by a line that came from high in the left tank itself. By isolating one of the forward fuel feed lines from the vent interconnect line the passing of fuel from one tank to the other when the fuel level was below the vent interconnect line was stopped. The service manual describes vent position adjustment procedures for evening out fuel flows.
